the **play** inspection company

Annual Inspection

Bacton

St Mary's Close, Suffolk, IP14 4NW

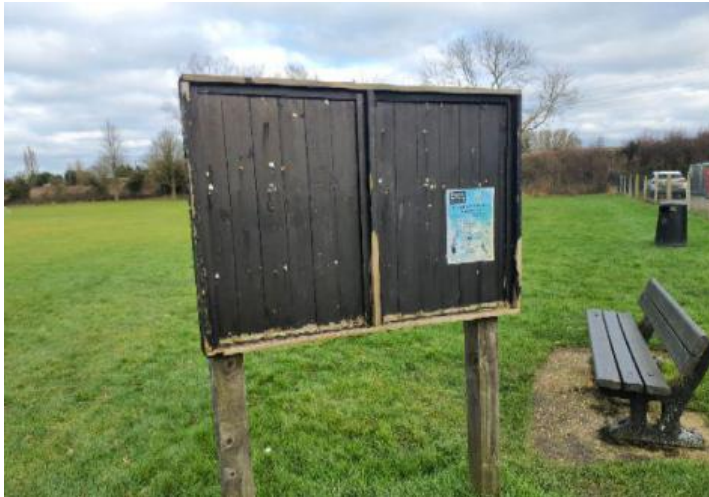
Finding: It is recommended that signage, with information including the site address, contact information for maintenance issues and emergency contact details are provided for the facility

Action: Provide in accordance with the recommendations

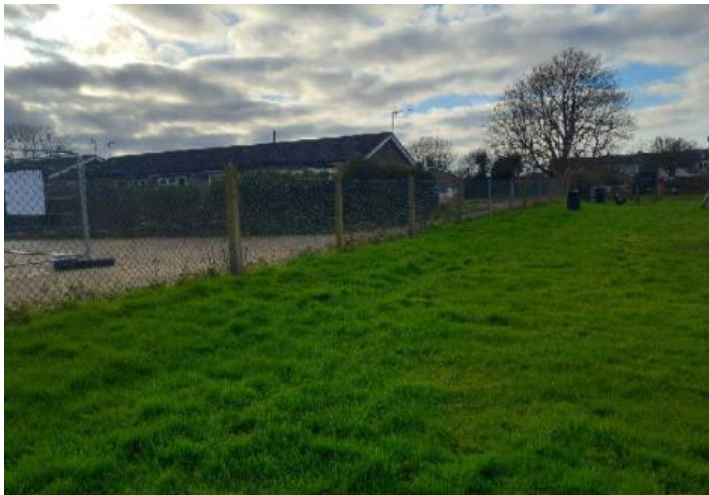
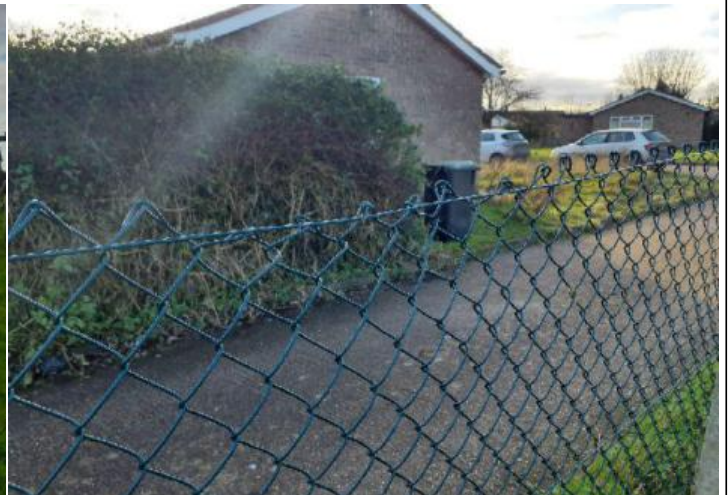
Finding: There is some damage to the fence sections

Action: Monitor for any further deterioration and repair as required

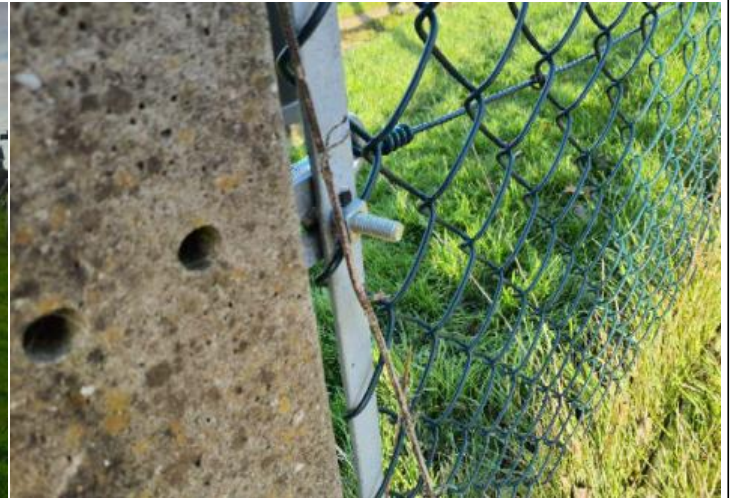
Finding: There are projecting bolt thread(s) present

Action: Remove excess thread length and deburr or provide cap

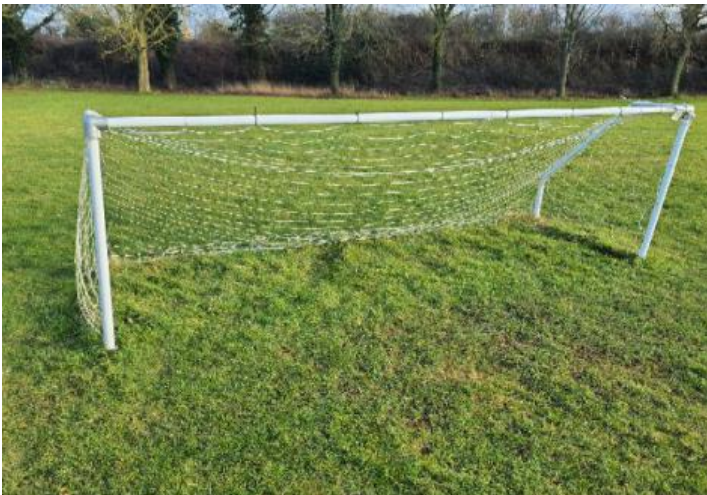
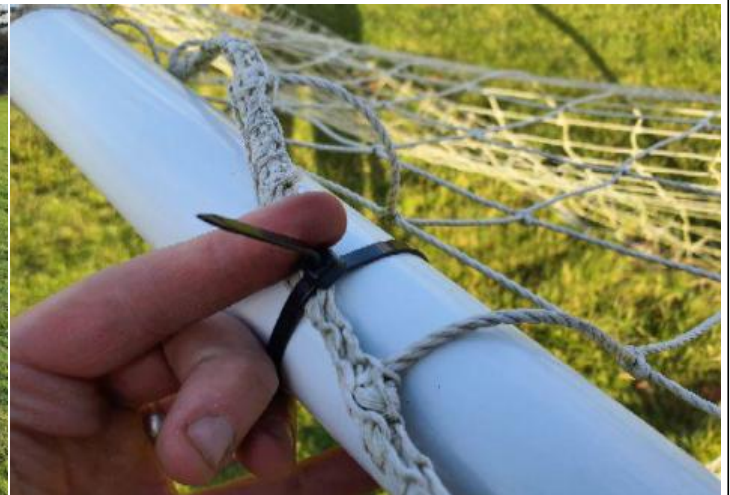
Finding: Cable ties are present and there are projecting ends

Action: Replace with a more appropriate fixing method

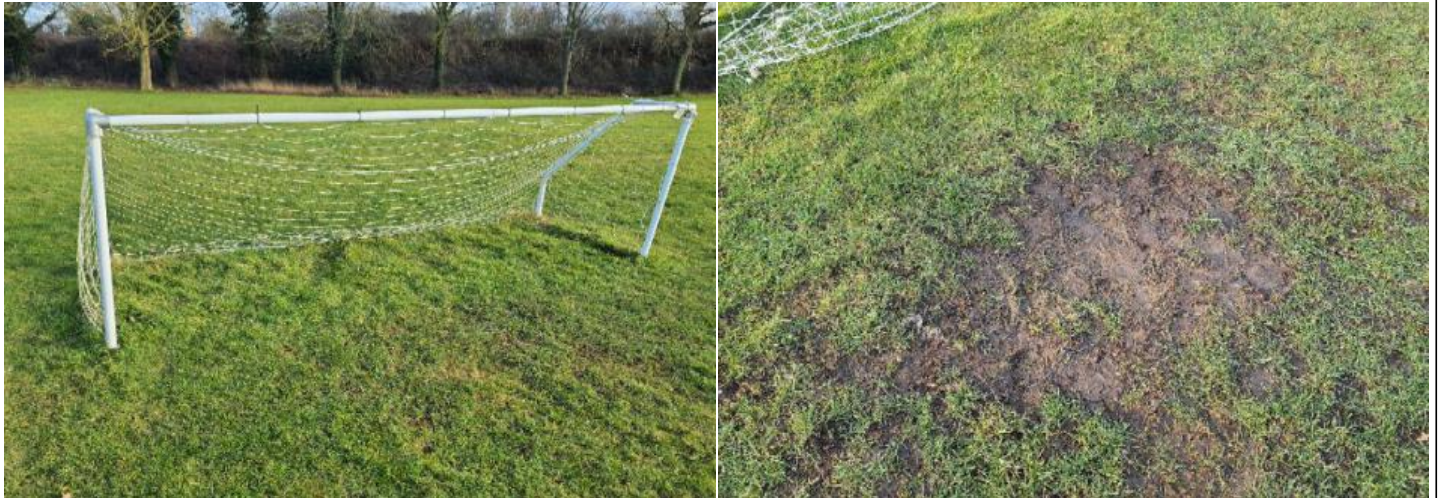
Finding: The surface has eroded in some areas and may be slippery in wet conditions
Action: Reinststate the surface

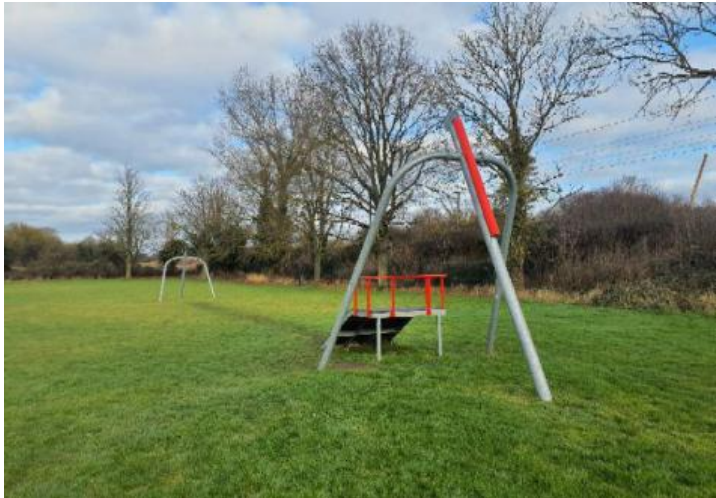
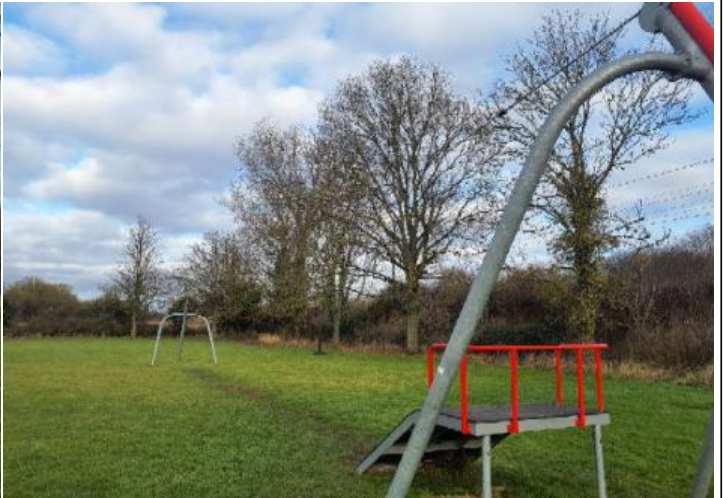
Finding: We have completed a visual inspection of the suspension links, cable and fixing points from ground level, however it is not possible to fully inspect these areas without either hiring equipment to gain access or removing the cable and suspension and inspecting at ground level. We recommend that the main cable and fixing security is thoroughly inspected at least in accordance with the manufacturers recommendations to check for wear, damage, security or internal rusting; this will help to ensure the continued safe use of the equipment

Action: Inspect in accordance with the manufacturers recommendations

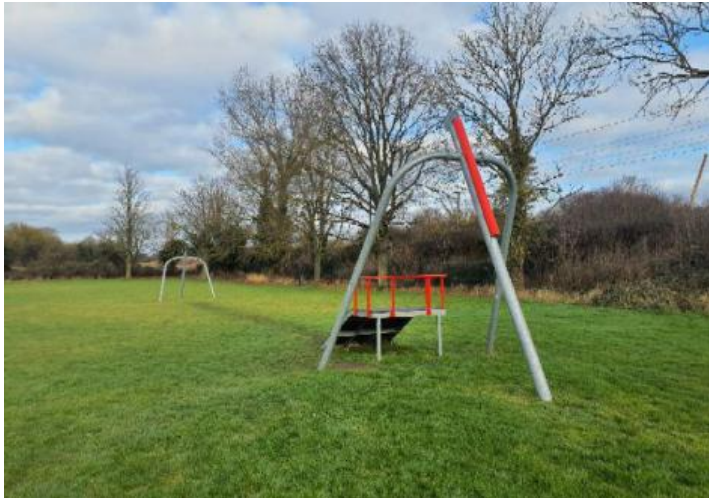
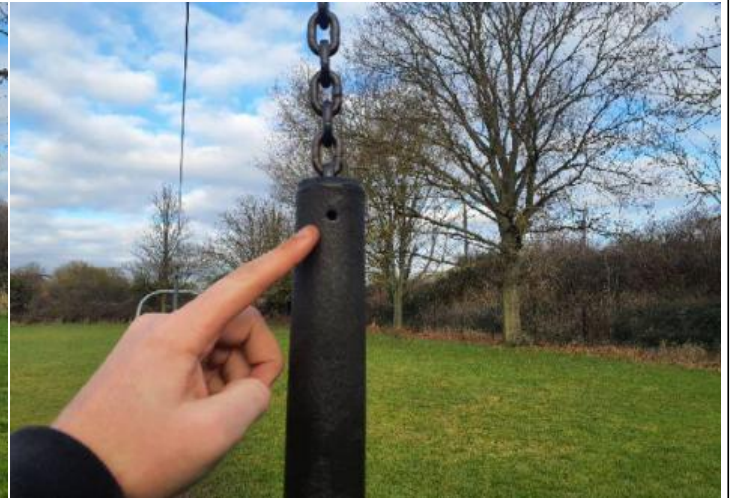
Finding: There is or are fixings missing on the item

Action: Replace all missing fixings

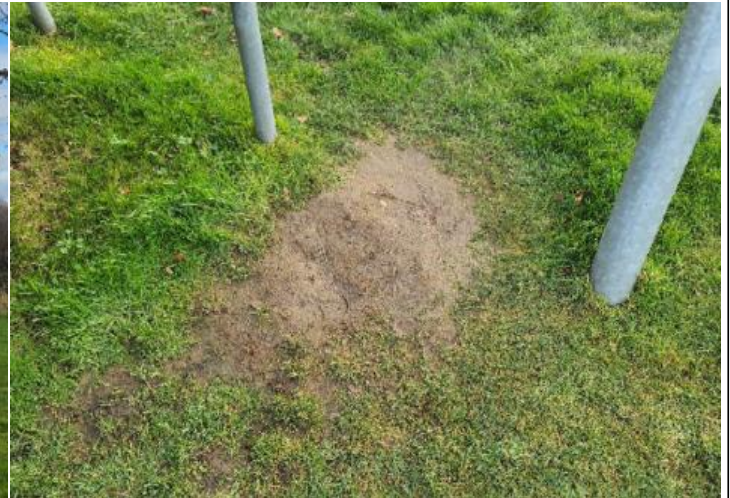
Finding: The grass has eroded within the impact area of the equipment and may not provide the necessary impact attenuating properties for the equipment fall height; the surface may also be slippery in wet weather
Action: Reinstatement the grass or provide an all weather surface

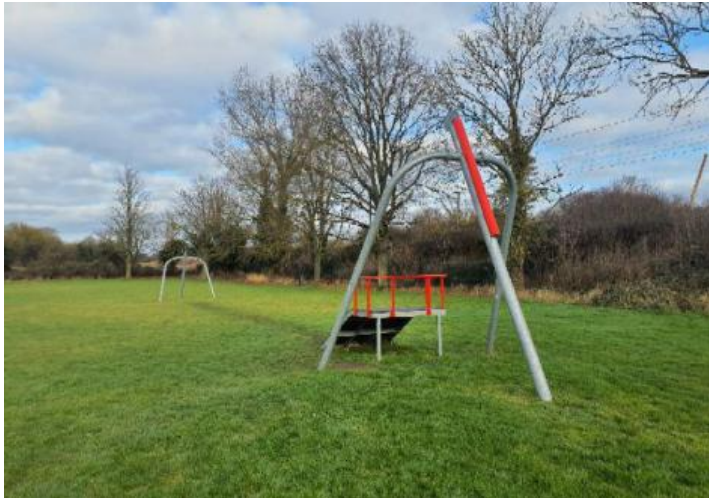
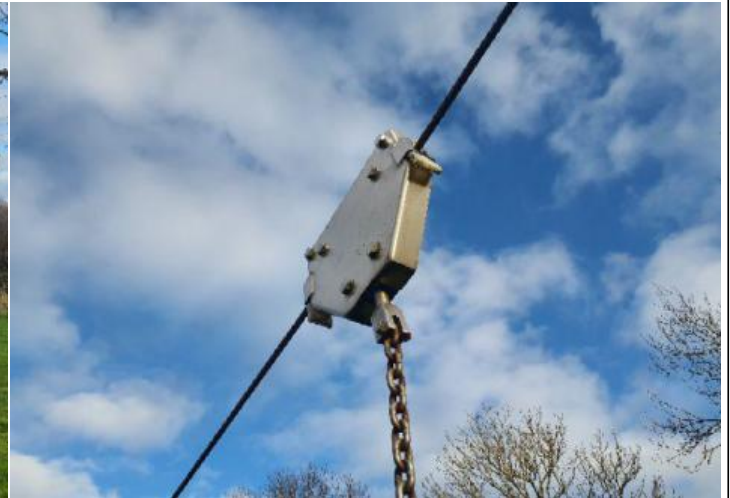
Finding: The traveller bearing is showing signs of wear

Action: Monitor for any further deterioration and repair or replace if required

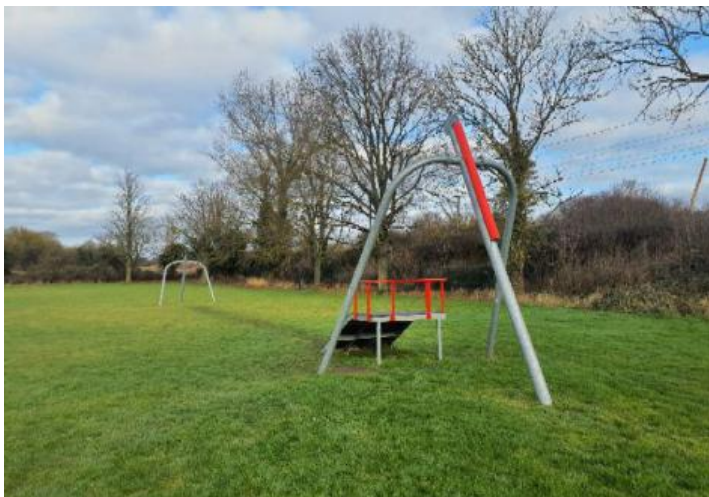
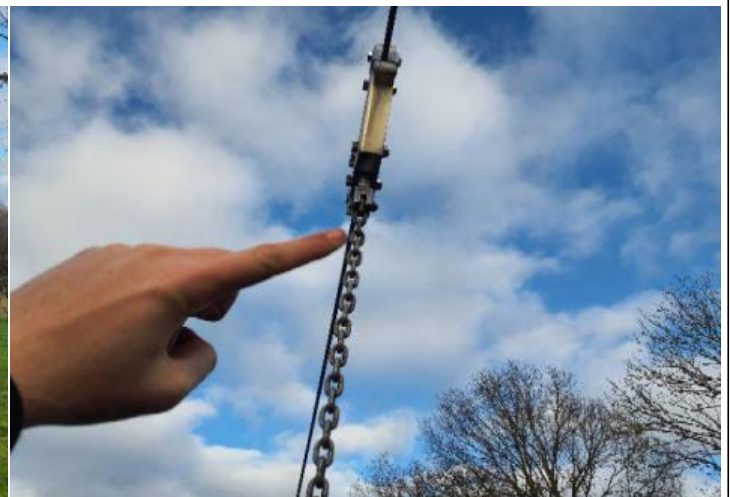
Finding: There is some notable evidence of chain wear

Action: Monitor for any further deterioration and replace when 40% worn

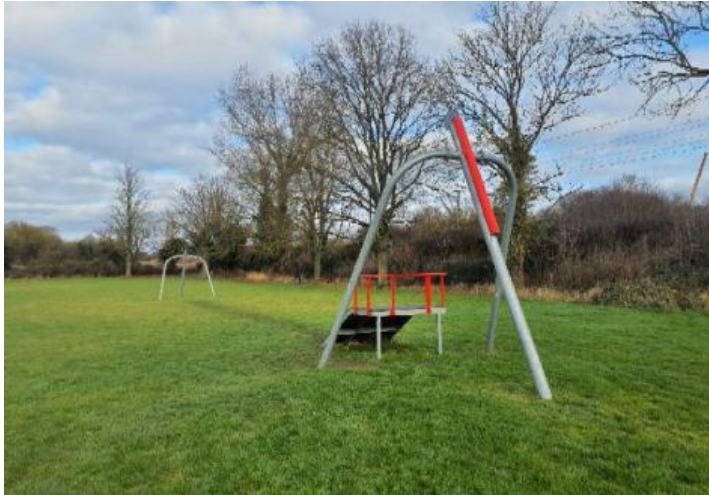
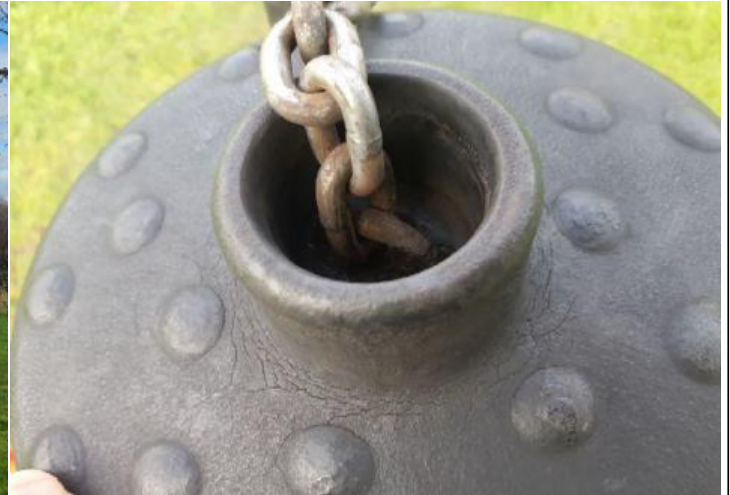
Finding: The seat connector is worn more than 40% and requires replacement

Action: Replace seat connector if possible or replace seat

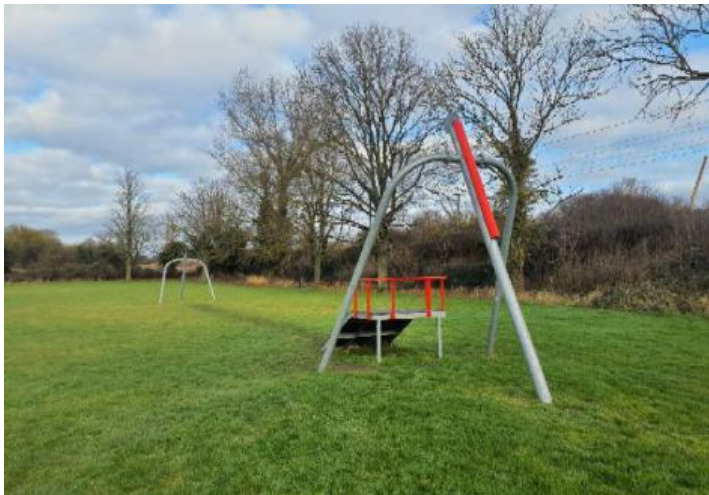
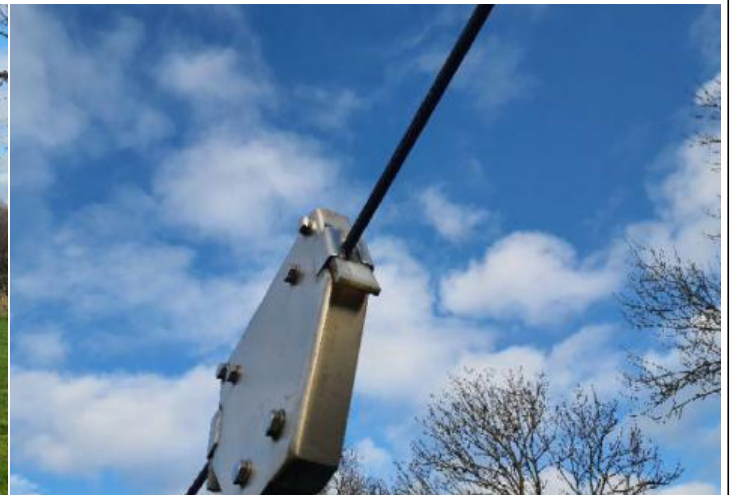
Finding: The nylon inserts are worn or missing at the point the cable enters the traveller

Action: Replace worn or missing inserts as required

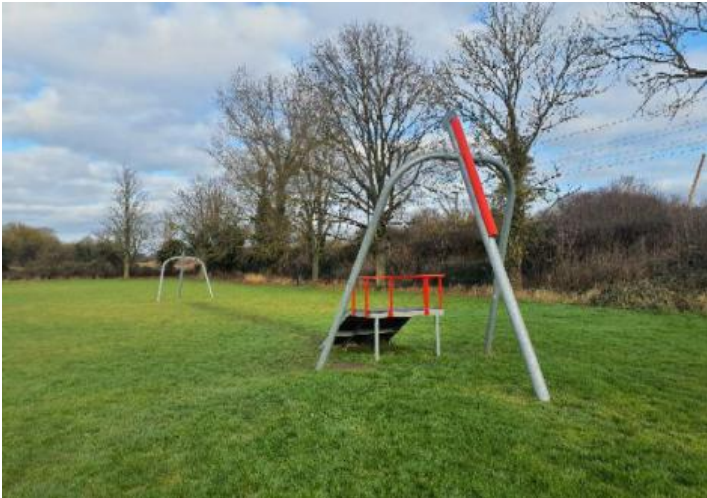
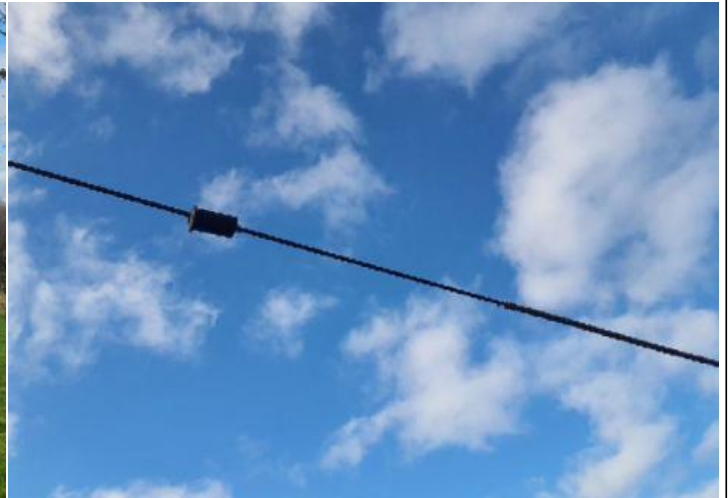
Finding: The dampening spring or tyre is damaged or broken on the item

Action: Replace spring or tyre

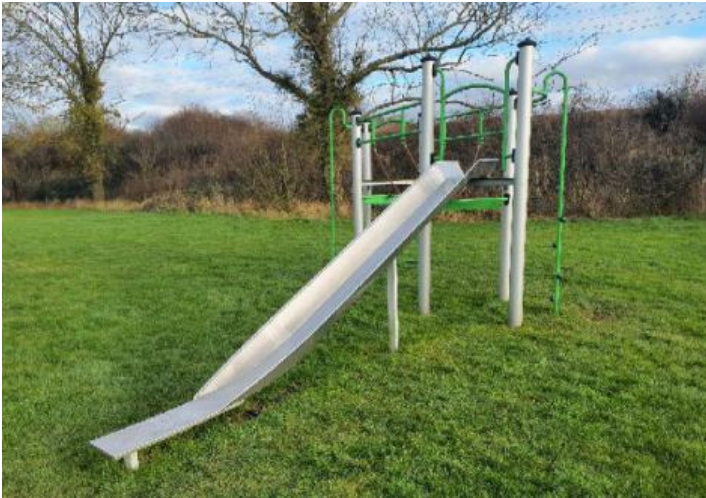
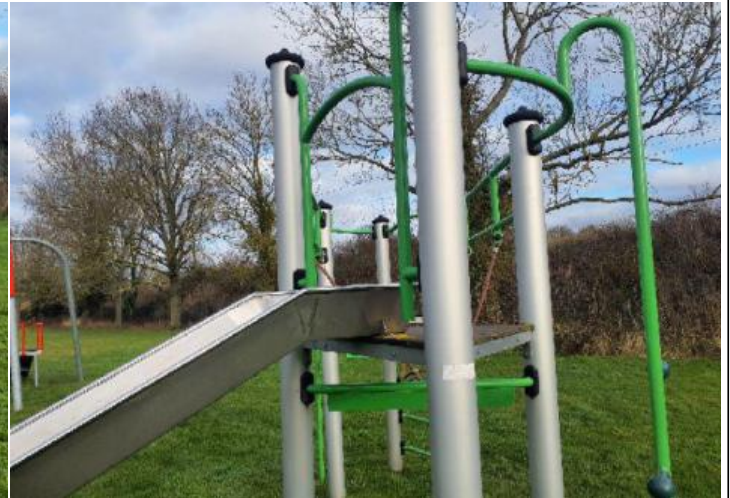
Finding: The side of the slide extends less than 500mm above the slide surface at the start section and does not meet the recommendations of BS EN 1176 Part 3

Action: Monitor - No action given the risk assessment

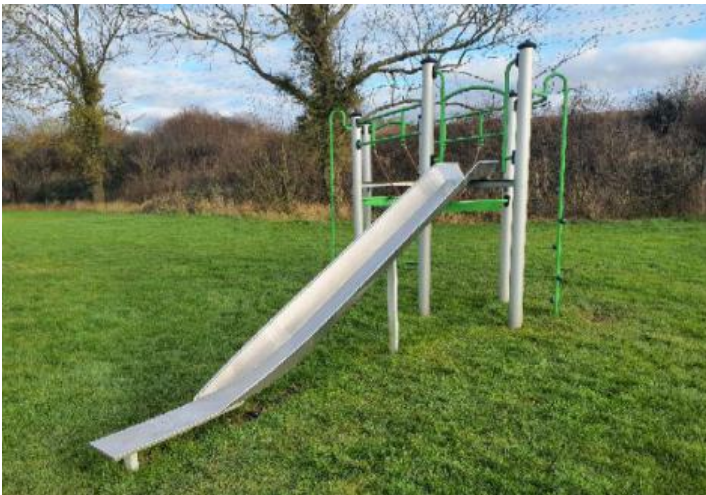
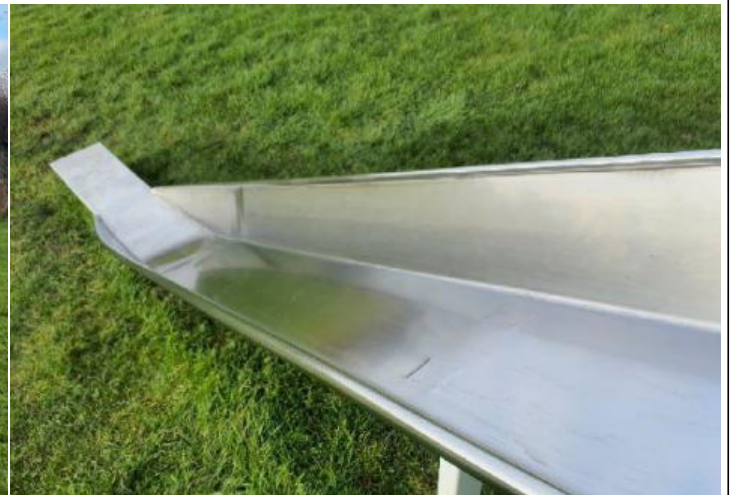
Finding: There are a number of dents in the slide surface

Action: Monitor for any further deterioration and repair as required

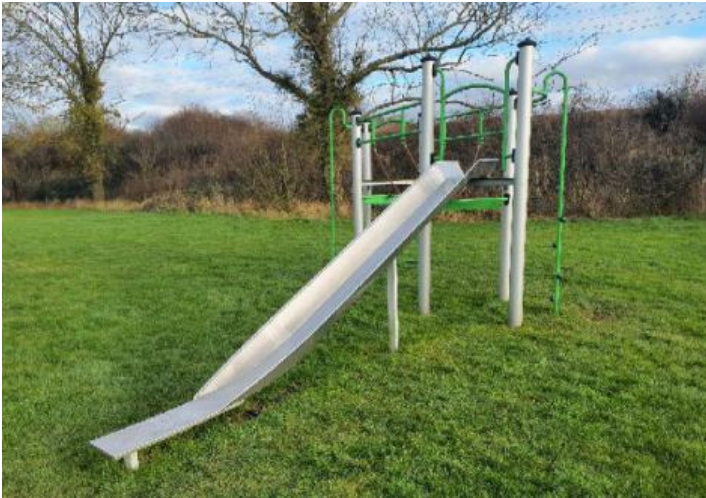
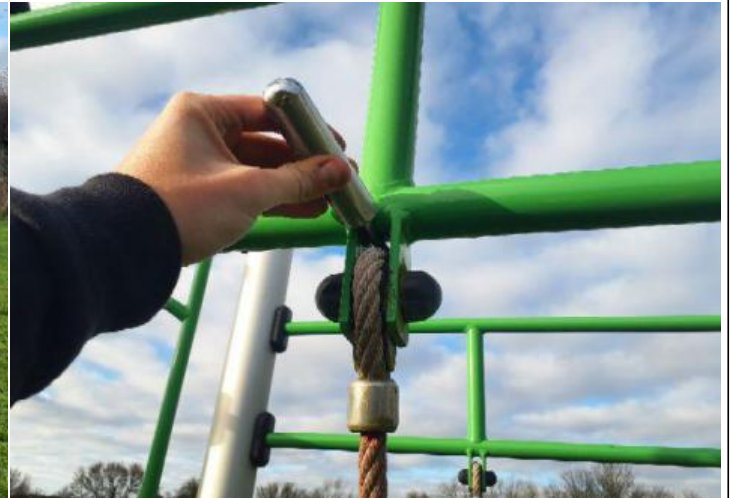
Finding: There is/are finger entrapment/s in the frame and the item fails to meet the requirements of BS EN 1176 Part 1 4.2.7.6 Entrapment of fingers

Action: Monitor - No action given the risk assessment

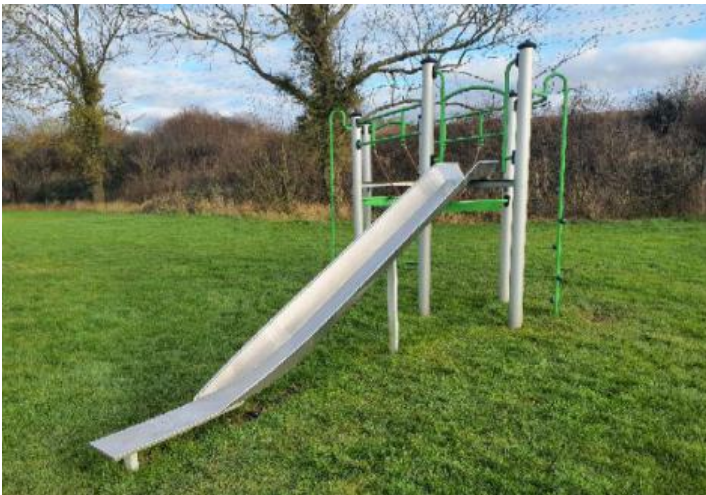
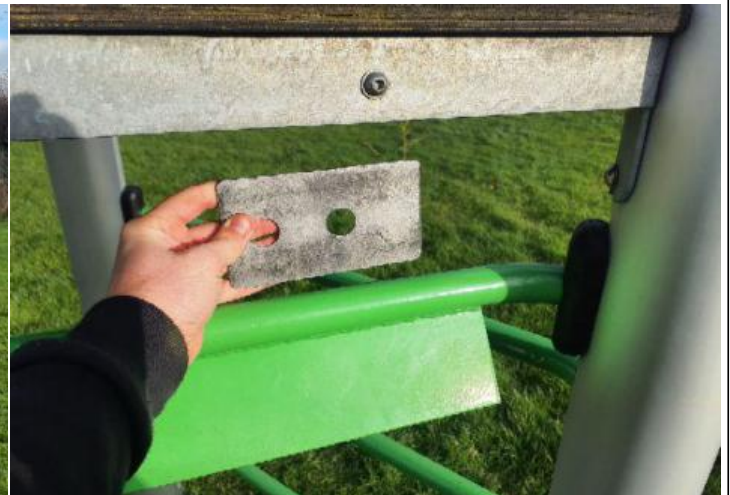
Finding: The item fails to meet the requirements of BS EN 1176 Part 1 4.2.7.2 for head and neck entrapment in the frame

Action: Monitor - No action given the risk assessment

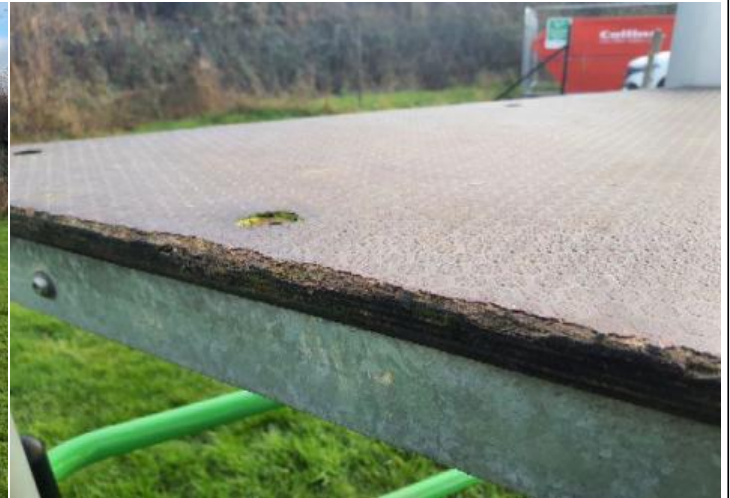
Finding: Parts of the timber are rough or splintered

Action: Remove all rough or sharp edges

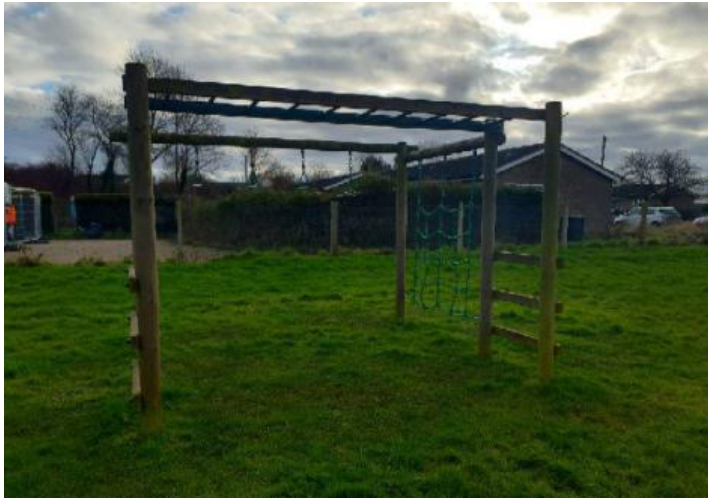
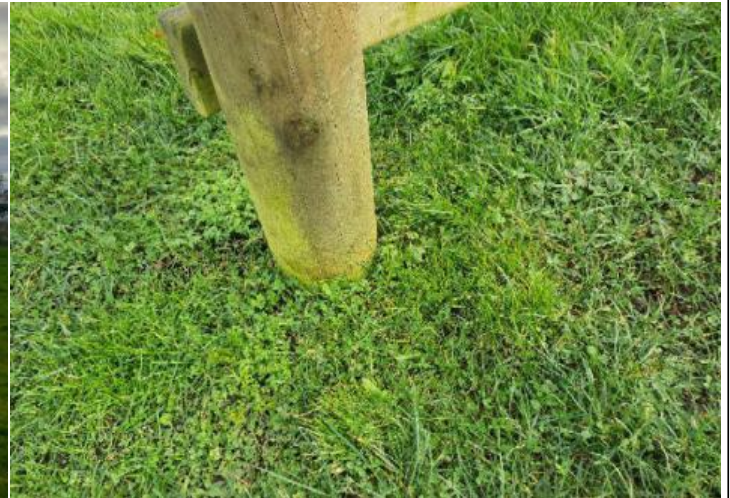
Finding: There is some strimmer / machinery damage apparent on the posts, this can penetrate the preservative applied to the timber and accelerate the rotting process

Action: Monitor for any deterioration (rot) and replace as required

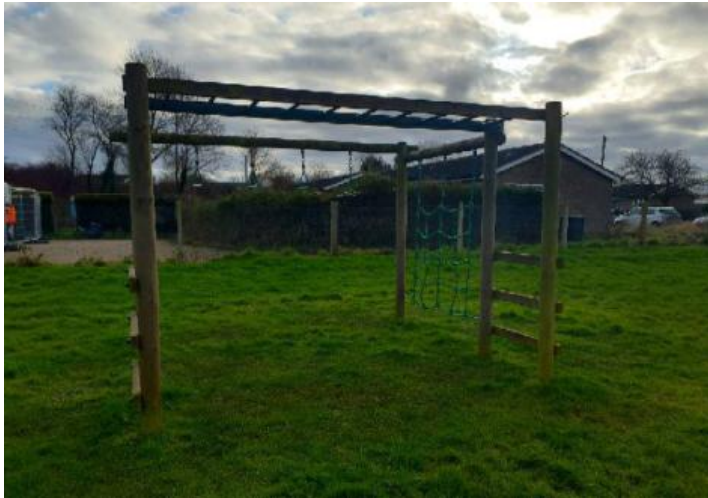
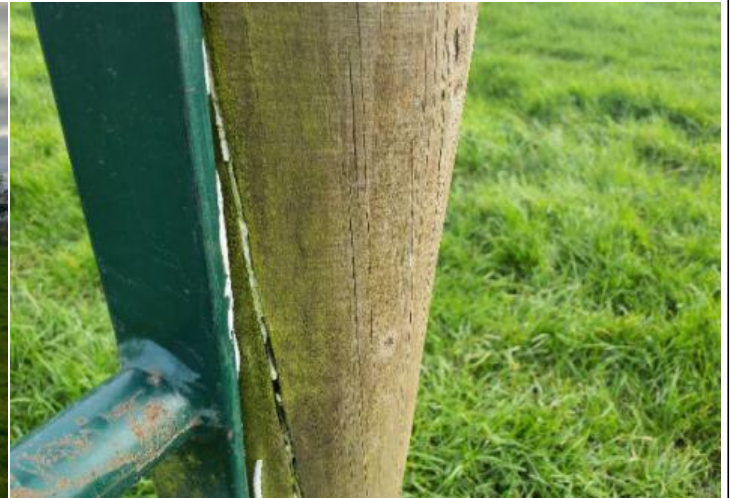
Finding: The use of synthetic fillers in timber is not recommended; timber being a natural material will expand and contract as the moisture content changes and the use of fillers can exacerbate the length and depth of these cracks or shakes in the timber. The only treatment that is normally required is the removal of any rough or sharp edges unless the structural integrity of the item is affected.

Action: Remove any rough or sharp edges and monitor timber for any further deterioration

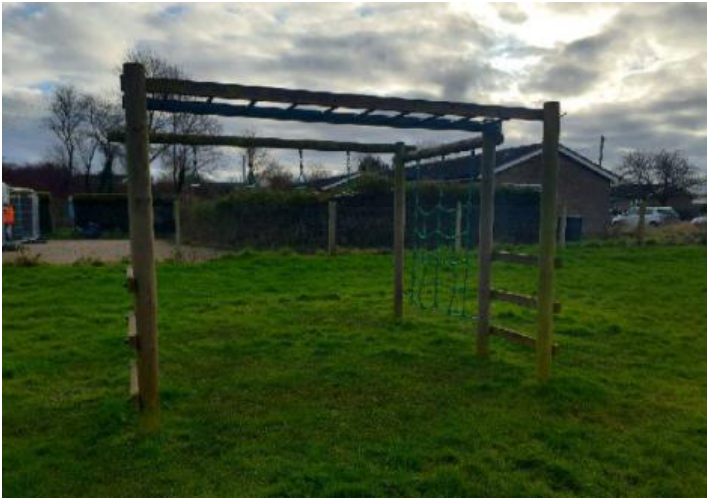
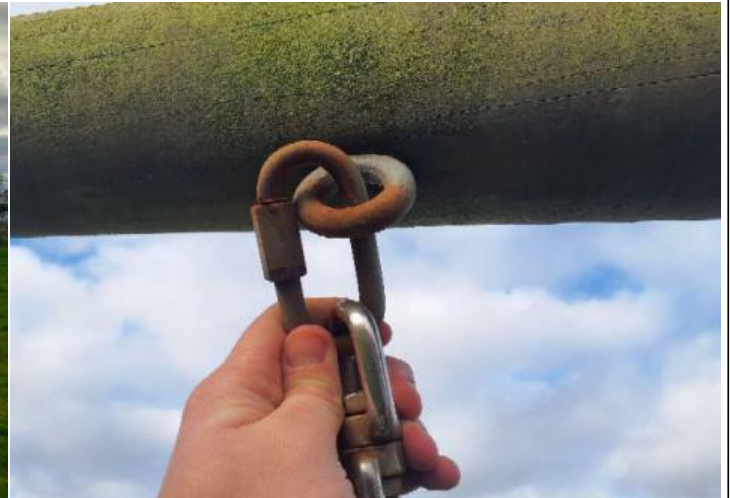
Finding: There is some wear to the shackles

Action: Monitor for any further deterioration and replace when 40% worn

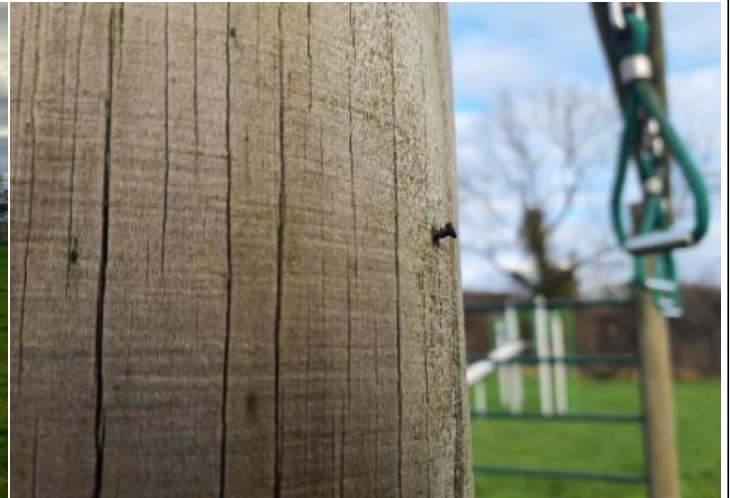
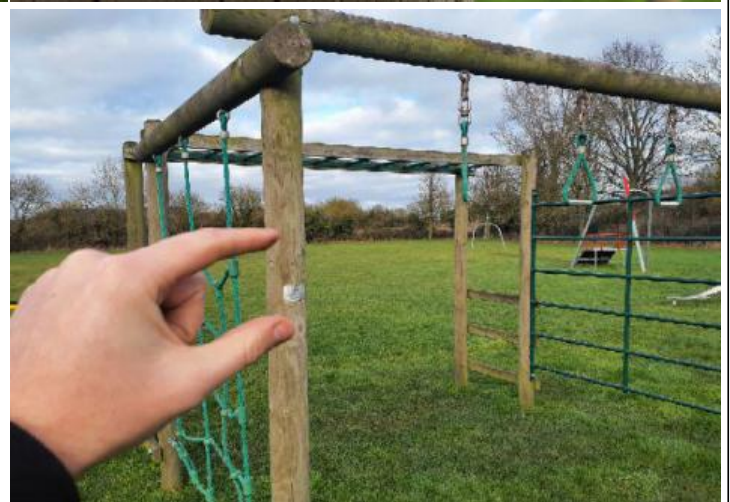
Finding: There are projecting nail ends present

Action: Remove

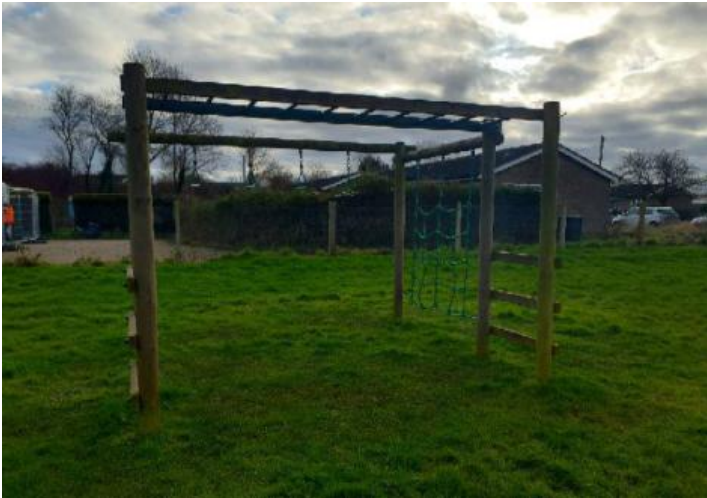
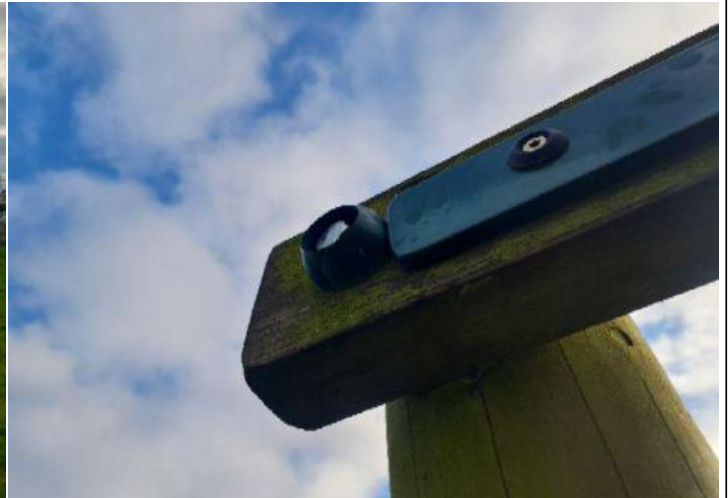
Finding: There is/are bolt cap covers missing or damaged on the item

Action: Replace missing or damaged bolt cap covers

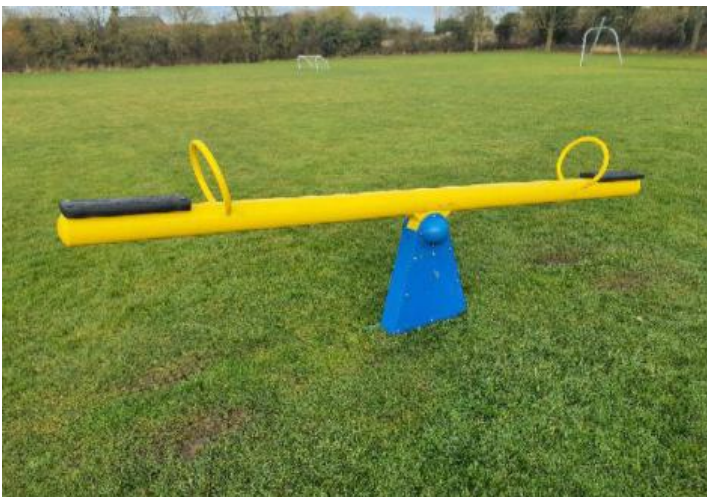
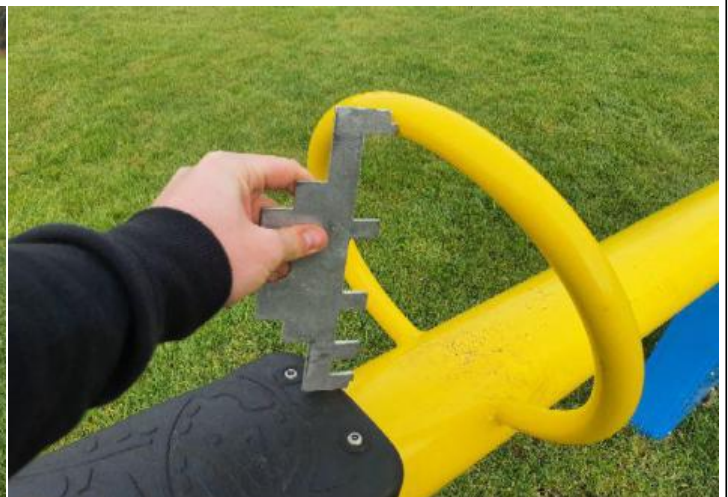
Finding: The item fails to meet the requirements of BS EN 1176 Part 1 4.2.7.2 for head and neck entrapment in the frame

Action: Monitor - No action given the risk assessment

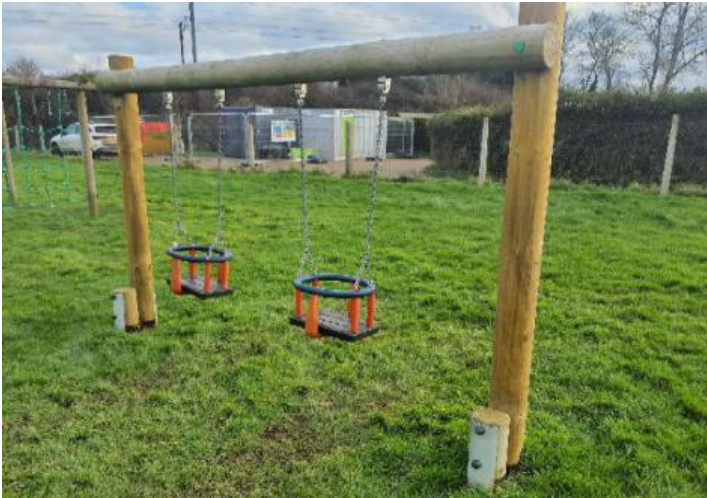
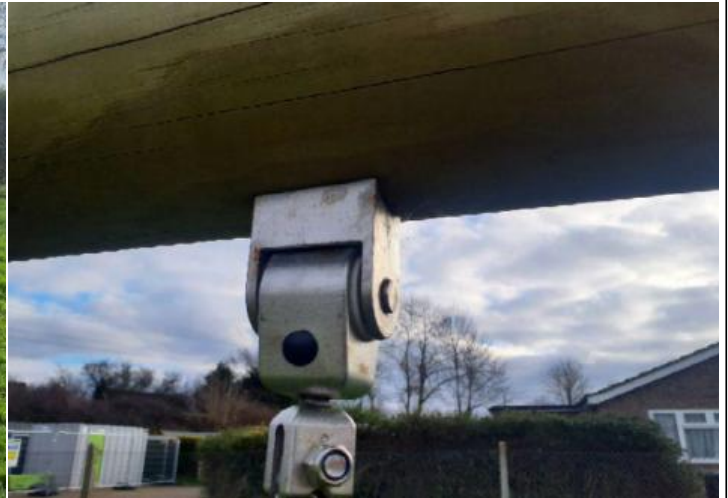
Finding: This design of swing joint has been known to fail on the weld connecting the joint to the threaded stud

Action: We would recommend that the joint be dismantled and checked on a regular basis or consulting with manufacturer on whether a Secondary Safety Device can be fitted

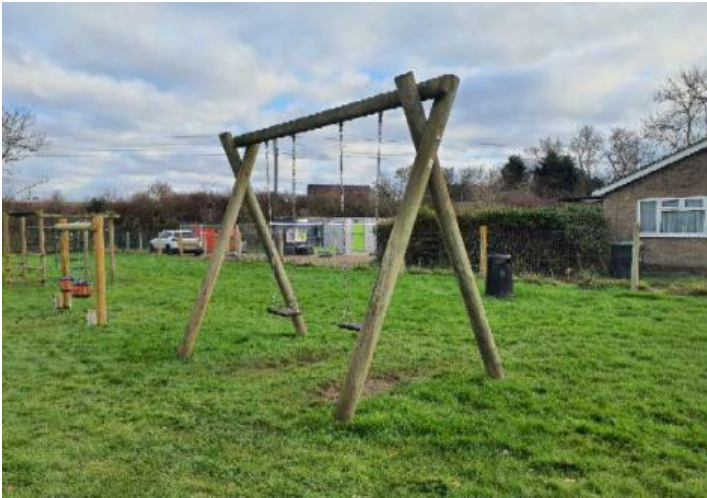
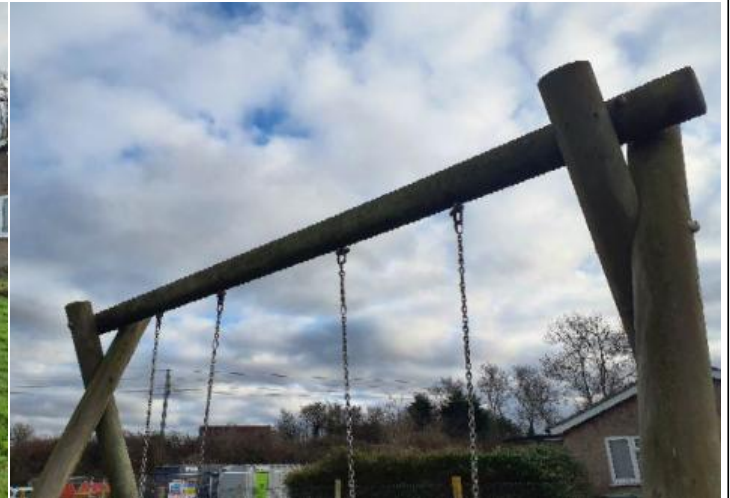
Finding: The fixings or components for this item were in excess of 2.5m above the standing surface and could not be fully accessed by the inspector. We have completed a visual inspection of the fixings from ground level but a maintenance inspection should be undertaken to assess the condition, security and wear of the components at intervals in accordance with the manufacturers recommendations.

Action: Inspect in accordance with the manufacturers recommendations

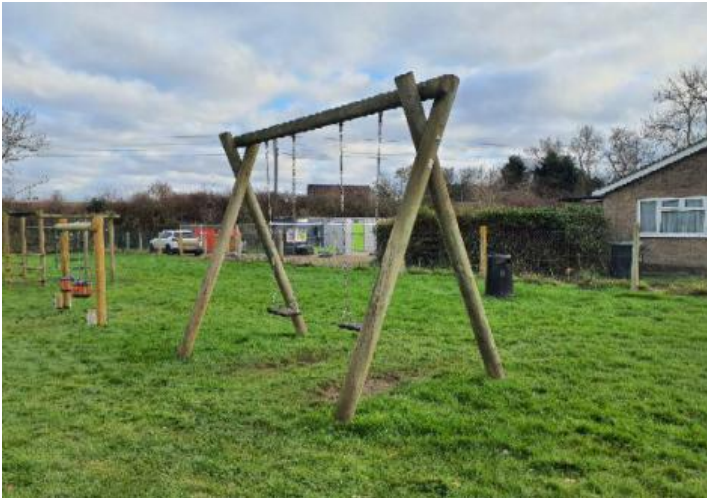
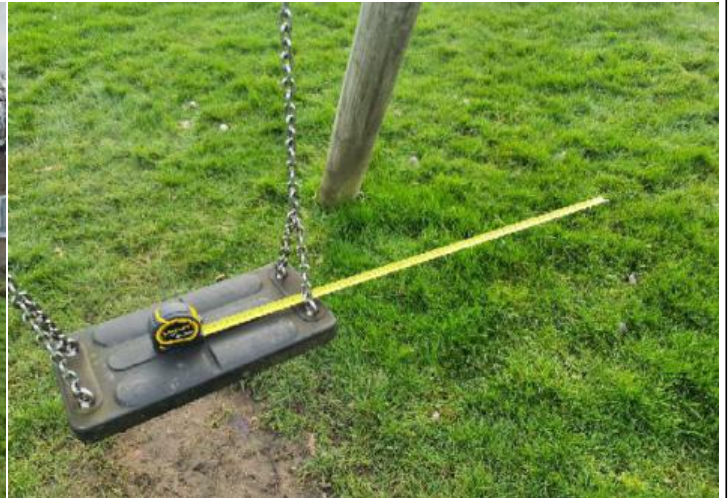
Finding: The surfacing width under the seat/s is / are less than 875mm when measured from the centre of the seat outwards, and fail the requirements of BS EN 1176 Part 2

Action: Monitor - No action given the risk assessment

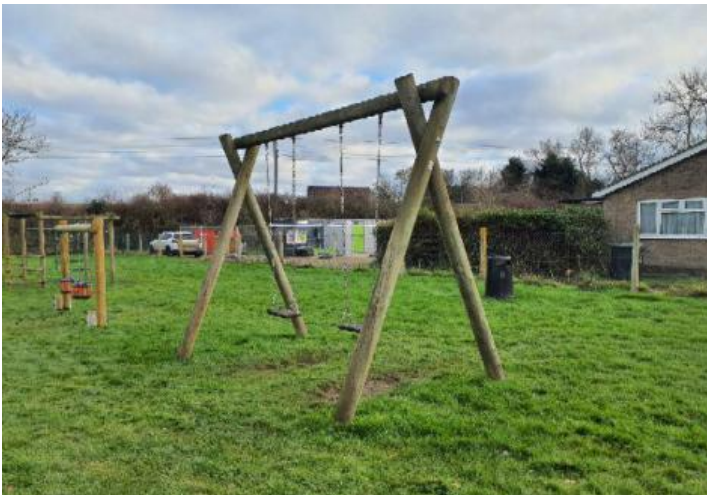
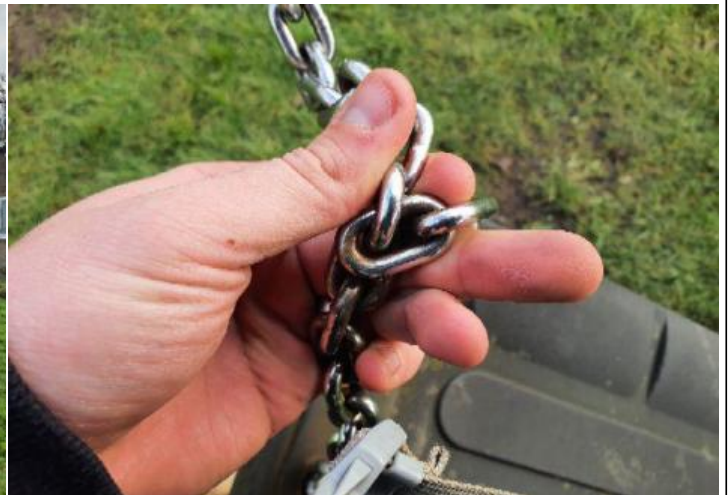
Finding: There is some notable evidence of chain wear

Action: Monitor for any further deterioration and replace when 40% worn

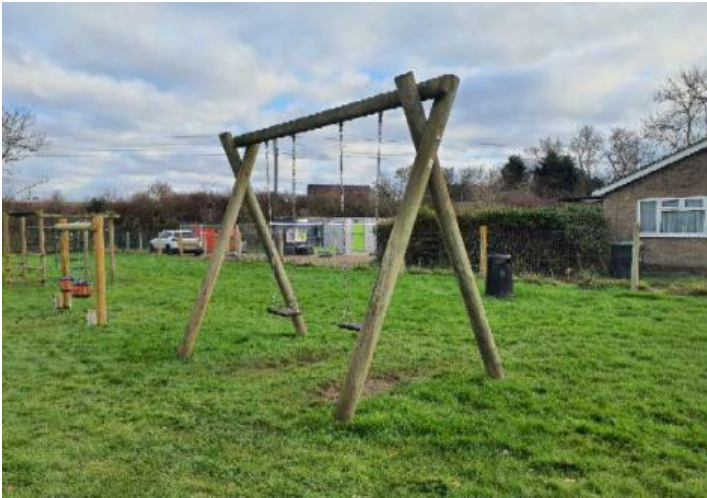
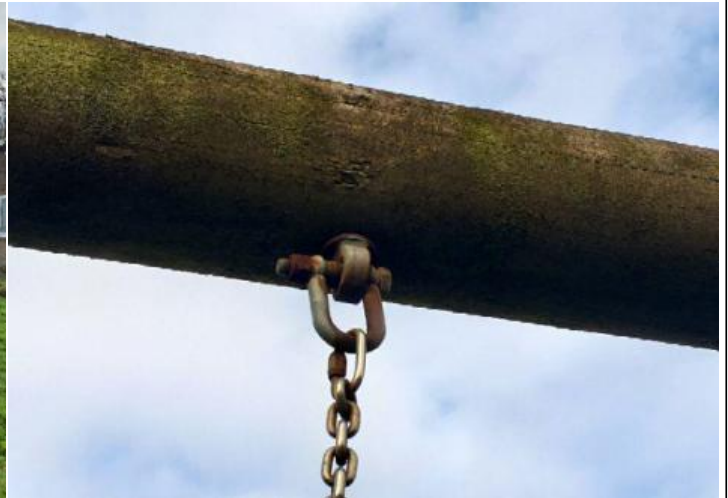
Finding: The bushes are worn or missing

Action: Replace worn or missing bushes

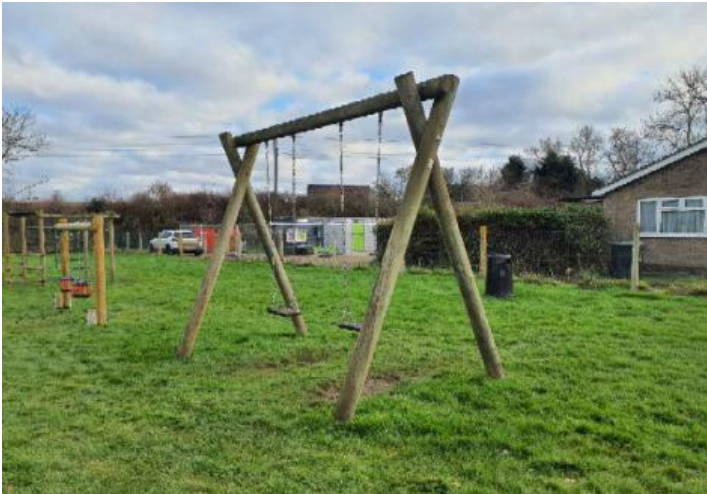
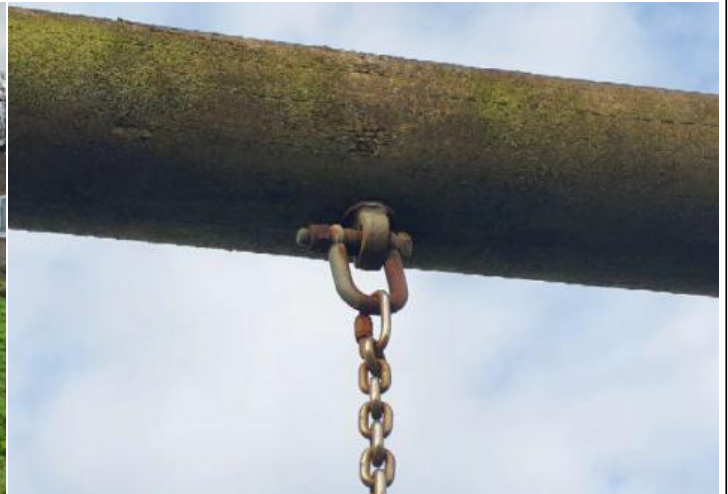
Finding: There is some wear to the shackles

Action: Monitor for any further deterioration and replace when 40% worn

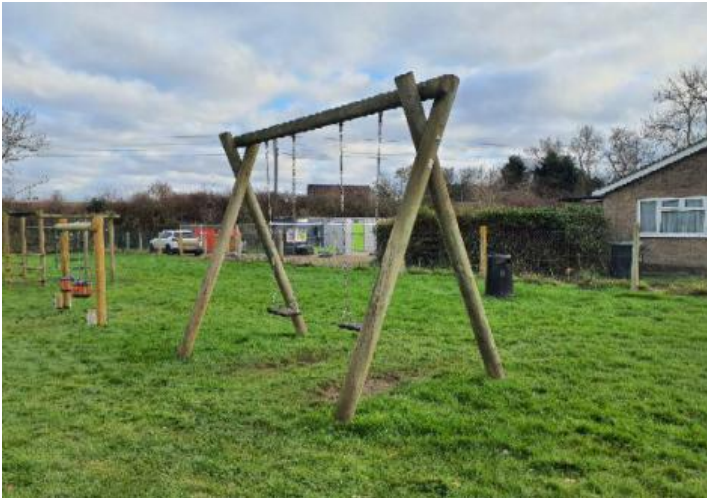
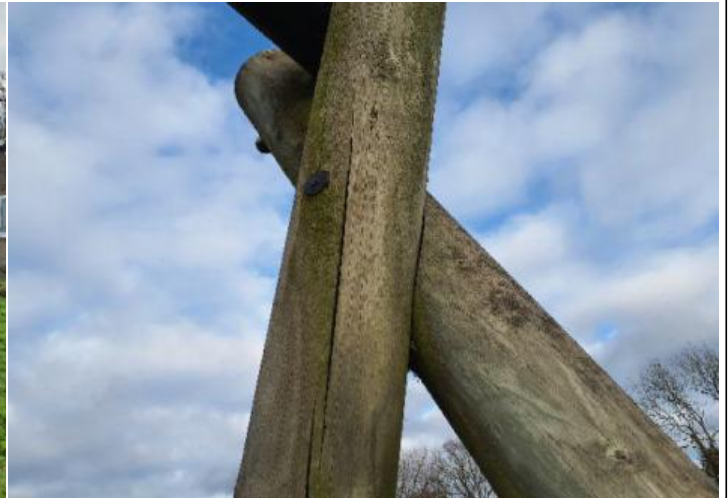
Finding: The timber has a number of splits/shakes or air cracks and this may affect the stability or allow water ingress which will accelerate the rotting process

Action: Monitor to ensure the splits do not cross through fixing points of the structure and/or cause any instability
