the **play** inspection company

Annual Inspection

Bacton

St Mary's Close, Suffolk, IP14 4NW

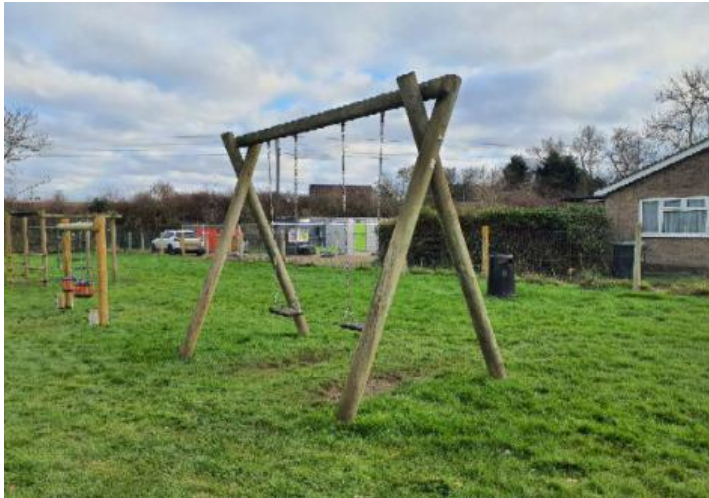
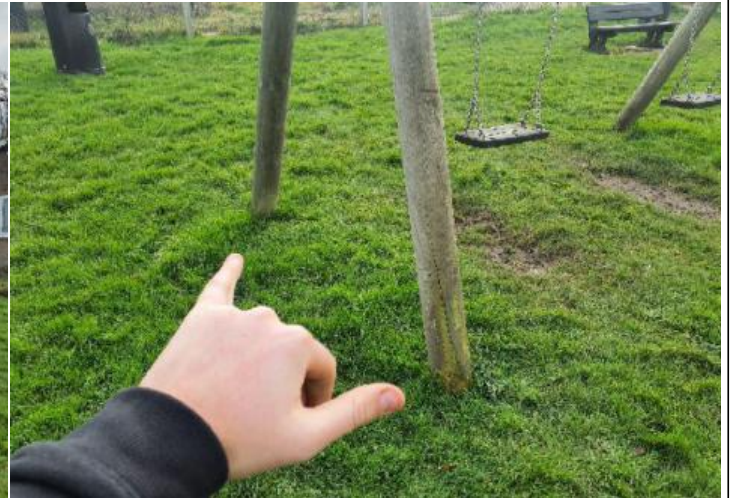
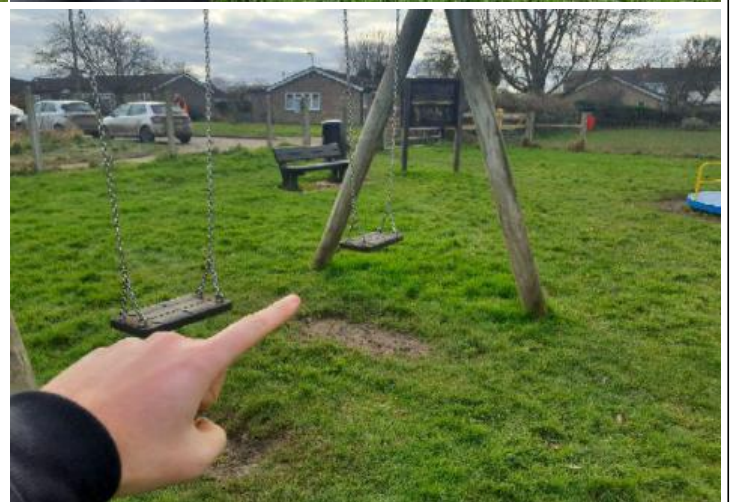
Finding: There is some evidence of rot in the timber

Action: Monitor for any further deterioration and replace as required

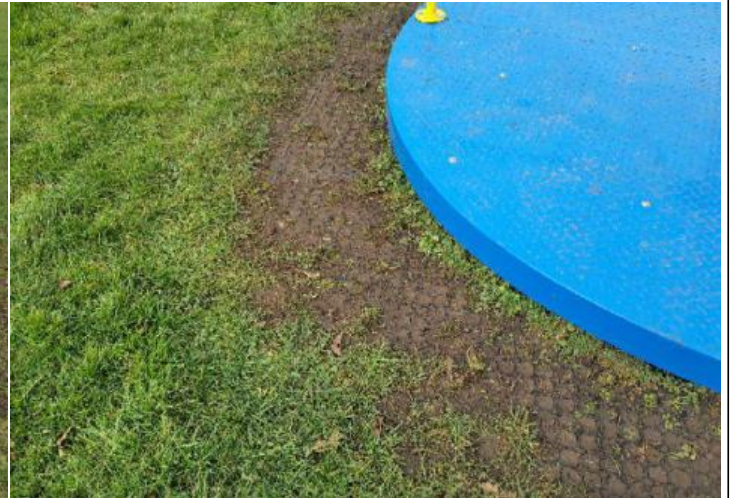
Finding: The grass mats are silted up, the soil is compacted and the area will become very slippery when the soil is wet.
Action: Reinstate as required
