the **play inspection** company

Annual Inspection

Mid Suffolk District Council

Bacton

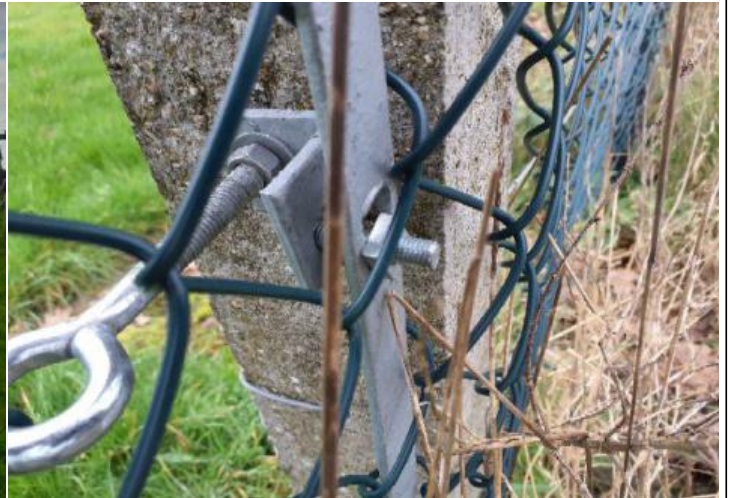
Item: Fences - Fence - Chainlink
Manufacturer: Not Identified

Finding: There are projecting bolt thread(s) present

Action: Remove excess thread length and deburr or provide cap

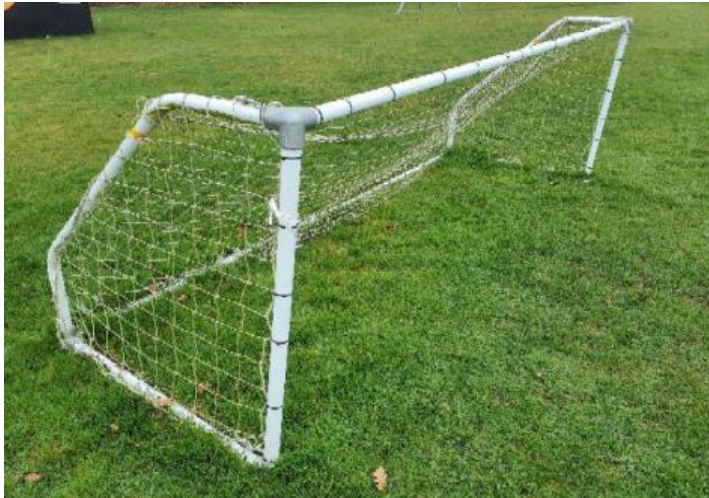
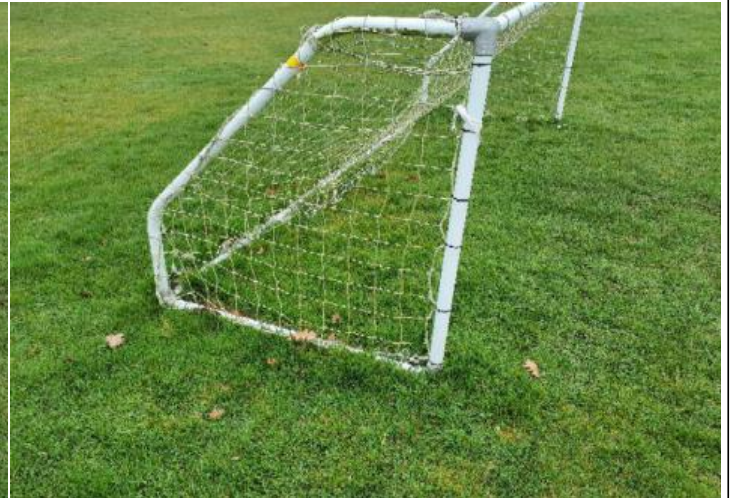
Item: Multi Use Games Area - 5 a side Goals
Manufacturer: Not Identified

Finding: The goals are not anchored in position

Action: Refer to manufacturer recommendations and provide as required

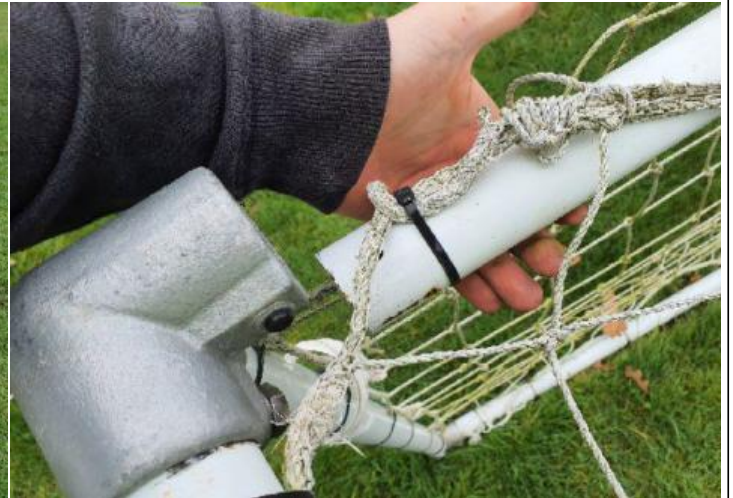
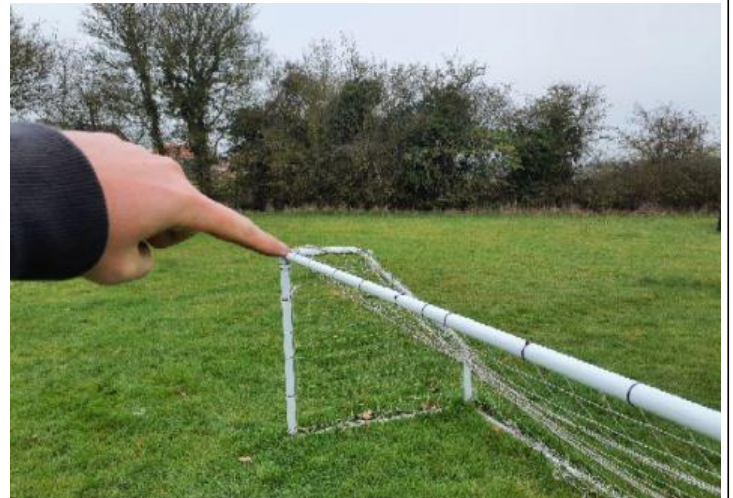
Item: Multi Use Games Area - 5 a side Goals
Manufacturer: Not Identified

Finding: Parts of the framework is unsecured

Action: Secure

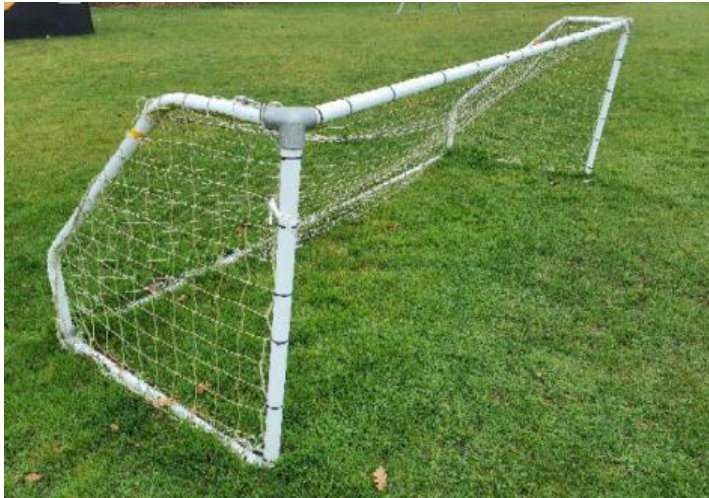
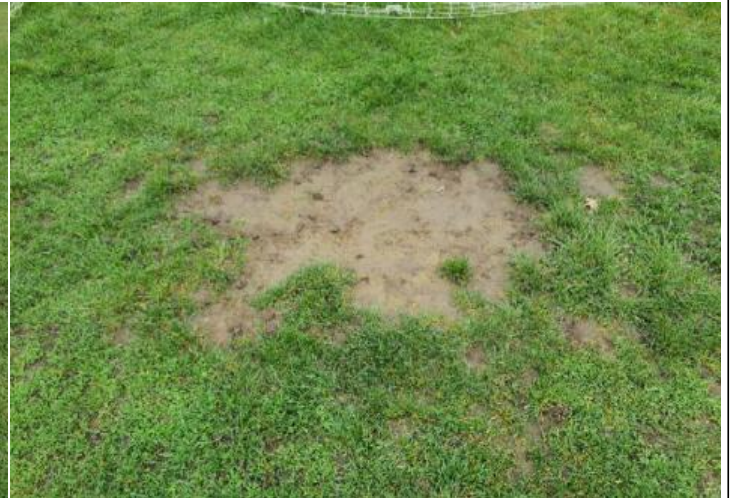
Item: Multi Use Games Area - 5 a side Goals
Manufacturer: Not Identified

Finding: The surface has eroded in some areas and may be slippery in wet conditions
Action: Reinstate the surface

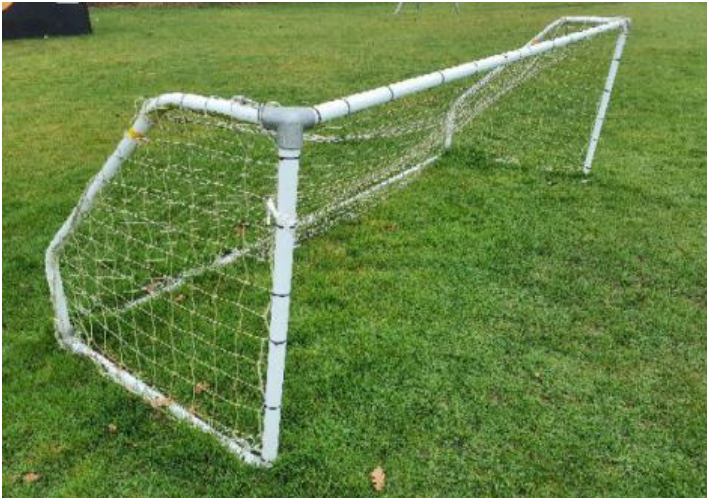
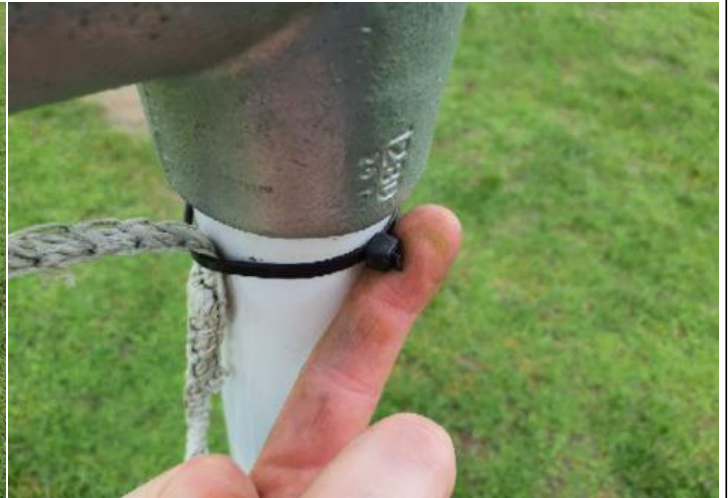
Item: Multi Use Games Area - 5 a side Goals
Manufacturer: Not Identified

Finding: Cable ties are present and there are sharp projecting ends

Action: Replace with a more appropriate fixing method

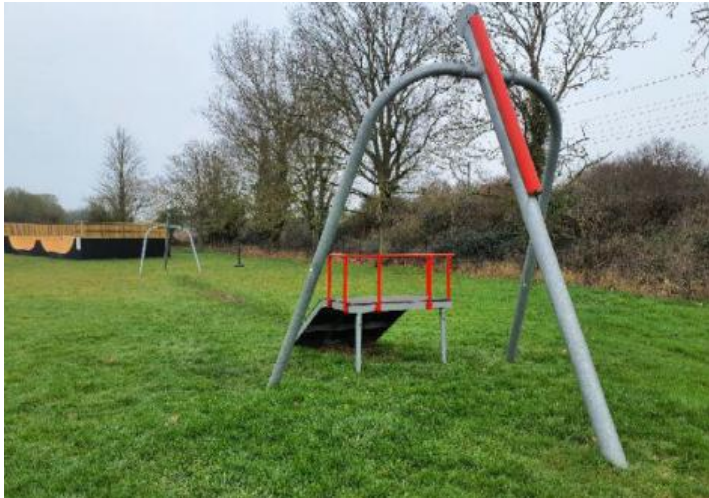
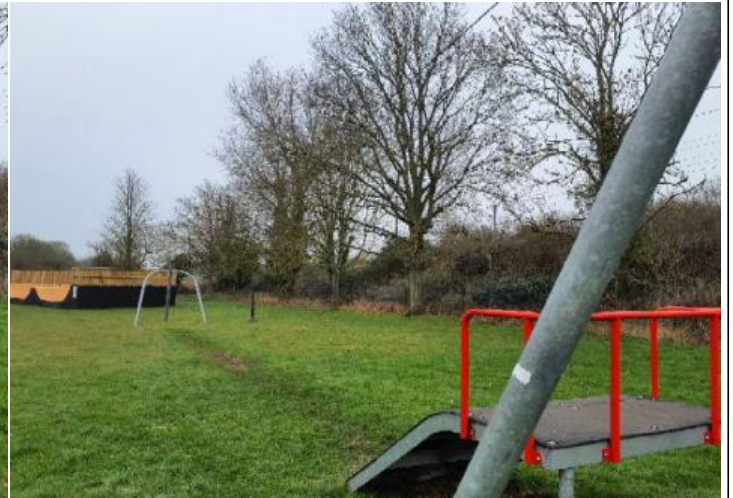
Item: Other - Cable Runway
Manufacturer: Sutcliffe Play Limited

Finding: We have completed a visual inspection of the suspension links, cable and fixing points from ground level, however it is not possible to fully inspect these areas without either hiring equipment to gain access or removing the cable and suspension and inspecting at ground level. We recommend that the main cable and fixing security is thoroughly inspected at least in accordance with the manufacturers recommendations to check for wear, damage, security or internal rusting; this will help to ensure the continued safe use of the equipment

Action: Inspect in accordance with the manufacturers recommendations

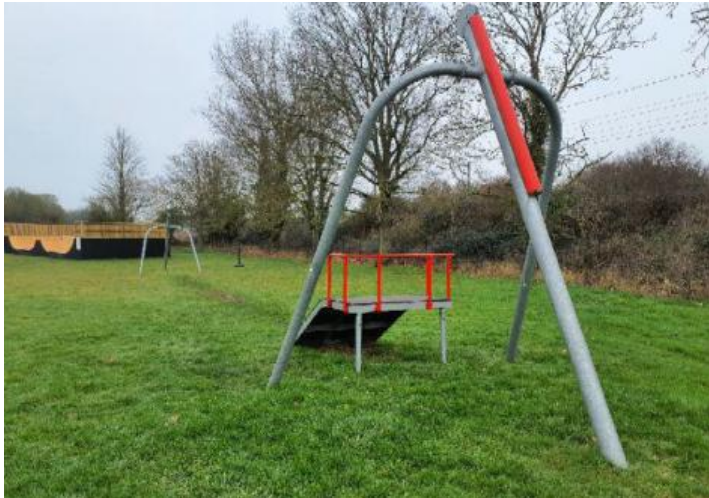
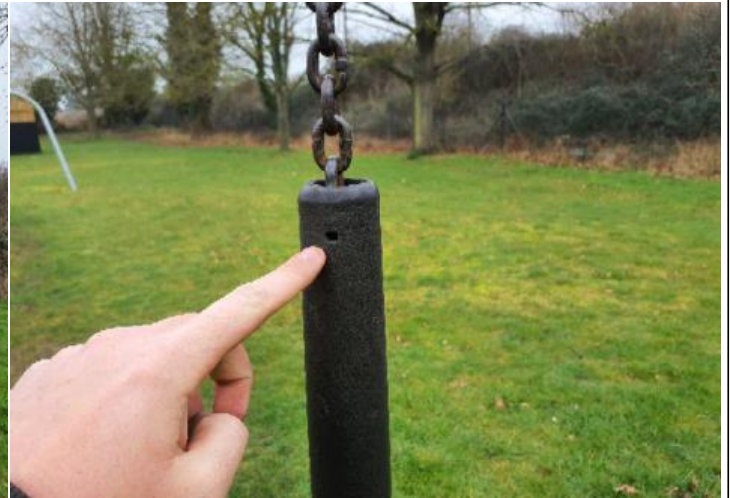
Item: Other - Cable Runway
Manufacturer: Sutcliffe Play Limited

Finding: There is or are fixings missing on the item

Action: Replace all missing fixings

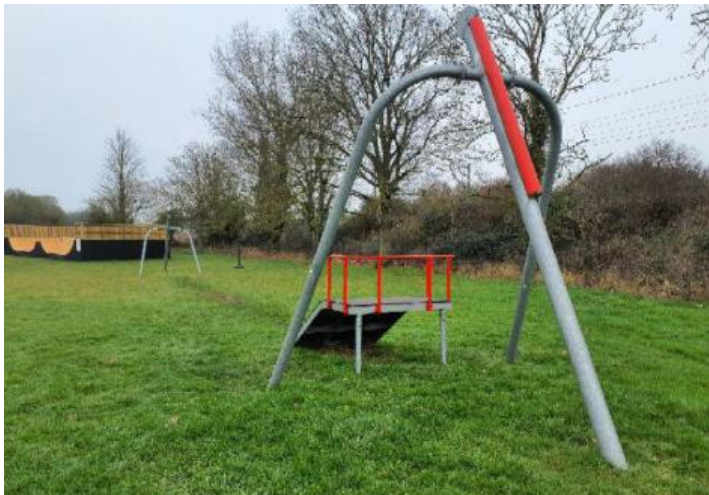
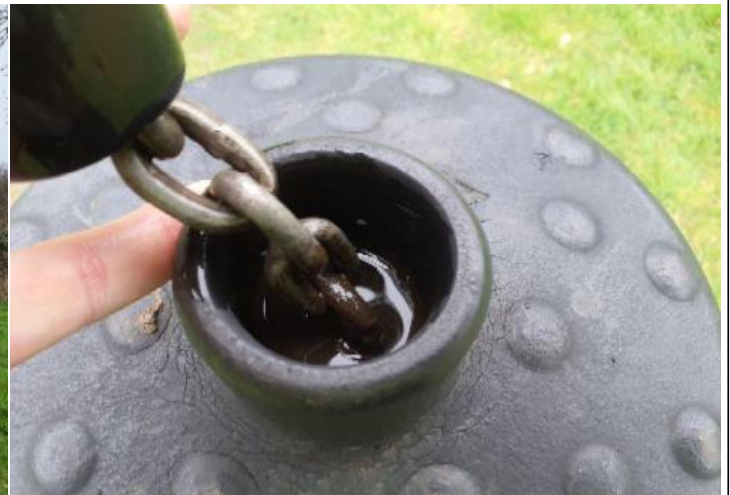
Item: Other - Cable Runway
Manufacturer: Sutcliffe Play Limited

Finding: The seat connector is worn more than 40% and requires replacement

Action: Replace seat connector if possible or replace seat

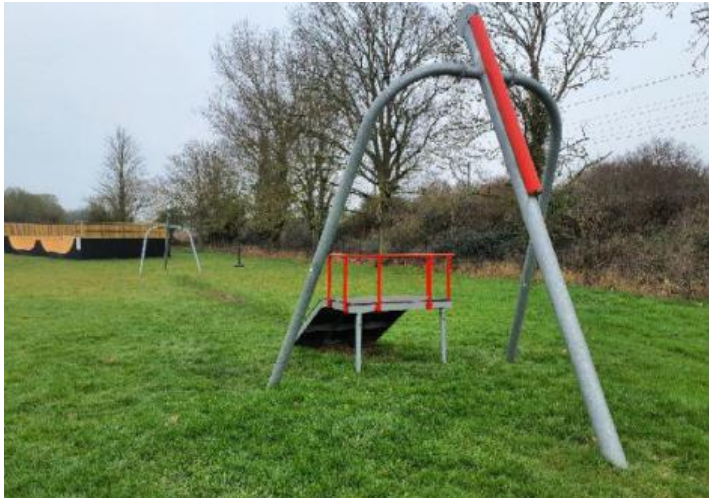
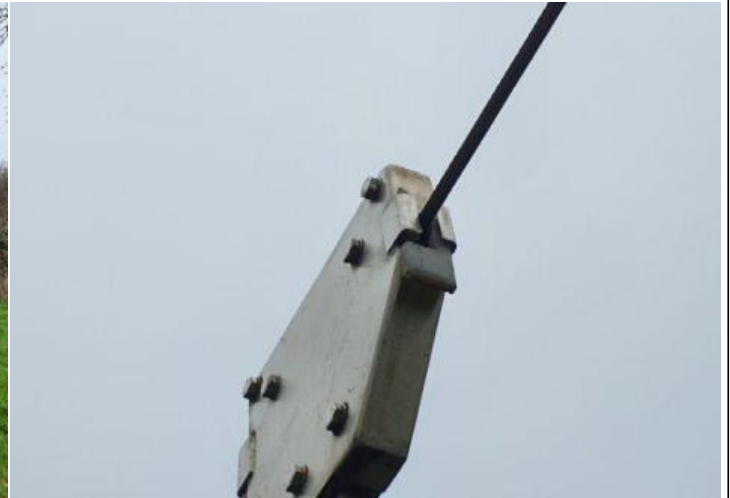
Item: Other - Cable Runway
Manufacturer: Sutcliffe Play Limited

Finding: The nylon inserts are worn or missing at the point the cable enters the traveller

Action: Replace worn or missing inserts as required

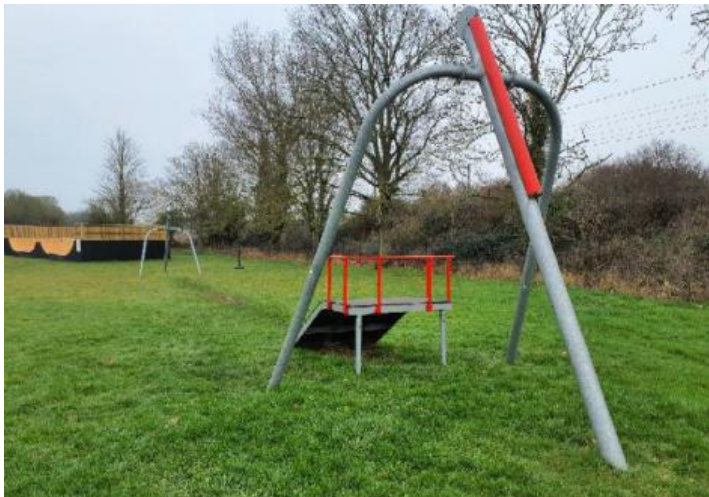
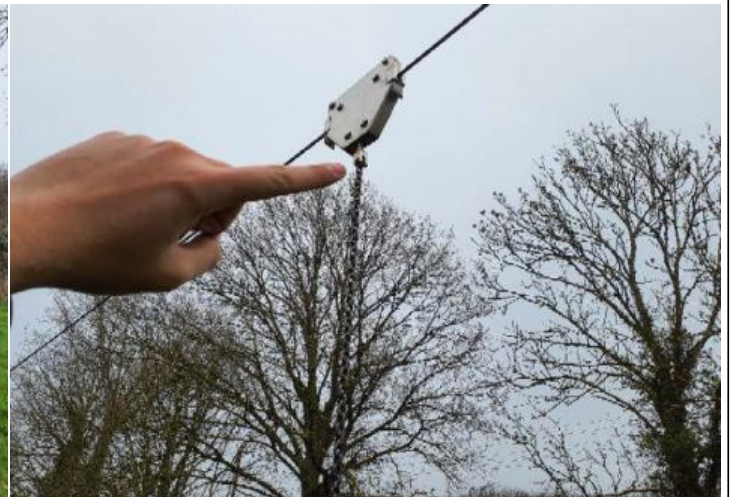
Item: Other - Cable Runway
Manufacturer: Sutcliffe Play Limited

Finding: The top chain links are worn excessively and require renewing

Action: Replace worn chains

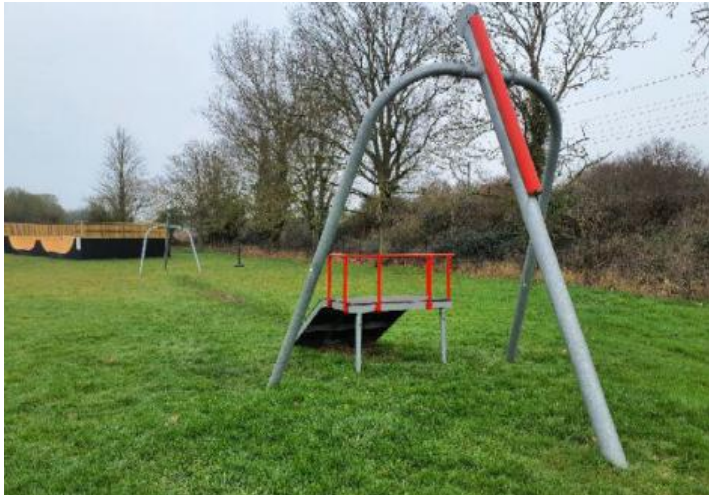
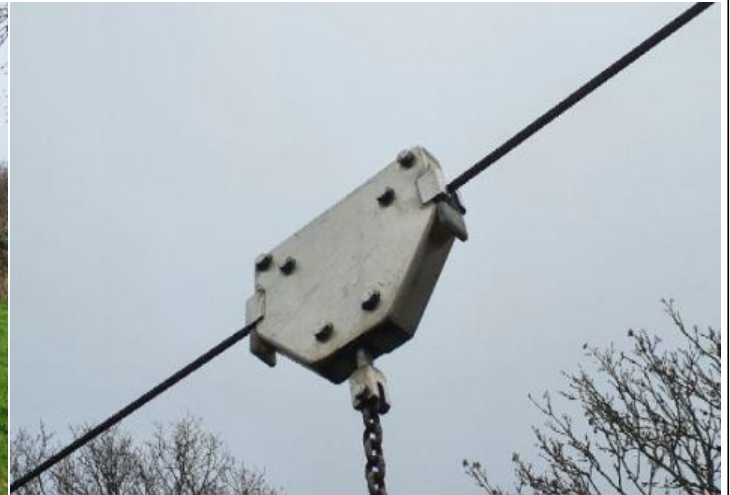
Item: Other - Cable Runway
Manufacturer: Sutcliffe Play Limited

Finding: The traveller bearing is showing signs of wear

Action: Monitor for any further deterioration and repair or replace if required

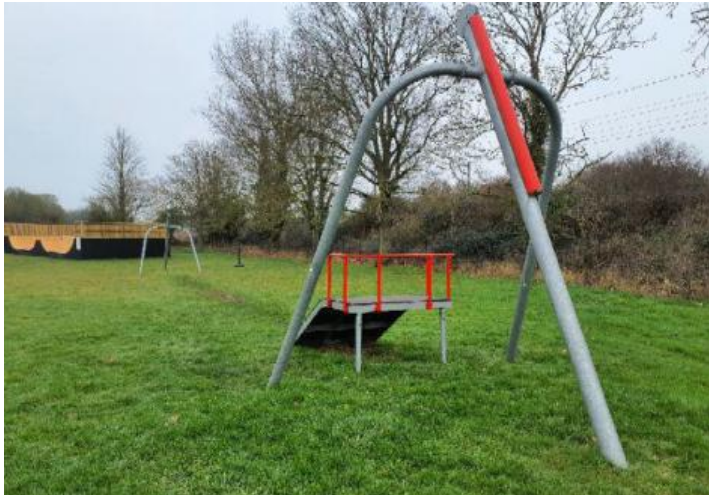
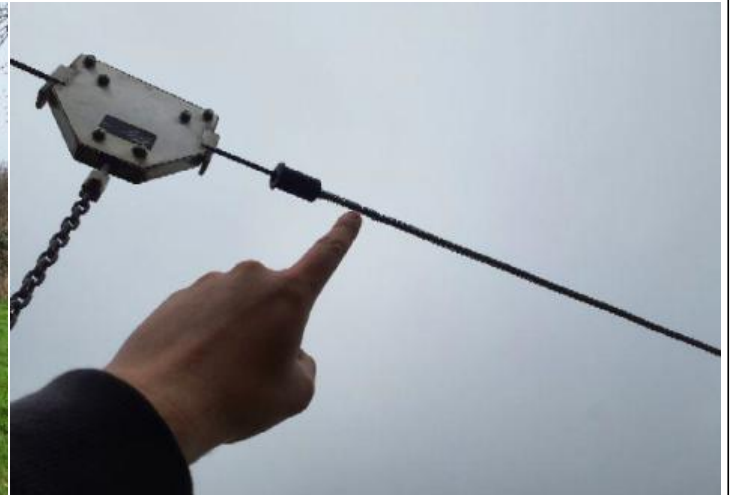
Item: Other - Cable Runway
Manufacturer: Sutcliffe Play Limited

Finding: The dampening spring or tyre is damaged or broken on the item

Action: Replace spring or tyre

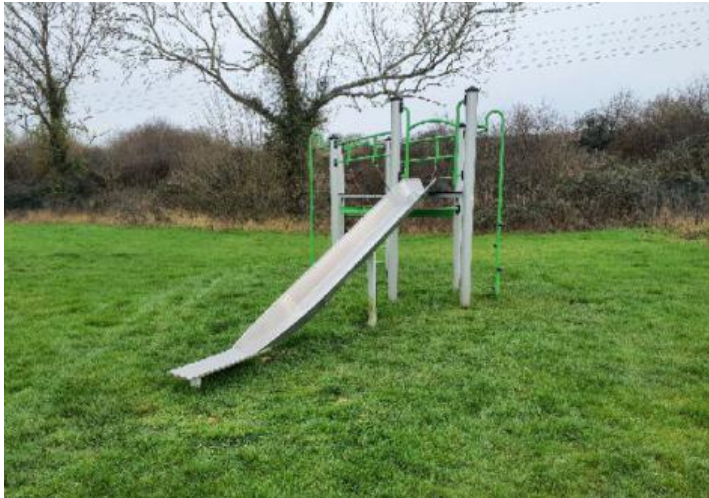
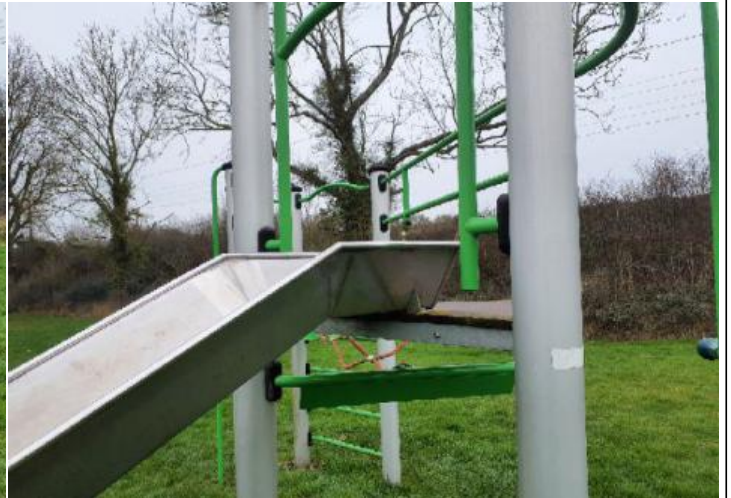
Item: Activity Equipment - Multi Play (Junior)
Manufacturer: Sutcliffe Play Limited

Finding: The side of the slide extends less than 500mm above the slide surface at the start section and does not meet the recommendations of BS EN 1176 Part 3

Action: Monitor - No action given the risk assessment

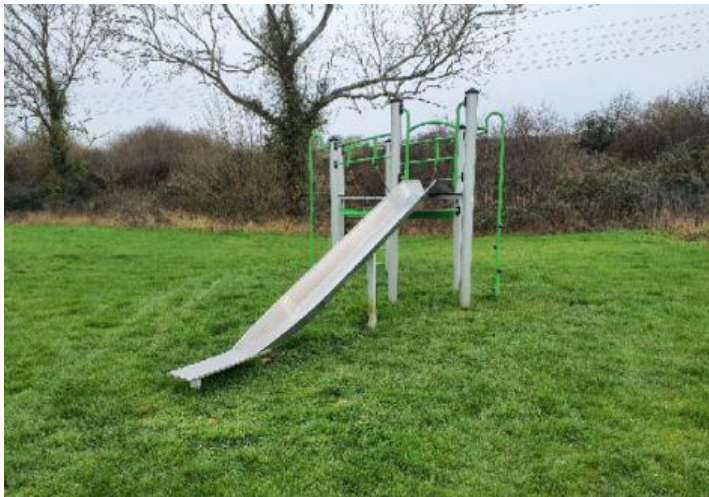
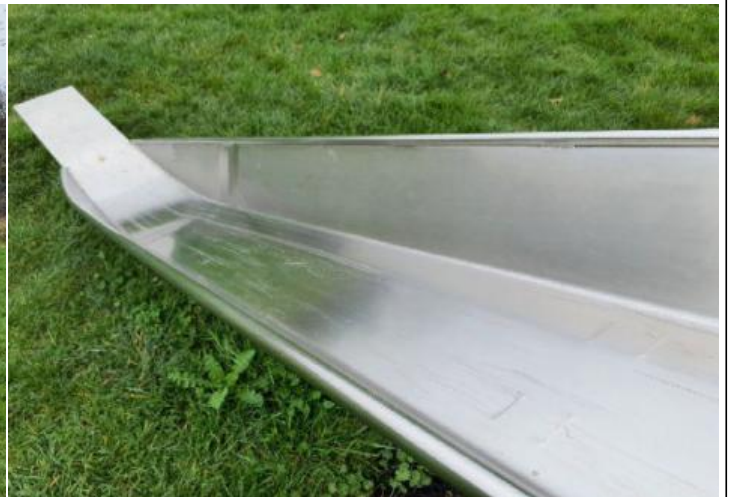
Item: Activity Equipment - Multi Play (Junior)
Manufacturer: Sutcliffe Play Limited

Finding: There are a number of dents in the slide surface

Action: Monitor for any further deterioration and repair as required

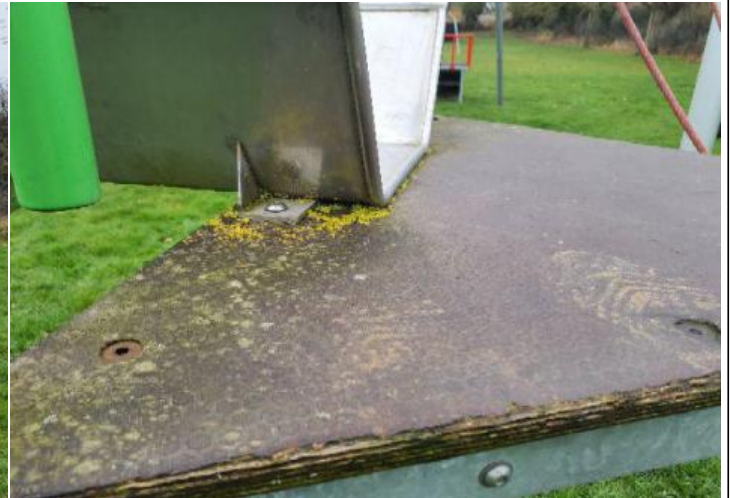
Item: Activity Equipment - Multi Play (Junior)
Manufacturer: Sutcliffe Play Limited

Finding: There is algae or moss on the surface of the equipment

Action: Clean and treat appropriately

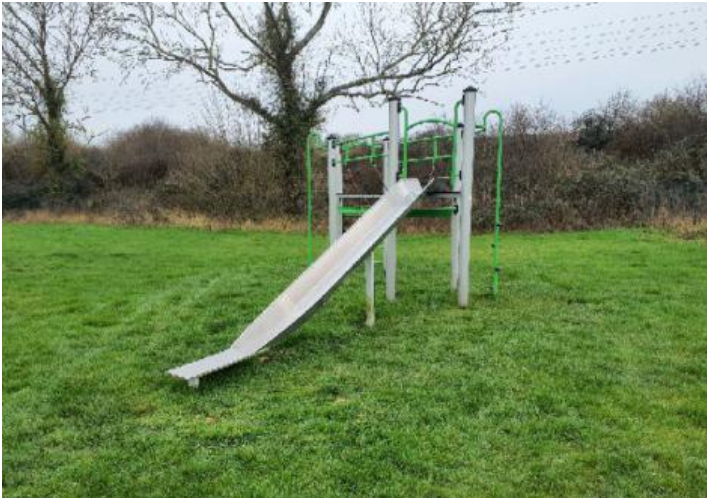
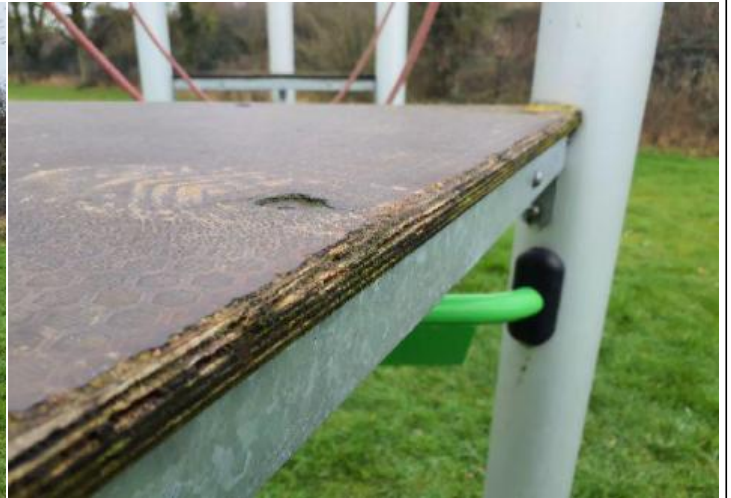
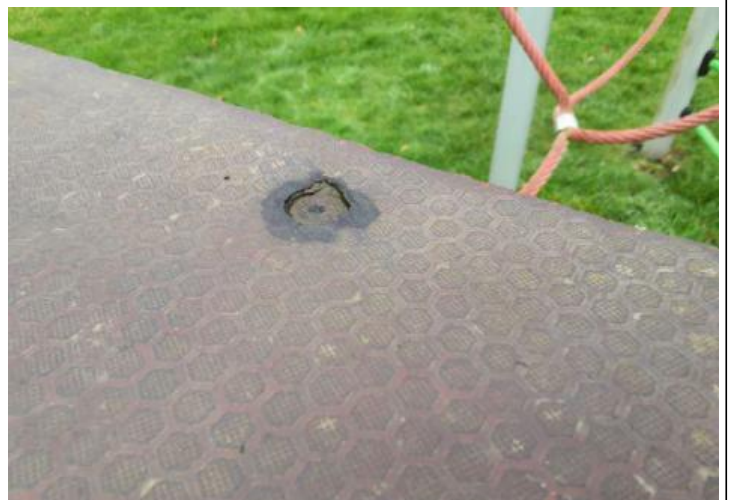
Item: Activity Equipment - Multi Play (Junior)
Manufacturer: Sutcliffe Play Limited

Finding: There is some evidence of rot in the timber

Action: Monitor for any further deterioration and replace as required

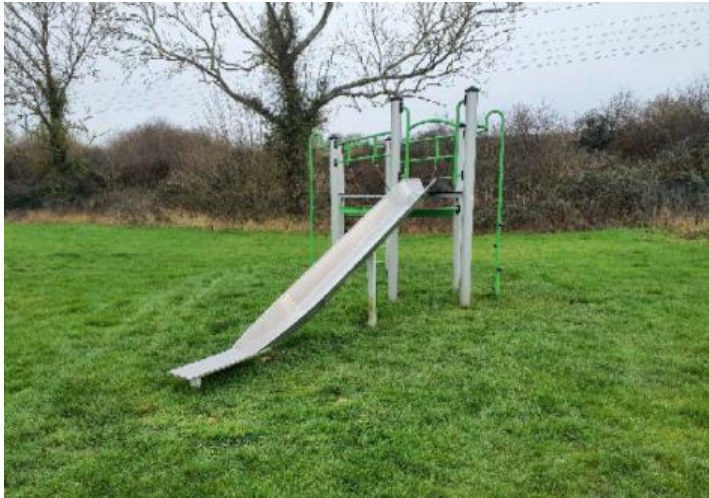
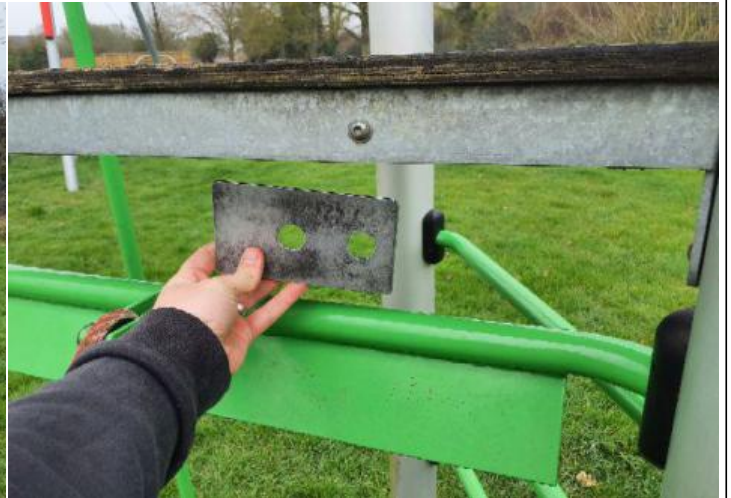
Item: Activity Equipment - Multi Play (Junior)
Manufacturer: Sutcliffe Play Limited

Finding: The item fails to meet the requirements of BS EN 1176 Part 1 4.2.7.2 for head and neck entrapment in the frame

Action: Monitor - No action given the risk assessment

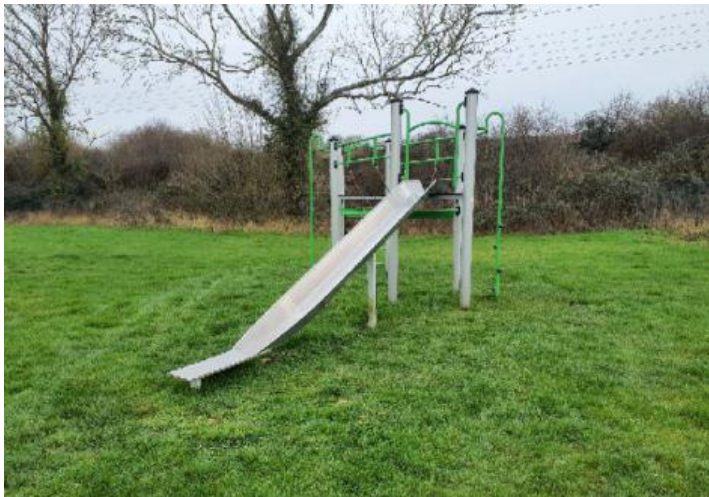
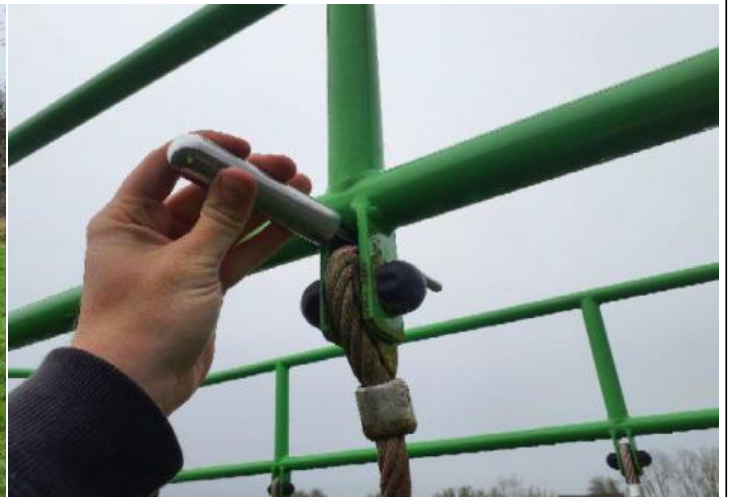
Item: Activity Equipment - Multi Play (Junior)
Manufacturer: Sutcliffe Play Limited

Finding: There is/are finger entrapment/s in the frame and the item fails to meet the requirements of BS EN 1176 Part 1 4.2.7.6 Entrapment of fingers

Action: Monitor - No action given the risk assessment

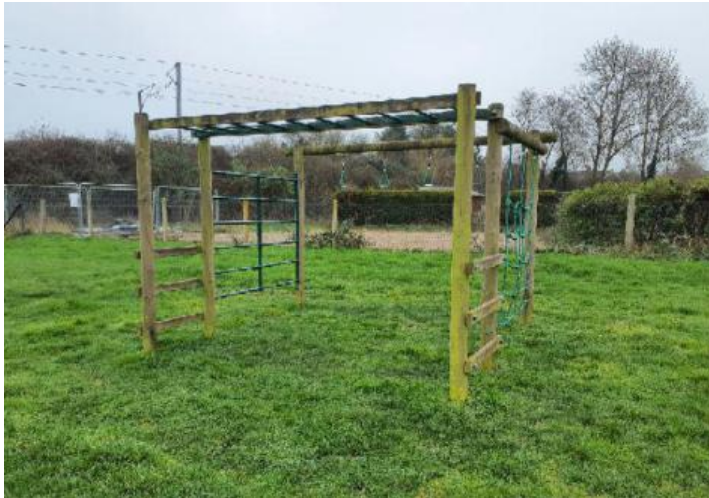
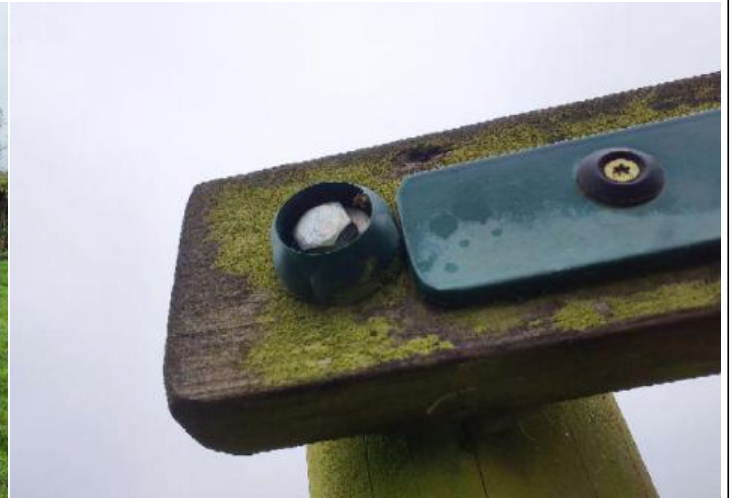
Item: Activity Equipment - Climbing Frame
Manufacturer: Action Play and Leisure

Finding: Bolt cap cover/s missing or damaged

Action: Replace

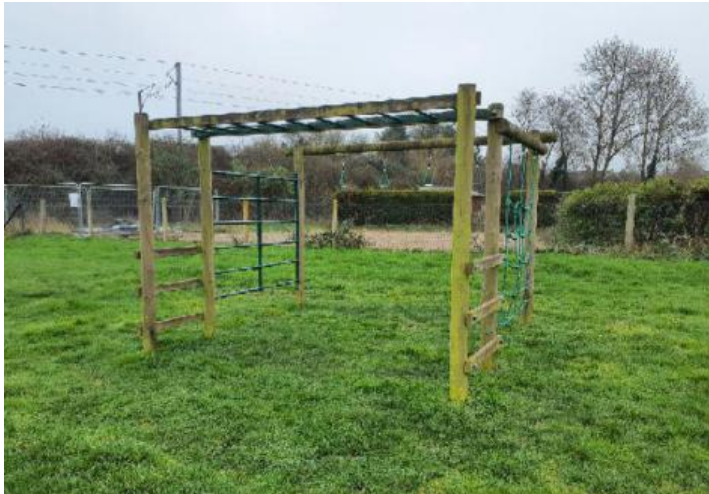
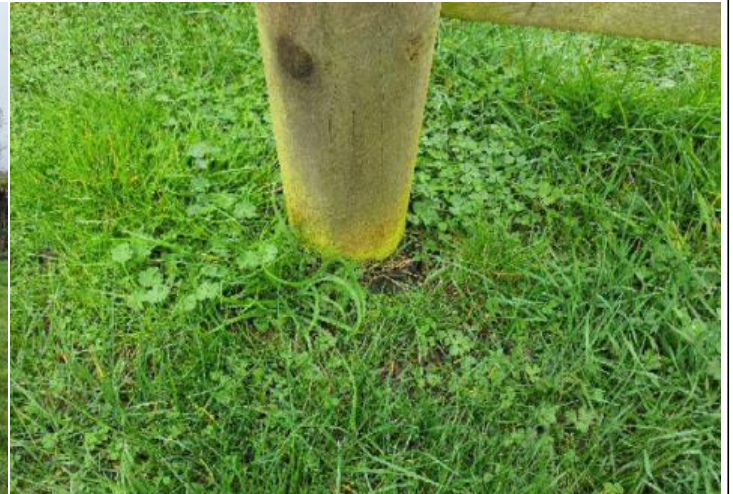
Item: Activity Equipment - Climbing Frame
Manufacturer: Action Play and Leisure

Finding: There is some strimmer / machinery damage apparent on the posts, this can penetrate the preservative applied to the timber and accelerate the rotting process

Action: Monitor for any deterioration (rot) and replace as required

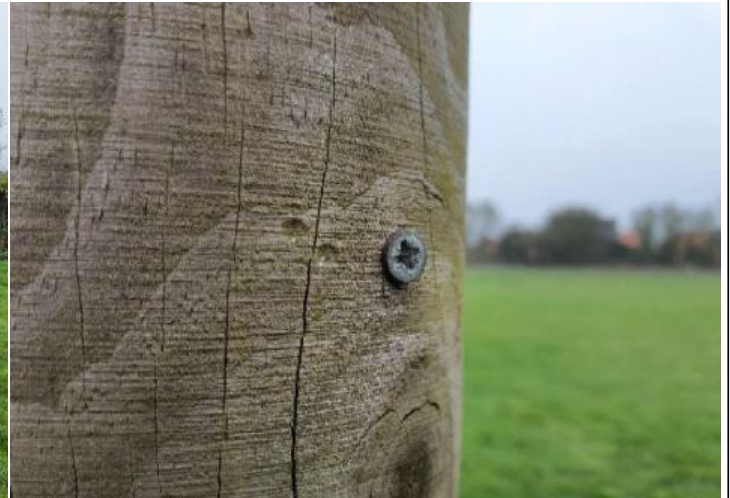
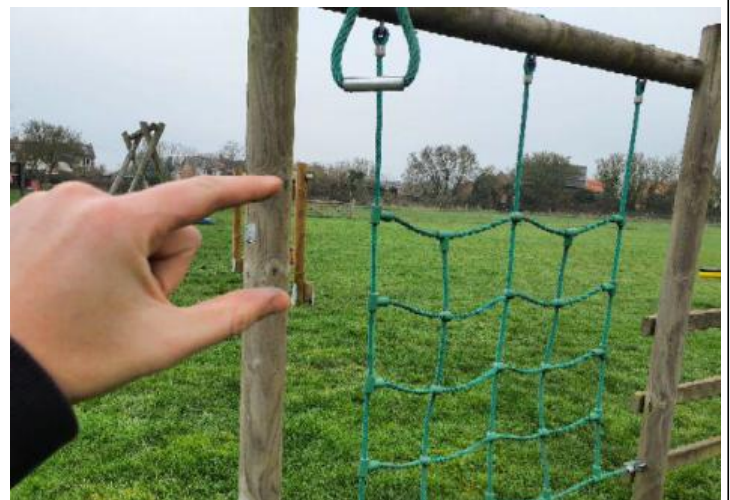
Item: Activity Equipment - Climbing Frame
Manufacturer: Action Play and Leisure

Finding: There are redundant screws in the post

Action: Remove

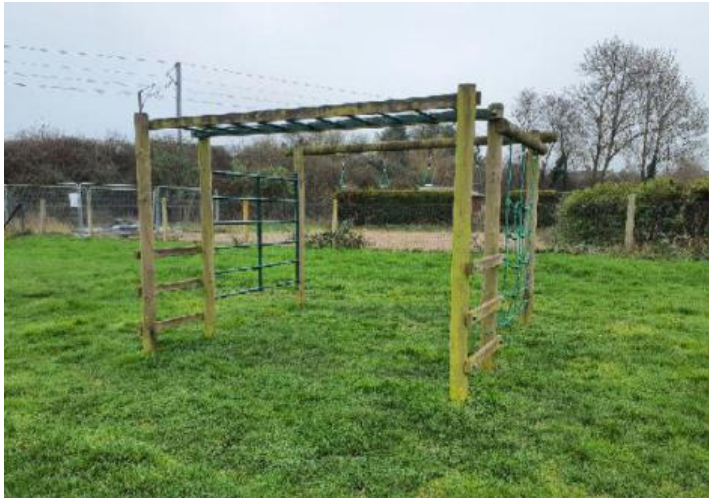
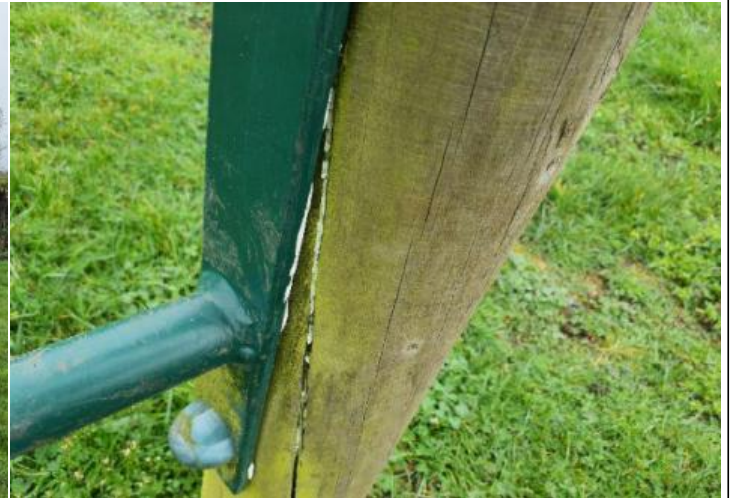
Item: Activity Equipment - Climbing Frame
Manufacturer: Action Play and Leisure

Finding: The use of synthetic fillers in timber is not recommended; timber being a natural material will expand and contract as the moisture content changes and the use of fillers can exacerbate the length and depth of these cracks or shakes in the timber. The only treatment that is normally required is the removal of any rough or sharp edges unless the structural integrity of the item is affected.

Action: Remove any rough or sharp edges and monitor timber for any further deterioration

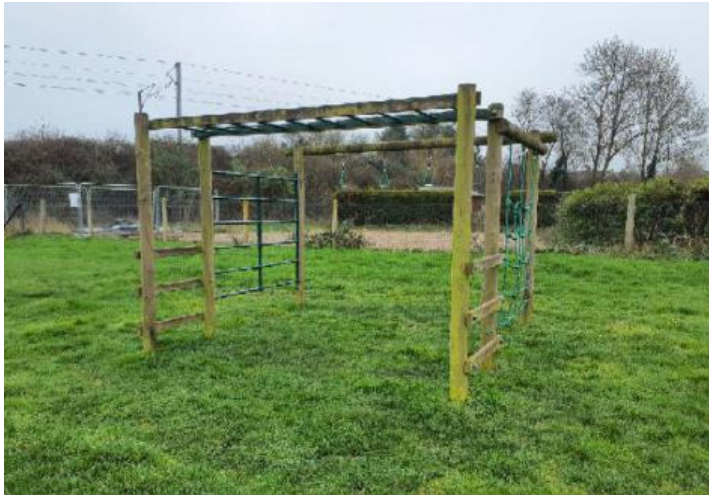
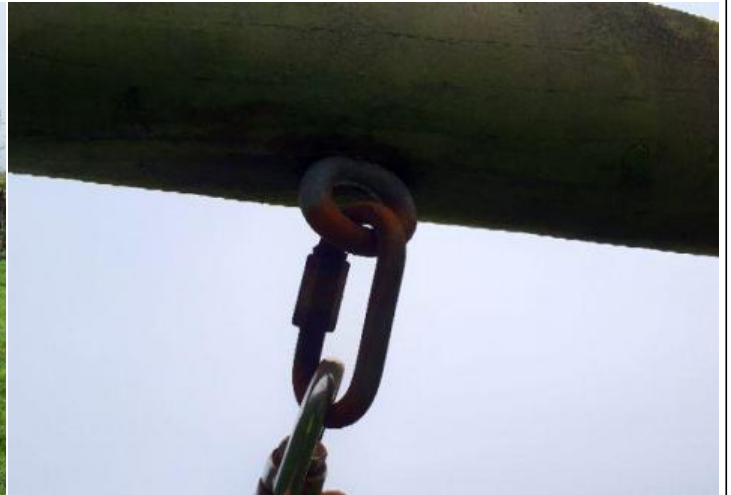
Item: Activity Equipment - Climbing Frame
Manufacturer: Action Play and Leisure

Finding: There is some wear to the shackles

Action: Monitor for any further deterioration and replace when 40% worn

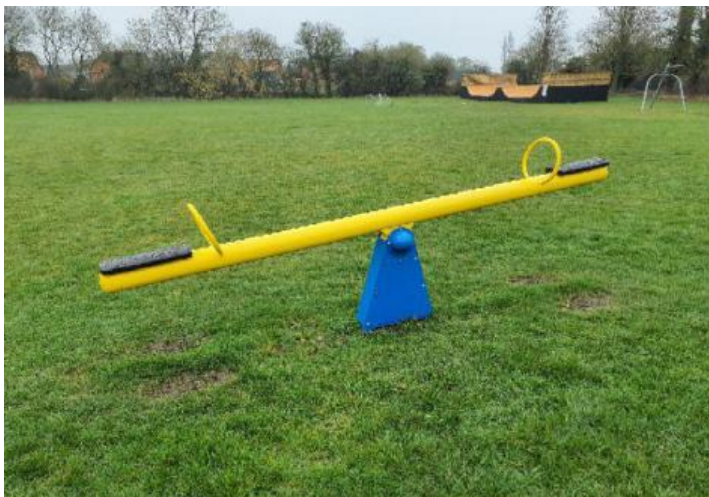
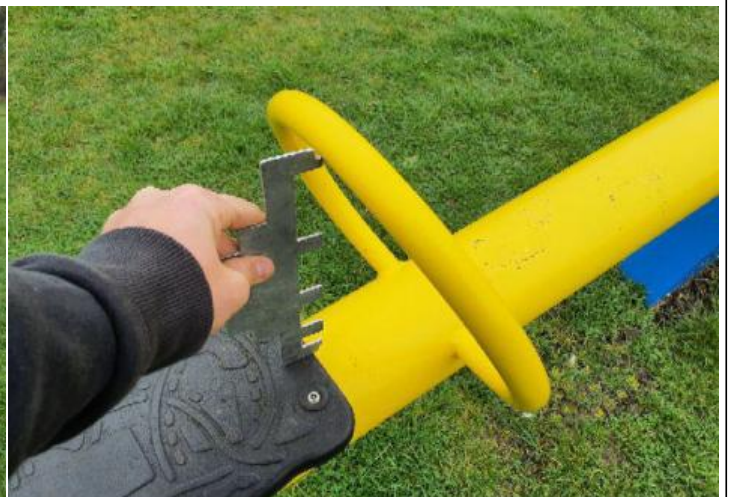
Item: Rocking Equipment - See Saw
Manufacturer: Yates Playgrounds Ltd

Finding: The item fails to meet the requirements of BS EN 1176 Part 1 4.2.7.2 for head and neck entrapment in the frame

Action: Monitor - No action given the risk assessment

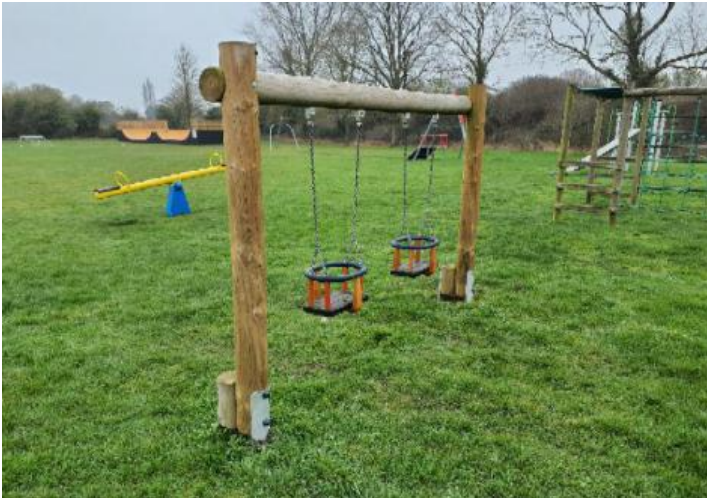
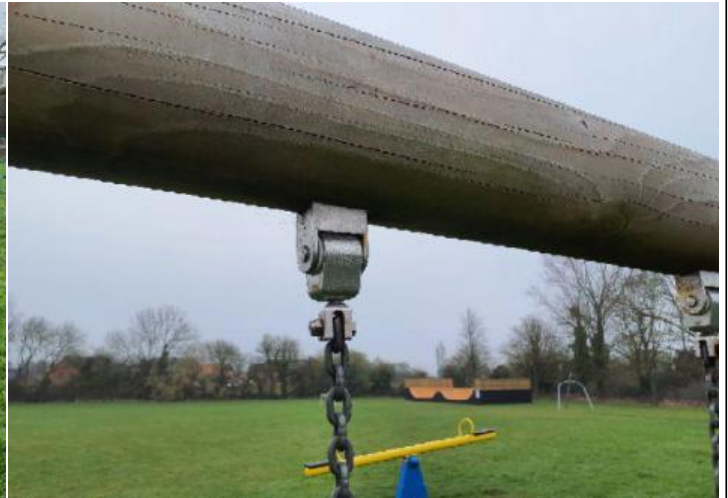
Item: Swings - 1 Bay 2 Seat (Cradle)
Manufacturer: Action Play and Leisure

Finding: This design of swing joint has been known to fail on the weld connecting the joint to the threaded stud

Action: We would recommend that the joint be dismantled and checked on a regular basis or consulting with manufacturer on whether a Secondary Safety Device can be fitted

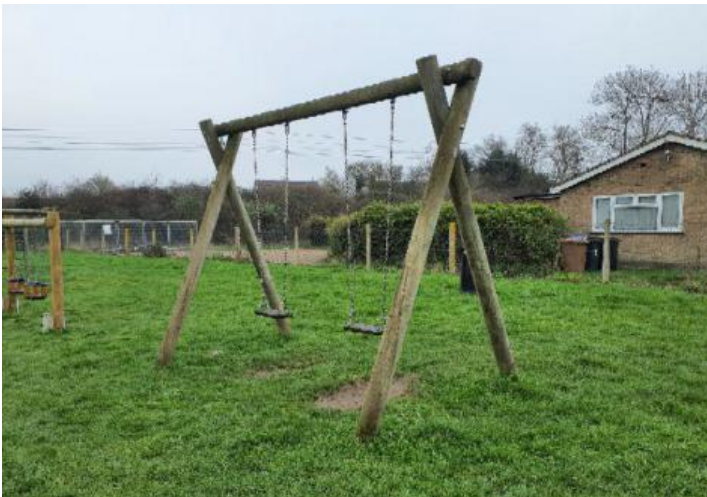
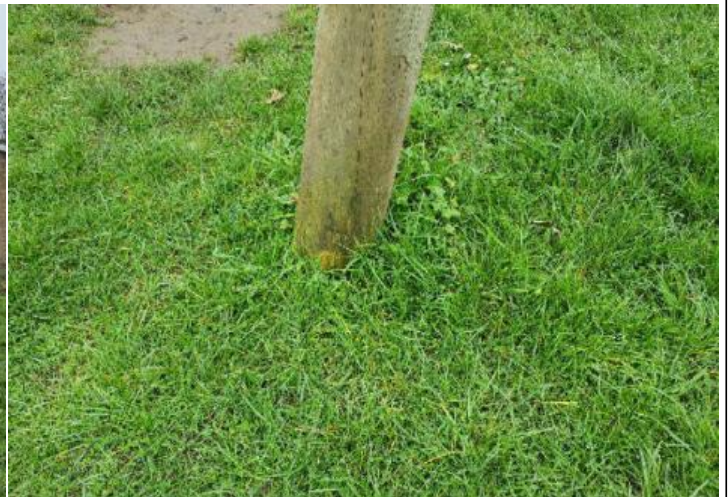
Item: Swings - 1 Bay 2 Seat (Flat)
Manufacturer: Adventure Playgrounds

Finding: There is some strimmer / machinery damage apparent on the posts, this can penetrate the preservative applied to the timber and accelerate the rotting process

Action: Monitor for any deterioration (rot) and replace as required

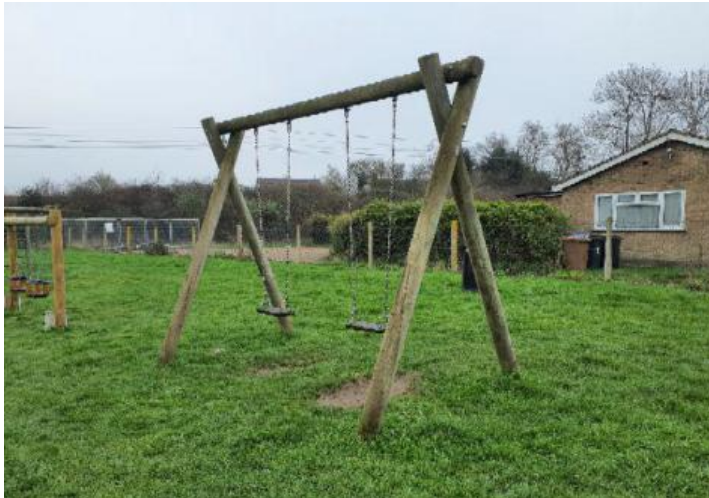
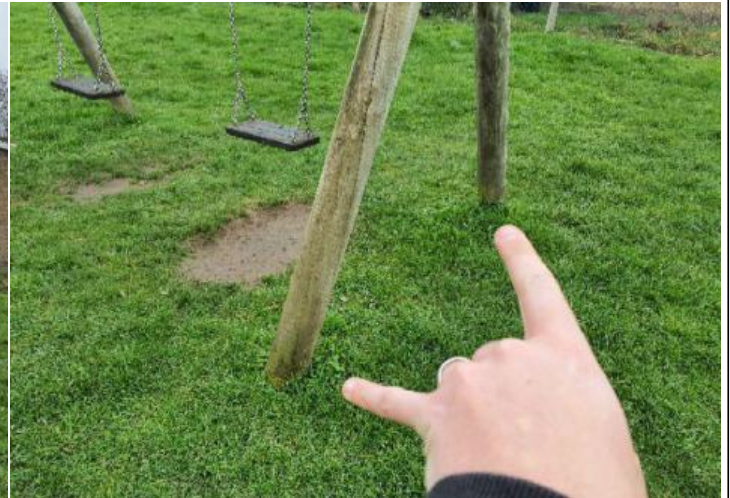
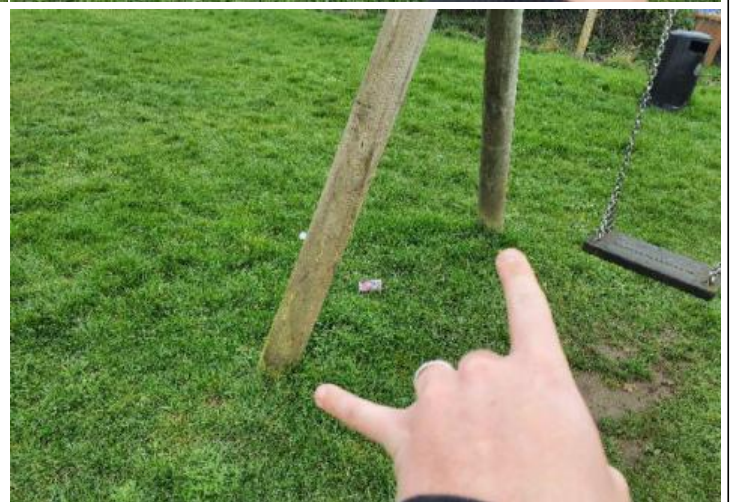
Item: Swings - 1 Bay 2 Seat (Flat)
Manufacturer: Adventure Playgrounds

Finding: There is some evidence of rot in the timber

Action: Monitor for any further deterioration and replace as required

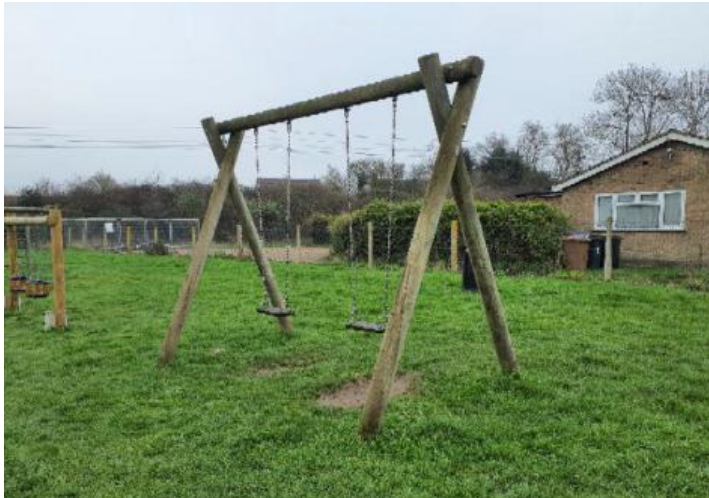
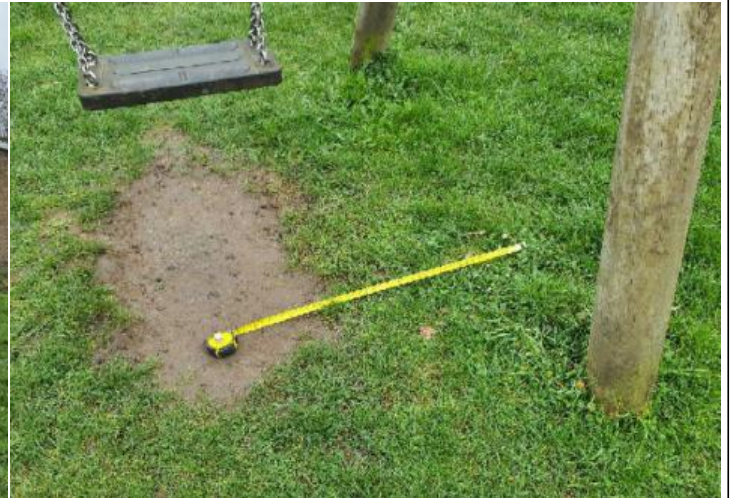
Item: Swings - 1 Bay 2 Seat (Flat)
Manufacturer: Adventure Playgrounds

Finding: The surfacing width under the seat/s is / are less than 875mm when measured from the centre of the seat outwards, and fail the requirements of BS EN 1176 Part 2

Action: Monitor - No action given the risk assessment

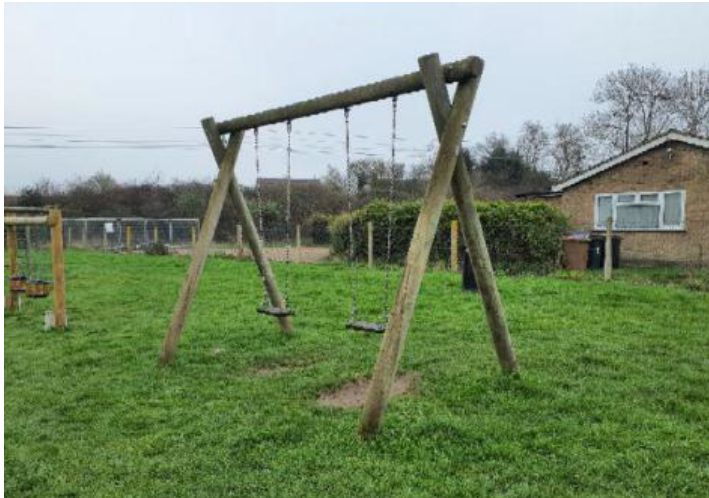
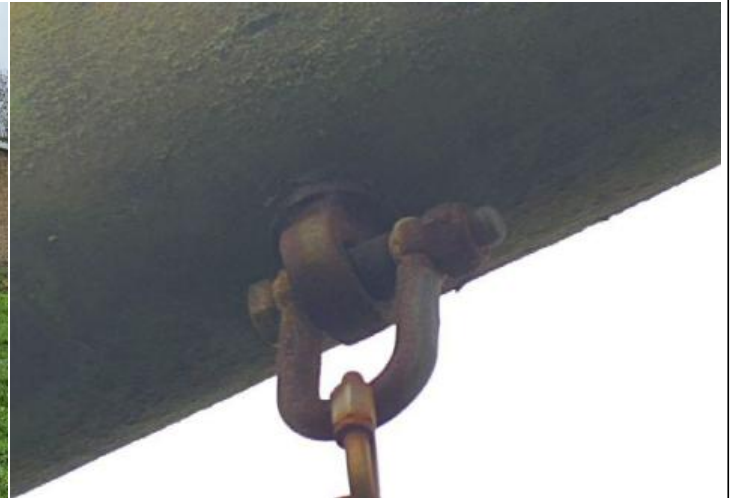
Finding: The bushes are worn or missing

Action: Replace worn or missing bushes
