the **play inspection** company

Annual Inspection

Mid Suffolk District Council

Bacton

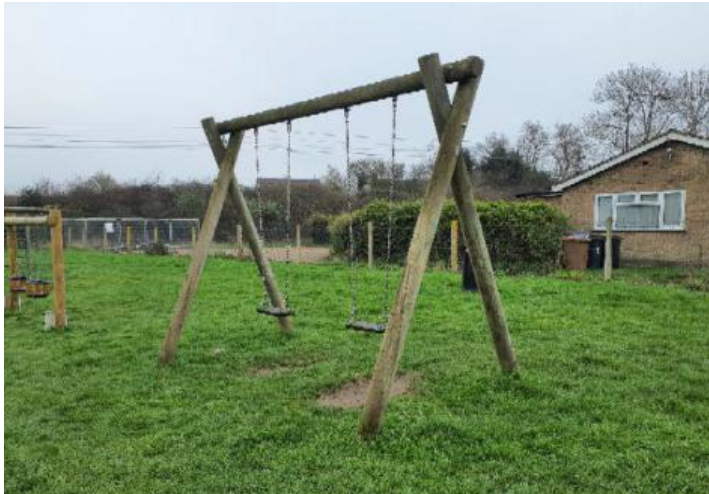
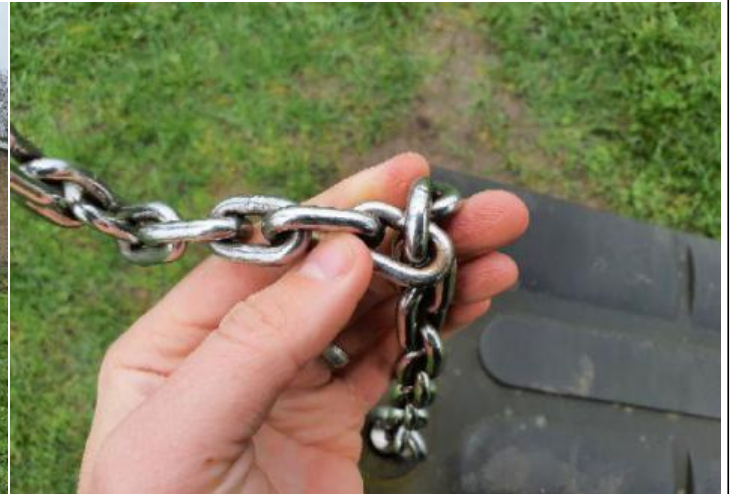
Finding: There is some notable evidence of chain wear

Action: Monitor for any further deterioration and replace when 40% worn

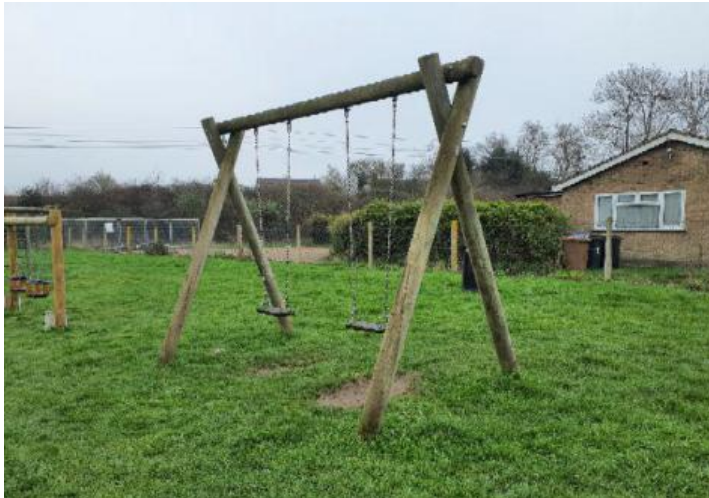
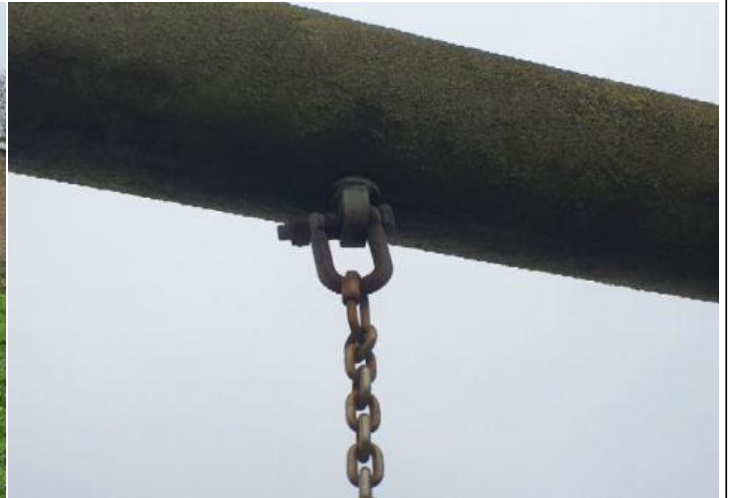
Finding: There is some wear to the shackles

Action: Monitor for any further deterioration and replace when 40% worn

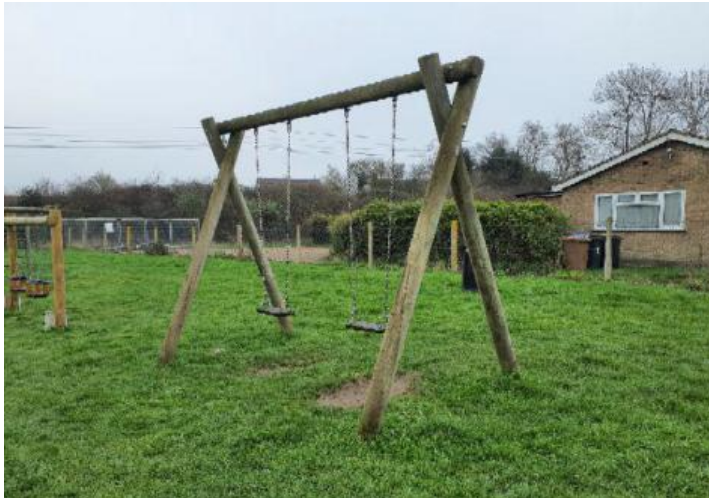
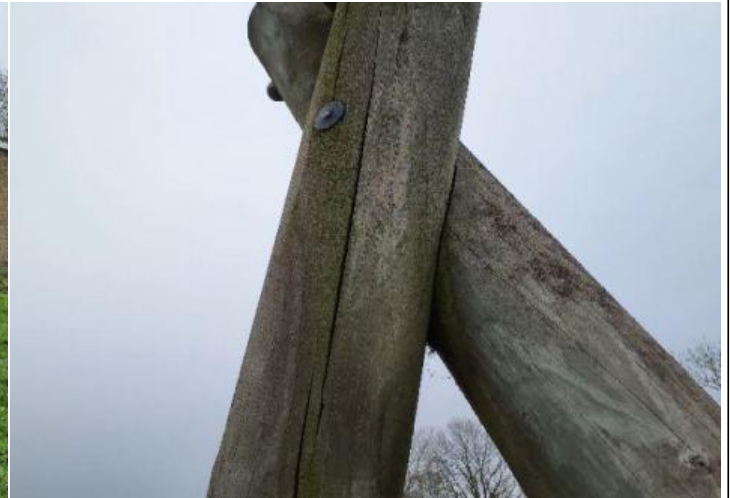
Finding: The timber has a number of splits/shakes or air cracks and this may affect the stability or allow water ingress which will accelerate the rotting process. Timber splits may also create rough / splintering edges.

Action: Monitor, sand down any rough edges and ensure the splits do not cross through fixing points of the structure and/or cause any instability

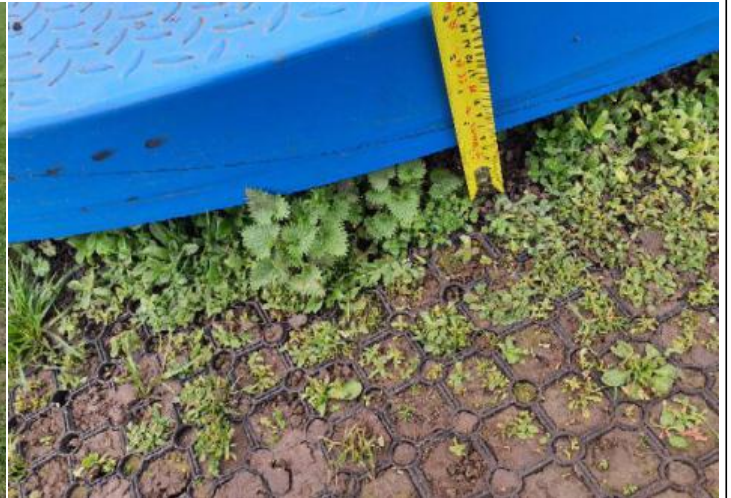
Finding: The distance between the underside of the roundabout platform and the playing surface is less than 60mm and contravenes the requirements of BS EN 1176 Part 5 which requires that the distance be maintained between 60mm-110mm for the entire circumference of the roundabout

Action: Monitor - No action given the risk assessment

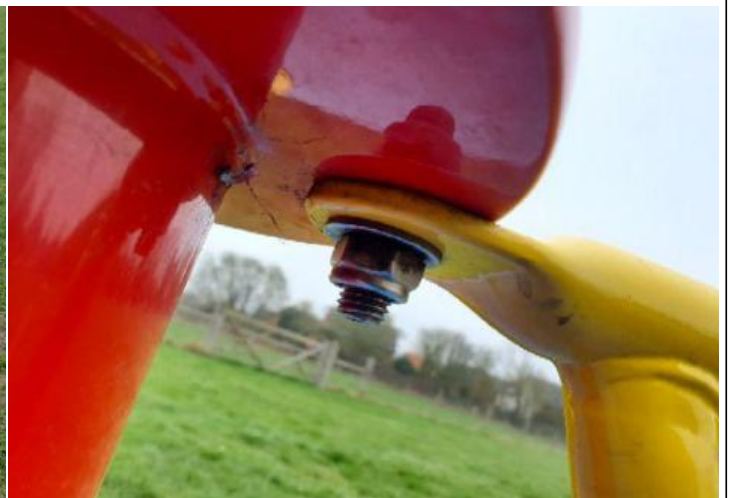
Finding: There are projecting bolt thread(s) present

Action: Remove excess thread length and deburr or provide cap
