the **play** inspection company

Annual Inspection

Bacton

St Mary's Close, Suffolk, IP14 4NW

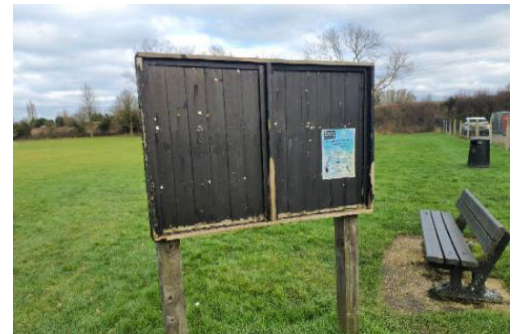
Item: Sign
Manufacturer: Not Identified
Surface Type: N/A
Item Quantity: 1
Equipment Compliance: N/A
Surface Area Compliance: N/A

It is recommended that signage, with information including the site address, contact information for maintenance issues and emergency contact details are provided for the facility - Provide in accordance with the recommendations

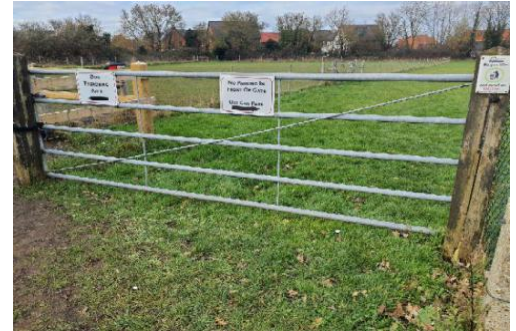
Item: Gate - Maintenance
Manufacturer: Not Identified
Surface Type: Grass
Item Quantity: 1
Equipment Compliance: N/A
Surface Area Compliance: N/A

The maintenance gate was correctly padlocked at the time of inspection, however this means that the inspector was unable to fully assess the gate - Ensure that there are 12mm gaps throughout the full range of motion on gate/s and between leaves where relevant

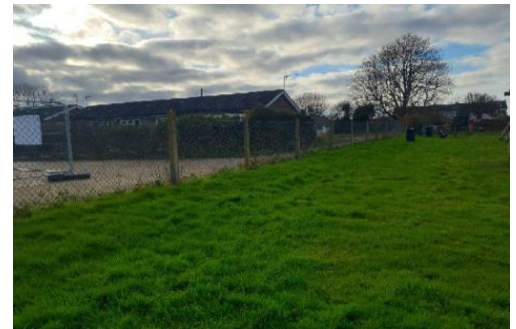
Item: Fence - Chainlink
Manufacturer: Not Identified
Surface Type: Grass
Item Quantity: 1
Equipment Compliance: N/A
Surface Area Compliance: N/A

There is some damage to the fence sections - Monitor for any further deterioration and repair as required

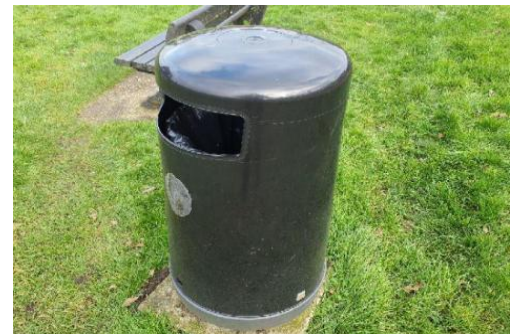
Item: Litter Bin
Manufacturer: Not Identified
Surface Type: Concrete
Item Quantity: 2
Equipment Compliance: N/A
Surface Area Compliance: N/A

The lid or door of the litter bin is not secured - Ensure the lid or door is kept locked

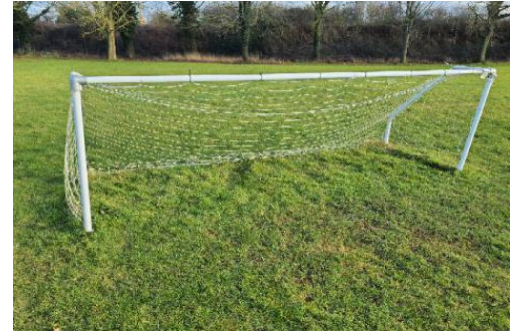
Item: 5 a side Goals
Manufacturer: Not Identified
Surface Type: Grass
Item Part Number:
Item Quantity: 1
Equipment Compliance: N/A
Surface Area Compliance: N/A
Total Findings: 3

NB: We have undertaken a maintenance inspection only of the football goal(s); full load testing falls outside the scope of our inspection. - Implement load testing as required

The surface has eroded in some areas and may be slippery in wet conditions - Reinstate the surface

Cable ties are present and there are projecting ends - Replace with a more appropriate fixing method

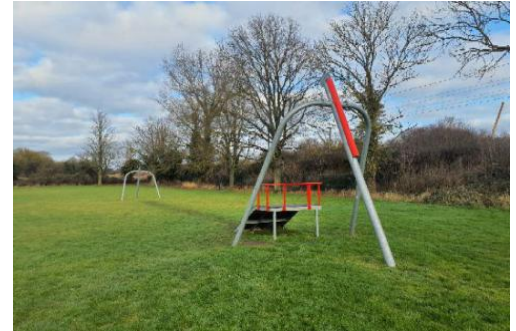
Item: Cable Runway
Manufacturer: Sutcliffe Play Limited
Surface Type: Grass Matrix Tiles
Item Quantity: 1
Equipment Compliance: No
Surface Area Compliance: Yes

We have completed a visual inspection of the suspension links, cable and fixing points from ground level, however it is not possible to fully inspect these areas without either hiring equipment to gain access or removing the cable and suspension and inspecting at ground level. We recommend that the main cable and fixing security is thoroughly inspected at least in accordance with the manufacturers recommendations to check for wear, damage, security or internal rusting; this will help to ensure the continued safe use of the equipment - Inspect in accordance with the manufacturers recommendations

There is or are fixings missing on the item - Replace all missing fixings

The traveller bearing is showing signs of wear - Monitor for any further deterioration and repair or replace if required

There is some notable evidence of chain wear - Monitor for any further deterioration and replace when 40% worn

The seat connector is worn more than 40% and requires replacement - Replace seat connector if possible or replace seat

The nylon inserts are worn or missing at the point the cable enters the traveller - Replace worn or missing inserts as required

The dampening spring or tyre is damaged or broken on the item - Replace spring or tyre

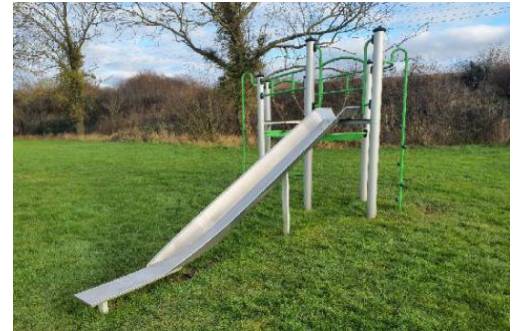
Item: Multi Play (Junior)
Manufacturer: Sutcliffe Play Limited
Surface Type: Grass Matrix Tiles
Item Quantity: 1
Equipment Compliance: No
Surface Area Compliance: Yes

The side of the slide extends less than 500mm above the slide surface at the start section and does not meet the recommendations of BS EN 1176 Part 3 - Monitor - No action given the risk assessment

There are a number of dents in the slide surface - Monitor for any further deterioration and repair as required

There is/are finger entrapment/s in the frame and the item fails to meet the requirements of BS EN 1176 Part 1 4.2.7.6 Entrapment of fingers - Monitor - No action given the risk assessment

The item fails to meet the requirements of BS EN 1176 Part 1 4.2.7.2 for head and neck entrapment in the frame - Monitor - No action given the risk assessment

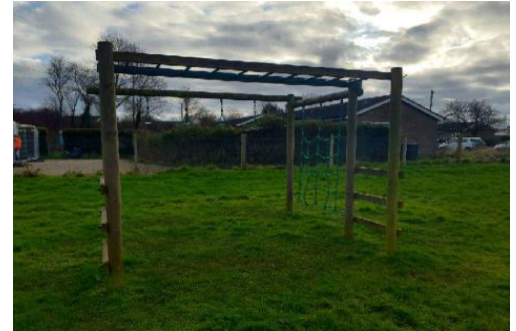
Item: Climbing Frame
Manufacturer: Action Play and Leisure
Surface Type: Grass Matrix Tiles
Item Quantity: 1
Equipment Compliance: Yes
Surface Area Compliance: Yes

There is some strimmer / machinery damage apparent on the posts, this can penetrate the preservative applied to the timber and accelerate the rotting process - Monitor for any deterioration (rot) and replace as required

The use of synthetic fillers in timber is not recommended; timber being a natural material will expand and contract as the moisture content changes and the use of fillers can exacerbate the length and depth of these cracks or shakes in the timber. The only treatment that is normally required is the removal of any rough or sharp edges unless the structural integrity of the item is affected. - Remove any rough or sharp edges and monitor timber for any further deterioration

There is some wear to the shackles - Monitor for any further deterioration and replace when 40% worn

There is/are bolt cap covers missing or damaged on the item - Replace missing or damaged bolt cap covers

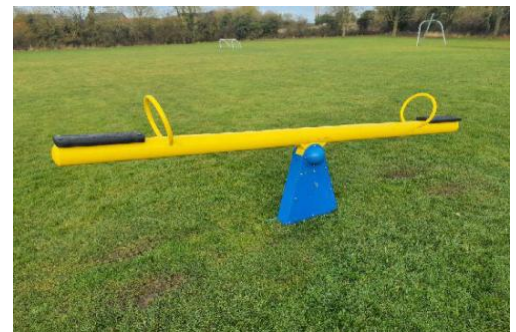
Item: See Saw
Manufacturer: Yates Playgrounds Ltd
Surface Type: Grass Matrix Tiles
Item Quantity: 1
Equipment Compliance: No
Surface Area Compliance: Yes

The item fails to meet the requirements of BS EN 1176 Part 1 4.2.7.2 for head and neck entrapment in the frame - Monitor - No action given the risk assessment

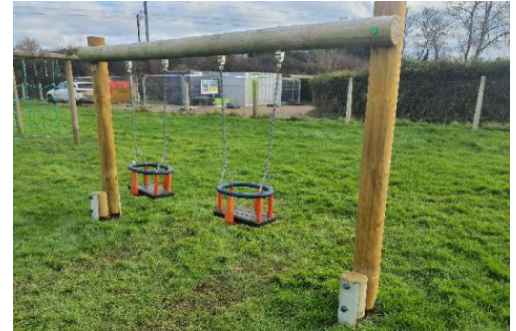
Item: 1 Bay 2 Seat (Cradle)
Manufacturer: Action Play and Leisure
Surface Type: Grass
Item Quantity: 1
Equipment Compliance: Yes
Surface Area Compliance: Yes

This design of swing joint has been known to fail on the weld connecting the joint to the threaded stud - We would recommend that the joint be dismantled and checked on a regular basis or consulting with manufacturer on whether a Secondary Safety Device can be fitted

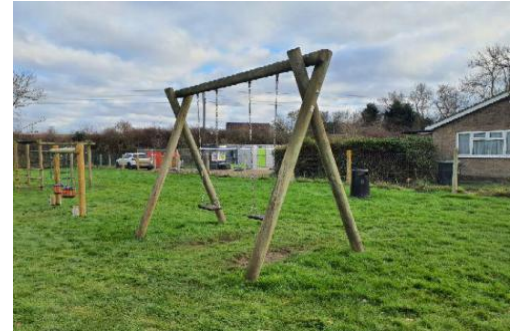
Item: 1 Bay 2 Seat (Flat)
Manufacturer: Adventure Playgrounds
Surface Type: Grass Matrix Tiles
Item Quantity: 1
Equipment Compliance: No
Surface Area Compliance: No

The grass mats are silted up, the soil is compacted and the area will become very slippery when the soil is wet. - Reinstate as required

The fixings or components for this item were in excess of 2.5m above the standing surface and could not be fully accessed by the inspector. We have completed a visual inspection of the fixings from ground level but a maintenance inspection should be undertaken to assess the condition, security and wear of the components at intervals in accordance with the manufacturers recommendations. - Inspect in accordance with the manufacturers recommendations

The surfacing width under the seat/s is / are less than 875mm when measured from the centre of the seat outwards, and fail the requirements of BS EN 1176 Part 2 - Monitor - No action given the risk assessment

There is some notable evidence of chain wear - Monitor for any further deterioration and replace when 40% worn

The bushes are worn or missing - Replace worn or missing bushes

There is some wear to the shackles - Monitor for any further deterioration and replace when 40% worn

The timber has a number of splits/shakes or air cracks and this may affect the stability or allow water ingress which will accelerate the rotting process - Monitor to ensure the splits do not cross through fixing points of the structure and/or cause any instability

There is some evidence of rot in the timber - Monitor for any further deterioration and replace as required

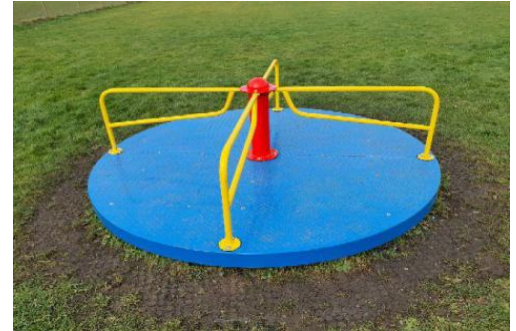
Item: Roundabout
Manufacturer: Yates Playgrounds Ltd
Surface Type: Grass Matrix Tiles
Item Quantity: 1
Equipment Compliance: No
Surface Area Compliance: Yes

The grass mats are silted up, the soil is compacted and the area will become very slippery when the soil is wet. - Reinstate as required

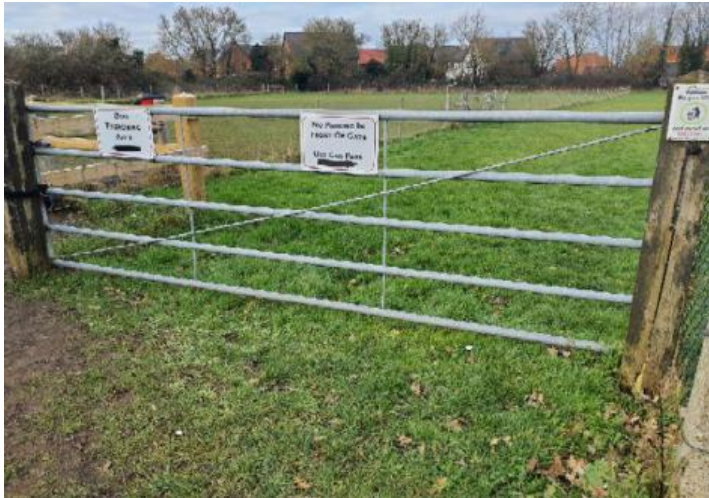
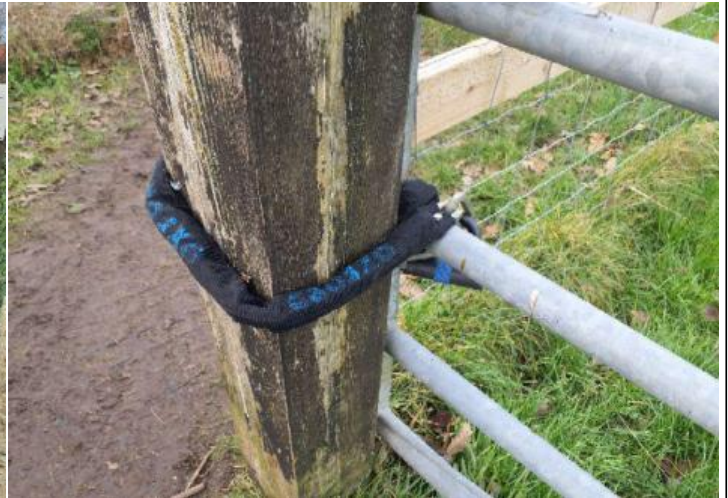
Item: Gates - Gate - Maintenance
Manufacturer: Not Identified

Finding: The maintenance gate was correctly padlocked at the time of inspection, however this means that the inspector was unable to fully assess the gate

Action: Ensure that there are 12mm gaps throughout the full range of motion on gate/s and between leaves where relevant

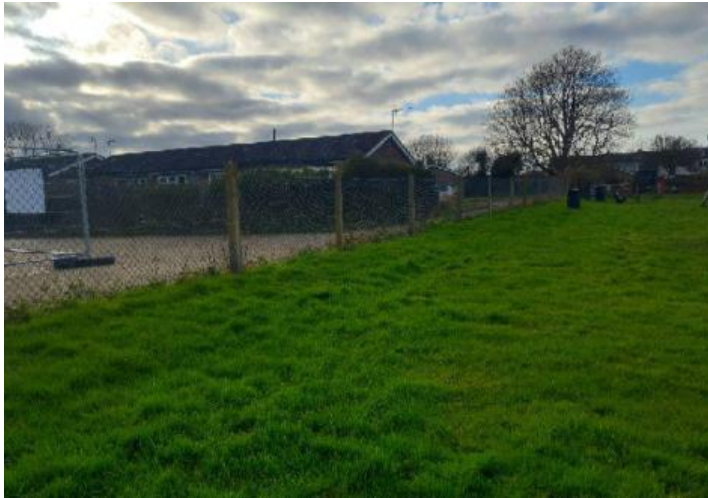
Item: Fences - Fence - Chainlink
Manufacturer: Not Identified

Finding: There are projecting bolt thread(s) present

Action: Remove excess thread length and deburr or provide cap

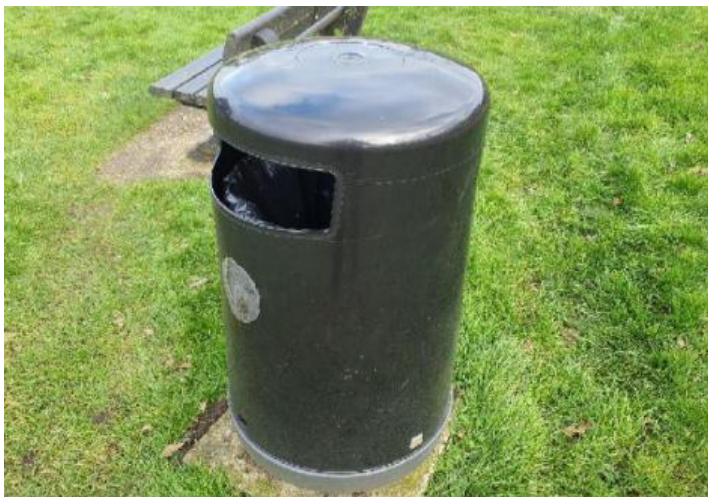
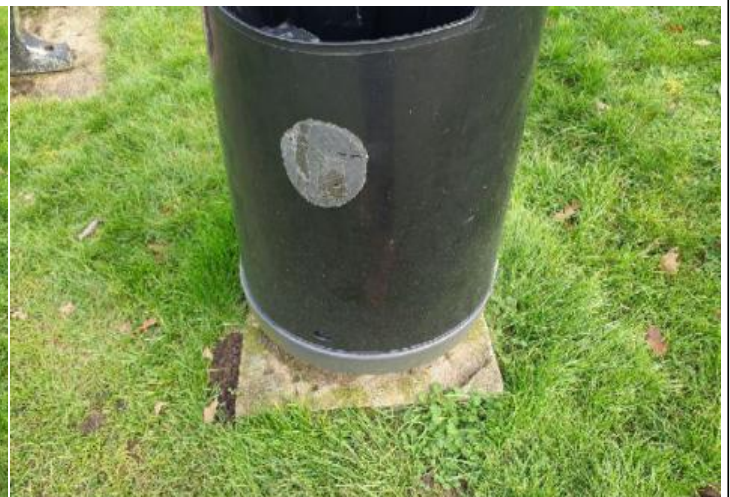
Item: Ancillary Items - Litter Bin
Manufacturer: Not Identified

Finding: The lid or door of the litter bin is not secured

Action: Ensure the lid or door is kept locked

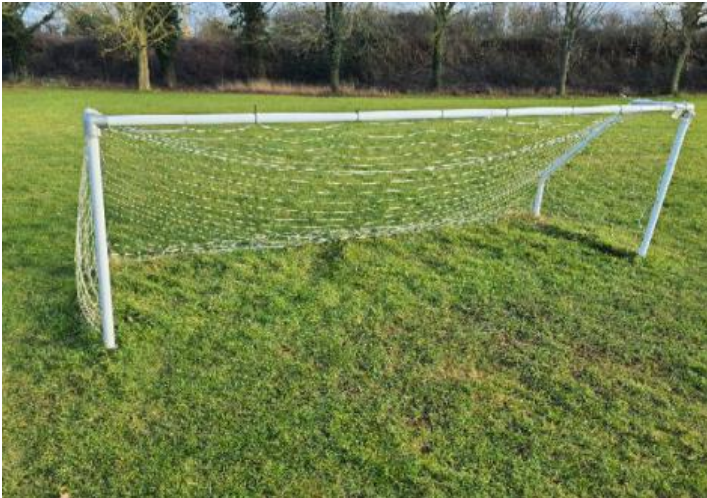
Item: Multi Use Games Area - 5 a side Goals
Manufacturer: Not Identified

Finding: NB: We have undertaken a maintenance inspection only of the football goal(s); full load testing falls outside the scope of our inspection.

Action: Implement load testing as required

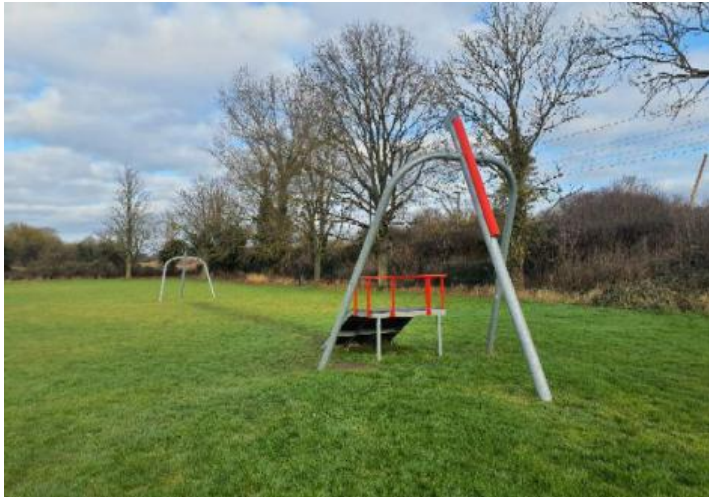
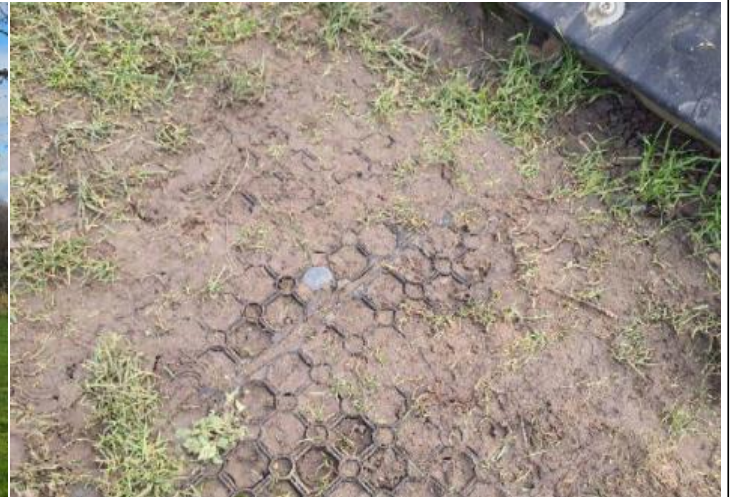
Item: Other - Cable Runway
Manufacturer: Sutcliffe Play Limited

Finding: Fixing Pins have been installed in the impact areas of the grass mats

Action: Remove pins from impact areas

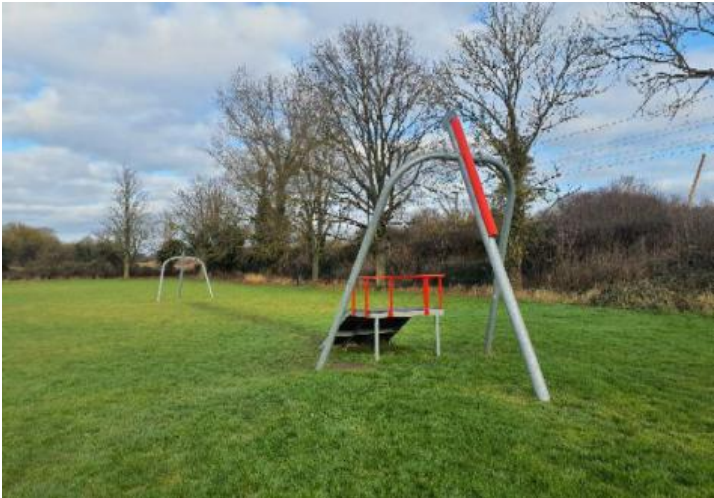
Item: Other - Cable Runway
Manufacturer: Sutcliffe Play Limited

Finding: The grass has eroded within the impact area of the equipment and may not provide the necessary impact attenuating properties for the equipment fall height; the surface may also be slippery in wet weather
Action: Reinstatement the grass or provide an all weather surface

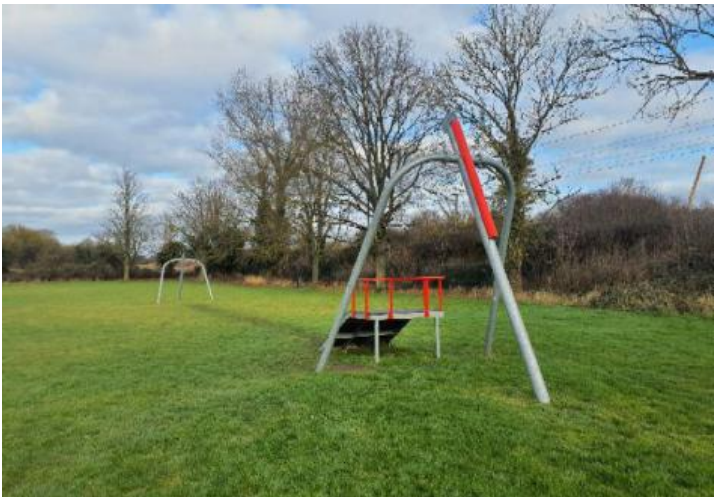
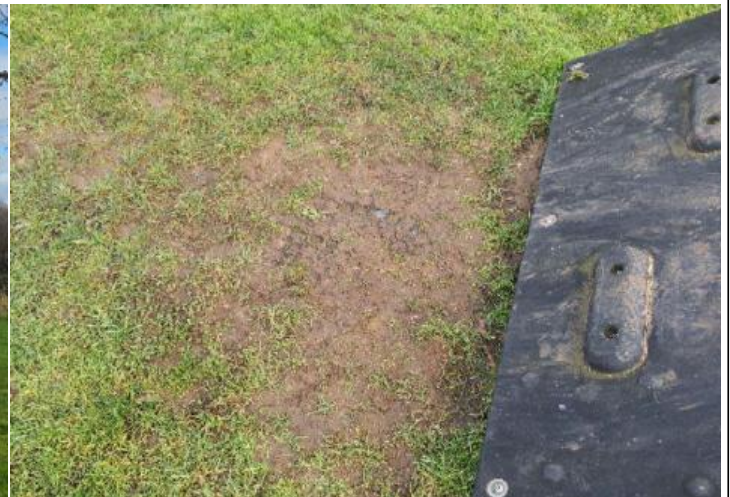
Item: Other - Cable Runway
Manufacturer: Sutcliffe Play Limited

Finding: The grass mats are silted up, the soil is compacted and the area will become very slippery when the soil is wet.
Action: Reinstatement as required

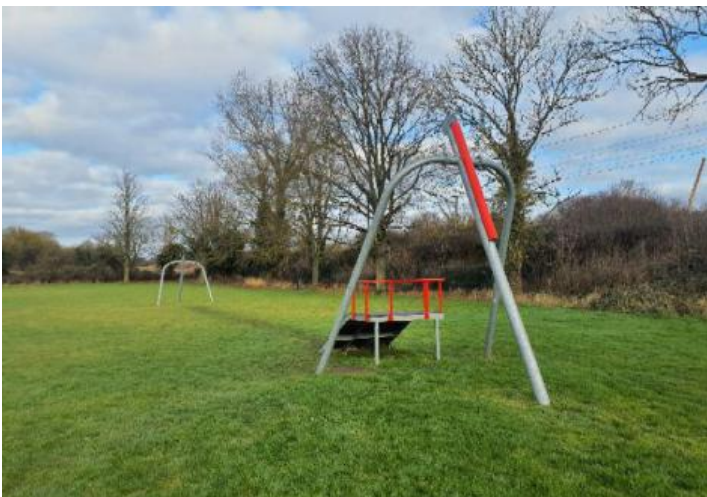
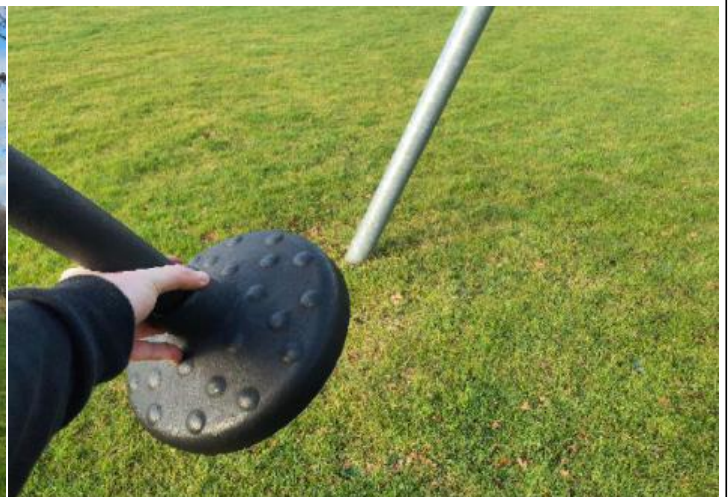
Item: Other - Cable Runway
Manufacturer: Sutcliffe Play Limited

Finding: The seat is less than 2.0 metres from the post when extended at 45 degrees at the end of the area of travel and does not meet the requirements of BS EN 1176 Part 4

Action: Adjust the cable stop position to ensure the minimum distance is maintained

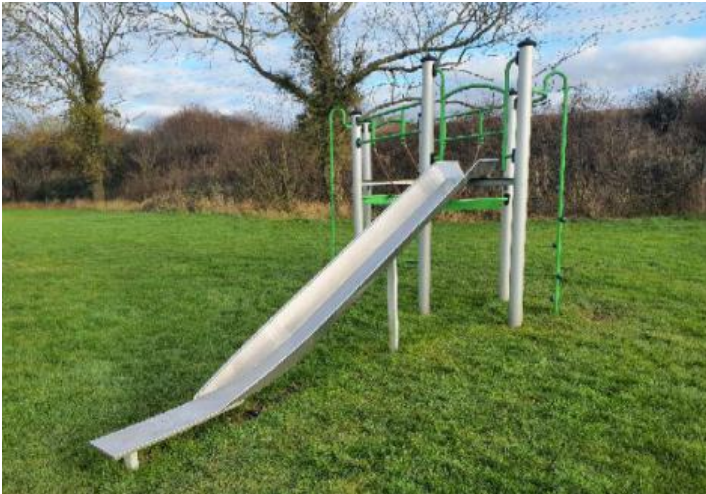
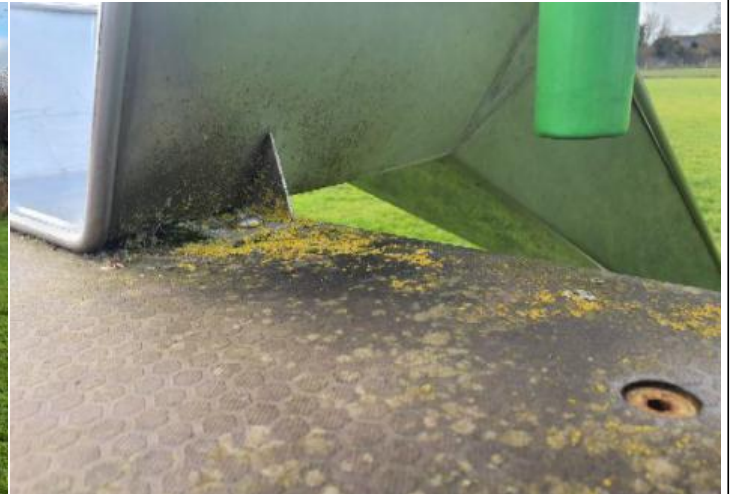
Item: Activity Equipment - Multi Play (Junior)
Manufacturer: Sutcliffe Play Limited

Finding: There is algae or moss on the surface of the equipment

Action: Clean and treat appropriately

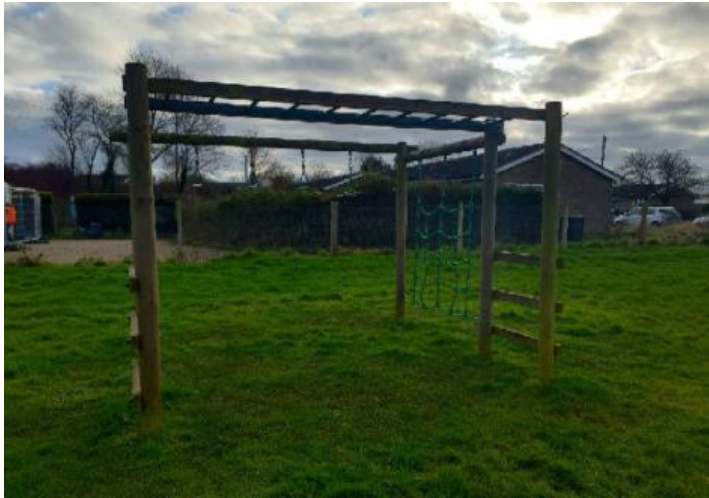
Item: Activity Equipment - Climbing Frame
Manufacturer: Action Play and Leisure

Finding: There are projecting nail ends present

Action: Remove

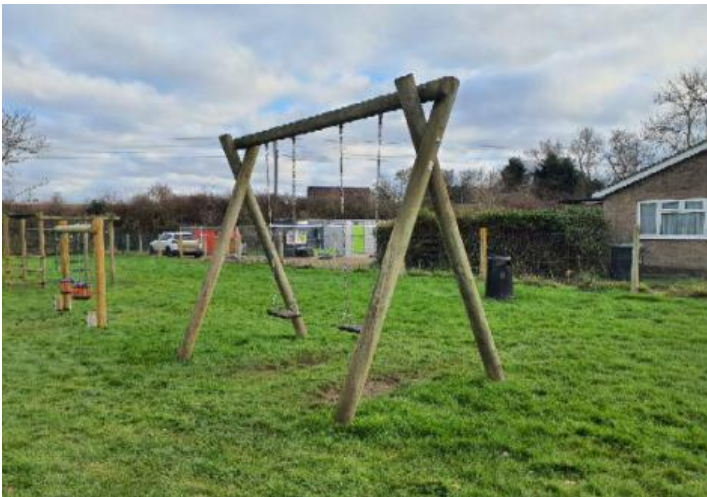
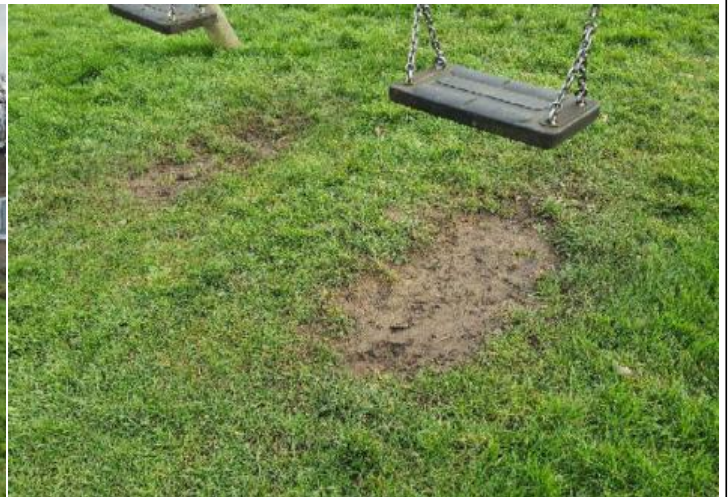
Item: Swings - 1 Bay 2 Seat (Flat)
Manufacturer: Adventure Playgrounds

Finding: The grass mats are silted up, the soil is compacted and the area will become very slippery when the soil is wet.

Action: Reinststate as required

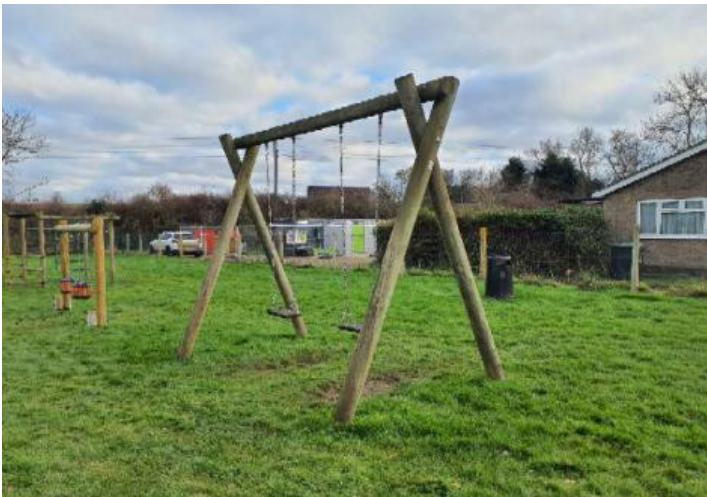
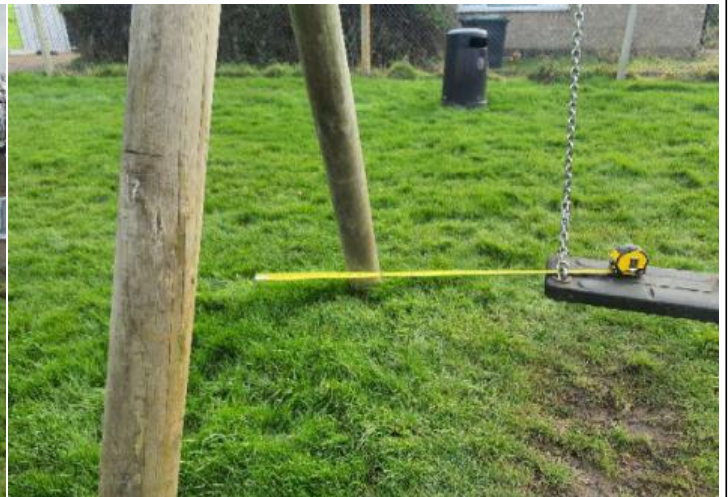
Item: Swings - 1 Bay 2 Seat (Flat)
Manufacturer: Adventure Playgrounds

Finding: The seat/s is / are too close to the frame as defined in BS EN 1176 Part 2

Action: Monitor - No action given the risk assessment

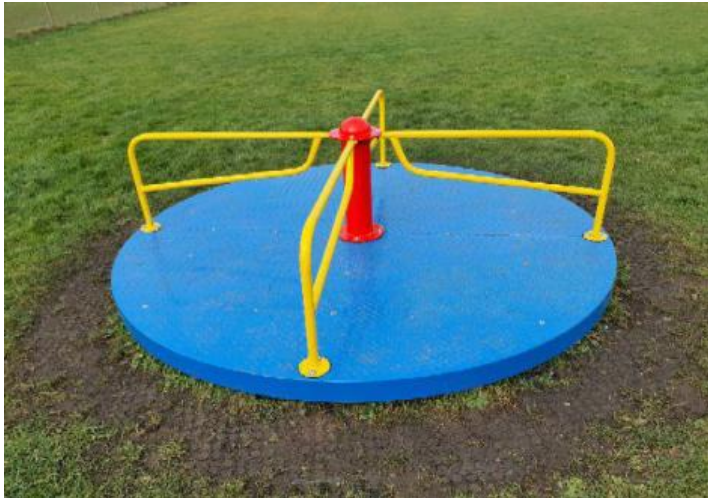
Item: Rotor Play - Roundabout
Manufacturer: Yates Playgrounds Ltd

Finding: The grass mats are silted up, the soil is compacted and the area will become very slippery when the soil is wet.
Action: Reinstate as required

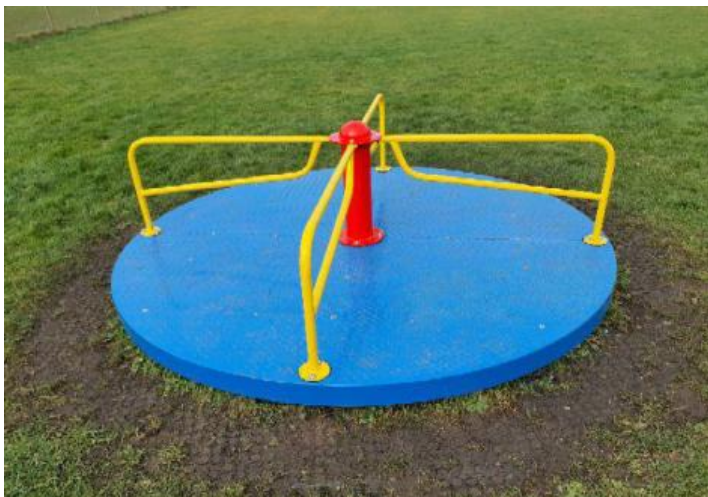
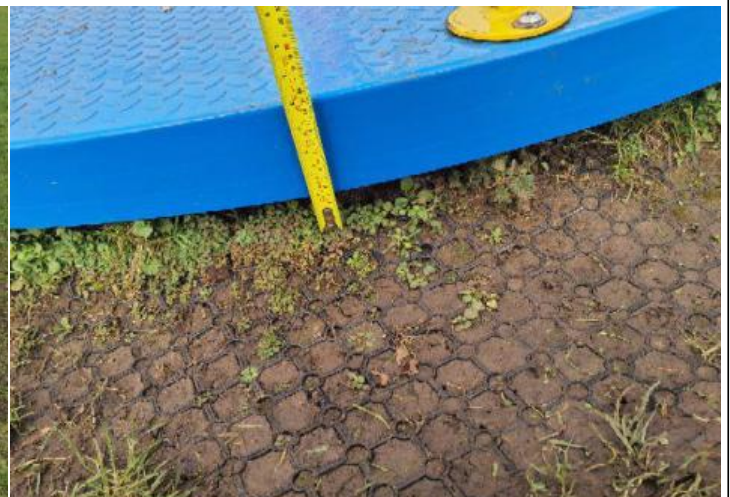
Item: Rotor Play - Roundabout
Manufacturer: Yates Playgrounds Ltd

Finding: The distance between the underside of the roundabout platform and the playing surface is less than 60mm and contravenes the requirements of BS EN 1176 Part 5 which requires that the distance be maintained between 60mm-110mm for the entire circumference of the roundabout

Action: Monitor - No action given the risk assessment

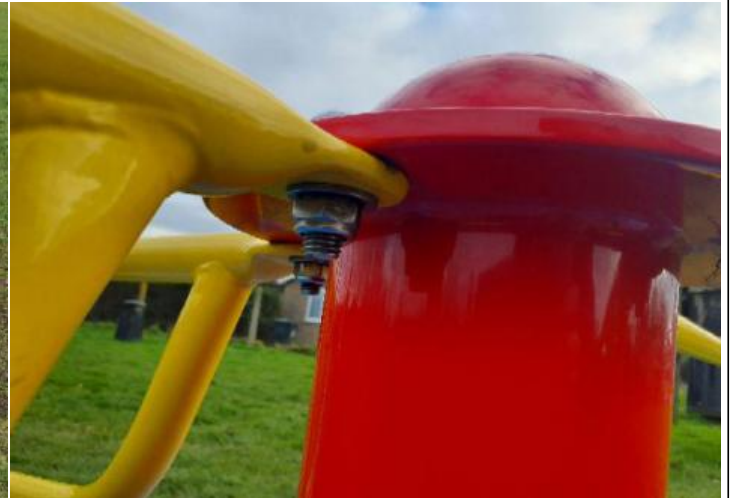
Item: Rotor Play - Roundabout
Manufacturer: Yates Playgrounds Ltd

Finding: There are projecting bolt thread(s) present

Action: Remove excess thread length and deburr or provide cap
