the **play inspection** company

Annual Inspection

Mid Suffolk District Council

Bacton

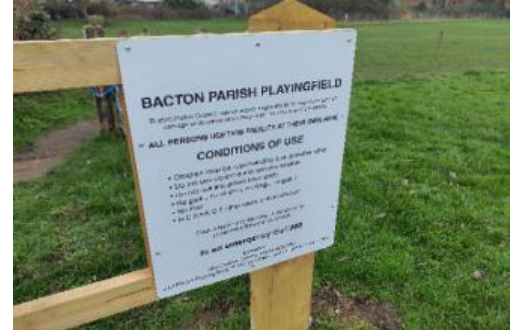
Item: Sign
Manufacturer: Not Identified
Surface Type: N/A
Item Quantity: 1
Equipment Compliance: N/A
Surface Area Compliance: N/A

This item is satisfactory - no work required -

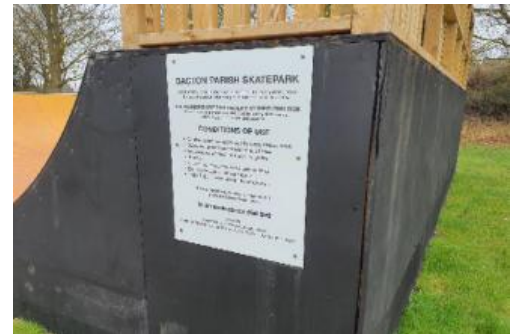
Item: Sign
Manufacturer: Not Identified
Surface Type: N/A
Item Quantity: 1
Equipment Compliance: N/A
Surface Area Compliance: N/A

This item is satisfactory - no work required -

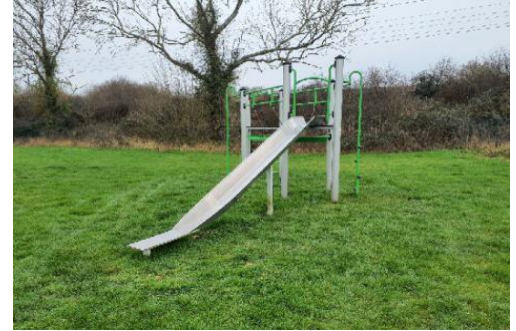
Item: Multi Play (Junior)
Manufacturer: Sutcliffe Play Limited
Surface Type: Grass Matrix Tiles
Item Quantity: 1
Equipment Compliance: No
Surface Area Compliance: Yes

The side of the slide extends less than 500mm above the slide surface at the start section and does not meet the recommendations of BS EN 1176 Part 3 - Monitor - No action given the risk assessment

There are a number of dents in the slide surface - Monitor for any further deterioration and repair as required

There is some evidence of rot in the timber - Monitor for any further deterioration and replace as required

The item fails to meet the requirements of BS EN 1176 Part 1 4.2.7.2 for head and neck entrapment in the frame - Monitor - No action given the risk assessment

There is/are finger entrapment/s in the frame and the item fails to meet the requirements of BS EN 1176 Part 1 4.2.7.6 Entrapment of fingers - Monitor - No action given the risk assessment

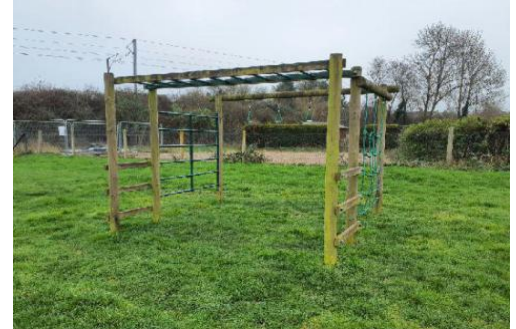
Item: Climbing Frame
Manufacturer: Action Play and Leisure
Surface Type: Grass Matrix Tiles
Item Quantity: 1
Equipment Compliance: Yes
Surface Area Compliance: Yes

Bolt cap cover/s missing or damaged - Replace

There is some wear to the shackles - Monitor for any further deterioration and replace when 40% worn

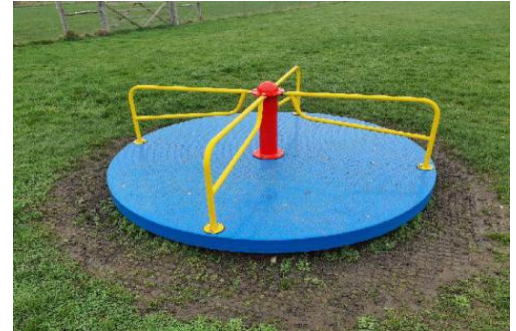
Item: Roundabout
Manufacturer: Yates Playgrounds Ltd
Surface Type: Grass Matrix Tiles
Item Quantity: 1
Equipment Compliance: No
Surface Area Compliance: Yes

The grass mats are silted up, the soil is compacted and the area will become very slippery when the soil is wet. - Reinstate as required

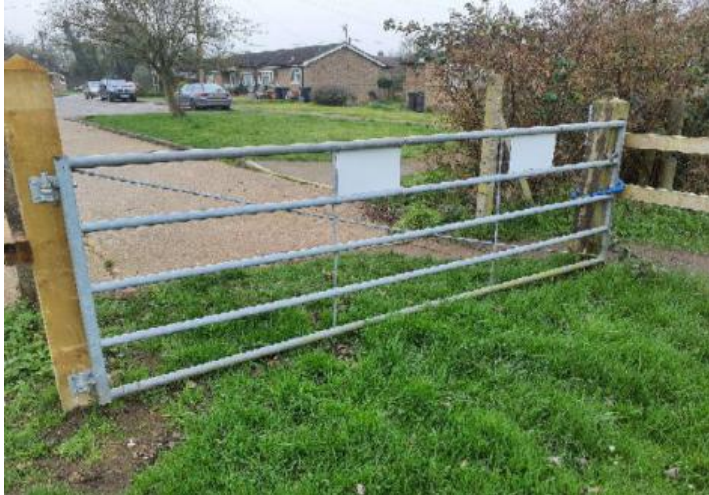
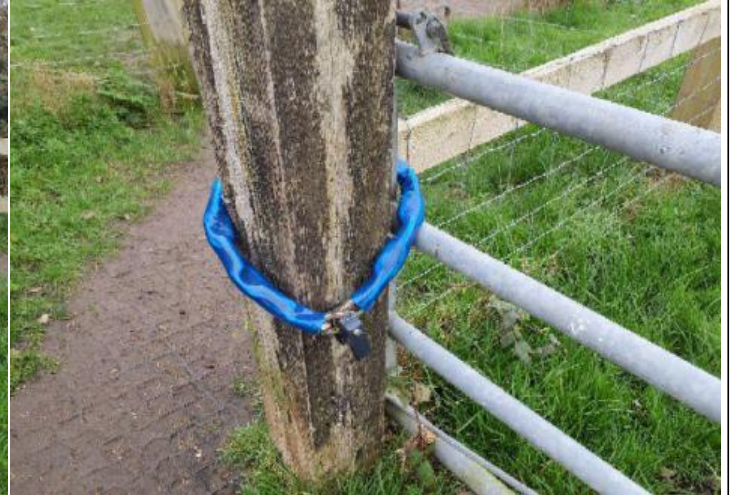
Item: Gates - Gate - Maintenance
Manufacturer: Not Identified

Finding: The maintenance gate was correctly padlocked at the time of inspection, however this means that the inspector was unable to fully assess the gate

Action: Ensure that there are 12mm gaps throughout the full range of motion on gate/s and between leaves where relevant

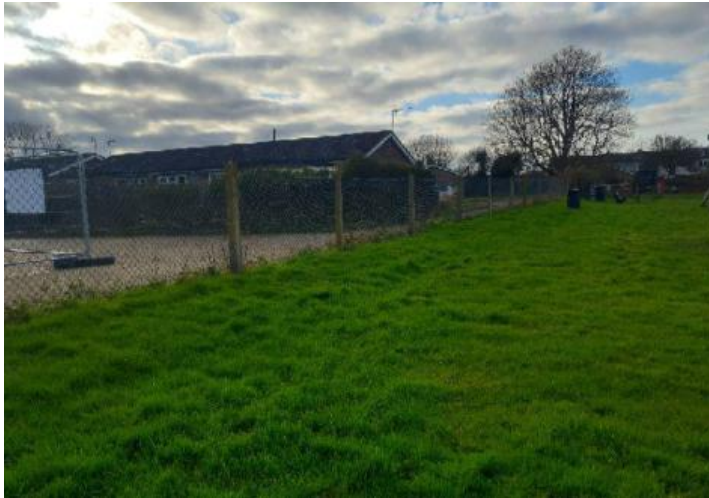
Item: Fences - Fence - Chainlink
Manufacturer: Not Identified

Finding: There are projecting bolt thread(s) present

Action: Remove excess thread length and deburr or provide cap

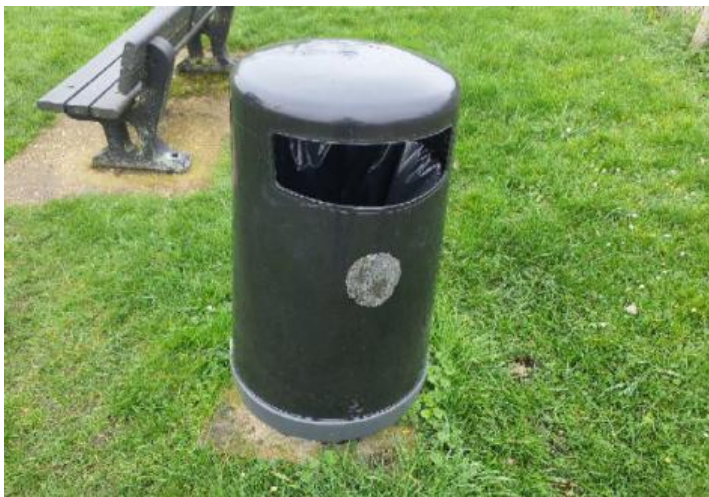
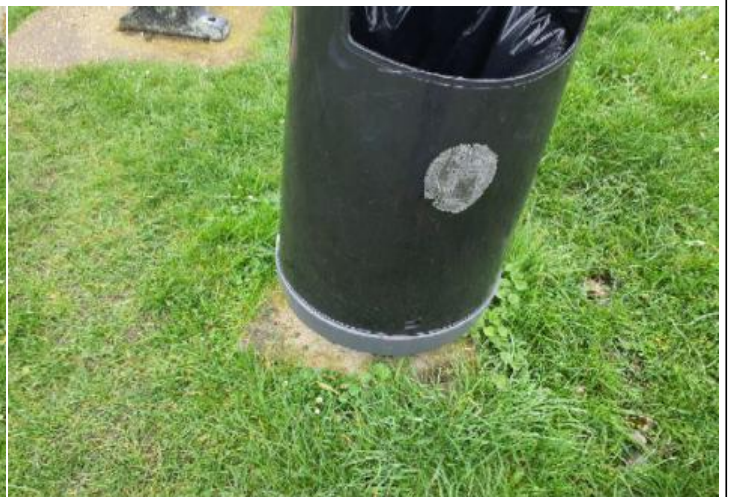
Item: Ancillary Items - Litter Bin
Manufacturer: Not Identified

Finding: The lid or door of the litter bin is not secured

Action: Ensure the lid or door is kept locked

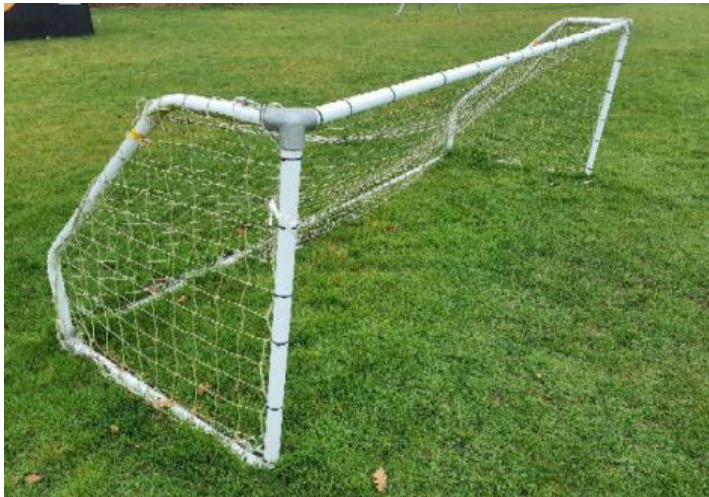
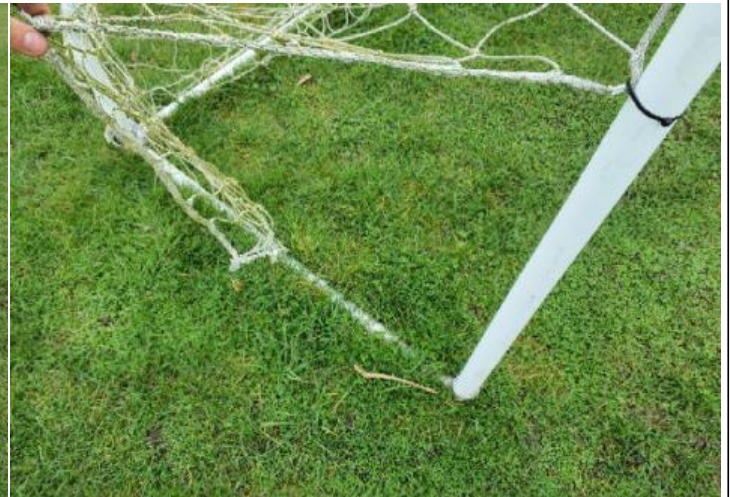
Item: Multi Use Games Area - 5 a side Goals
Manufacturer: Not Identified

Finding: The nets are not fully secured
Action: Secure nets

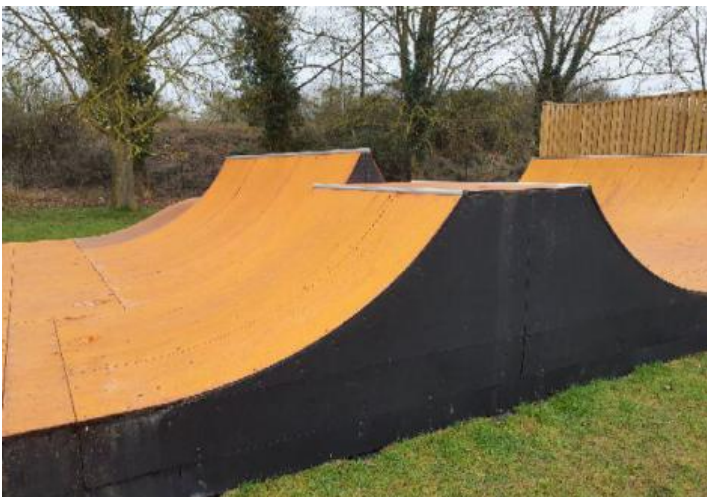
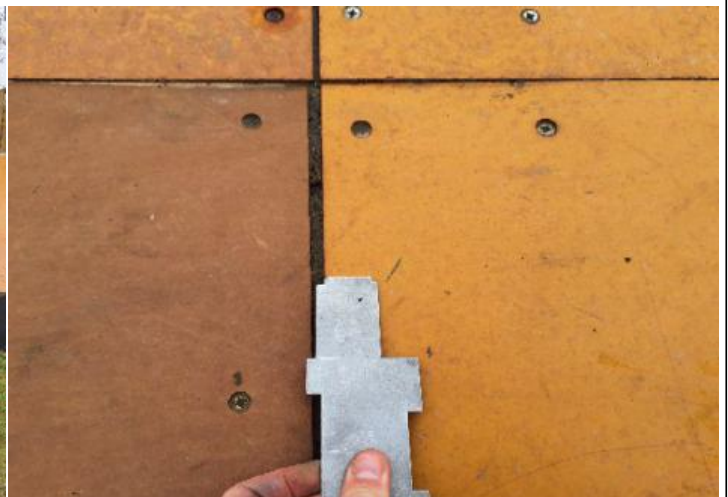
Item: Wheeled Sports - Multi Ramp
Manufacturer: Not Identified

Finding: Joints between the riding / rolling surfaces shall not be greater than 5mm in contravention of the requirements of BS EN 14974 – 6.2.4

Action: Take corrective action to ensure that the gaps between the joints do not exceed 5mm

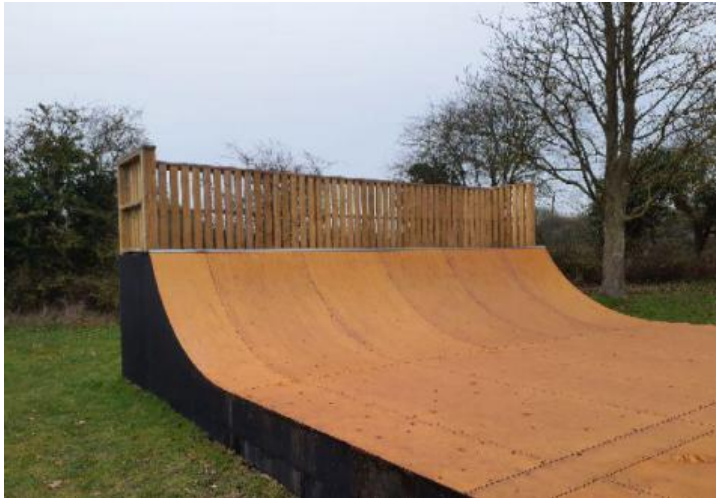
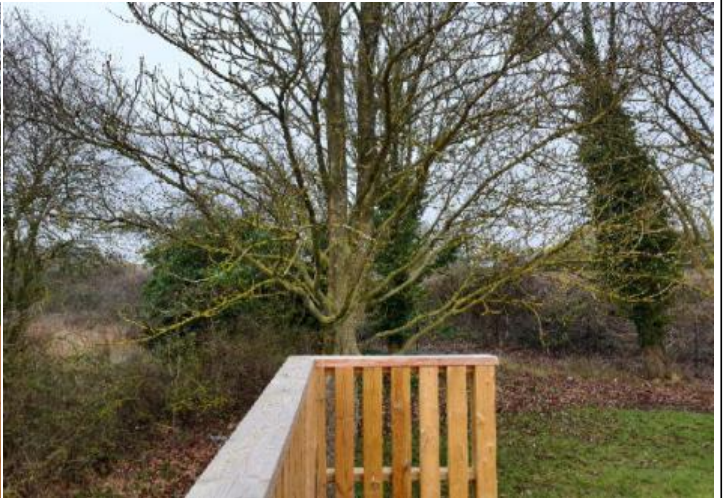
Item: Wheeled Sports - Quarter Pipe
Manufacturer: Not Identified

Finding: The tree canopy overhangs the equipment and is less than 2.0m away

Action: Lift tree canopy to ensure a minimum clearance of 2.0m from the equipment

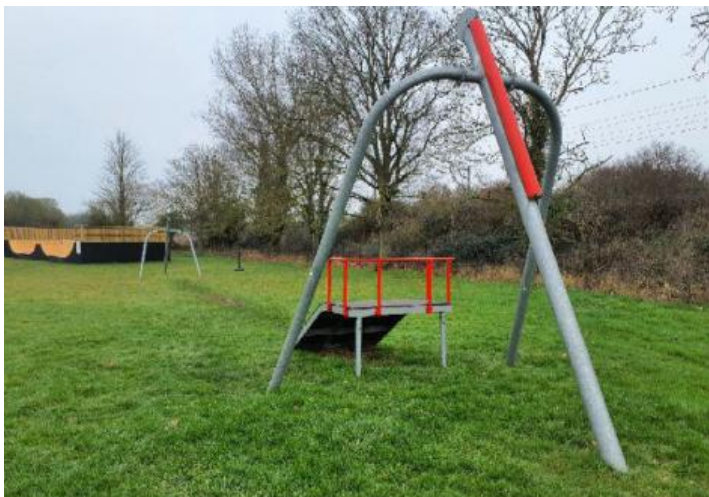
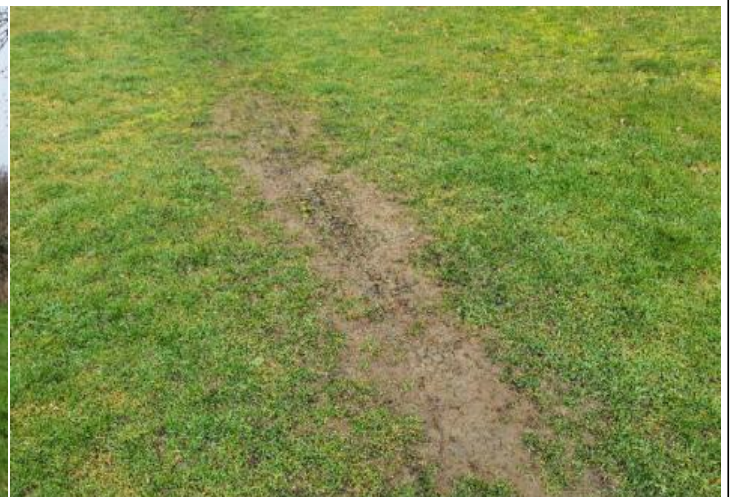
Item: Other - Cable Runway
Manufacturer: Sutcliffe Play Limited

Finding: The grass mats are silted up, the soil is compacted and the area will become very slippery when the soil is wet.

Action: Reinstate as required

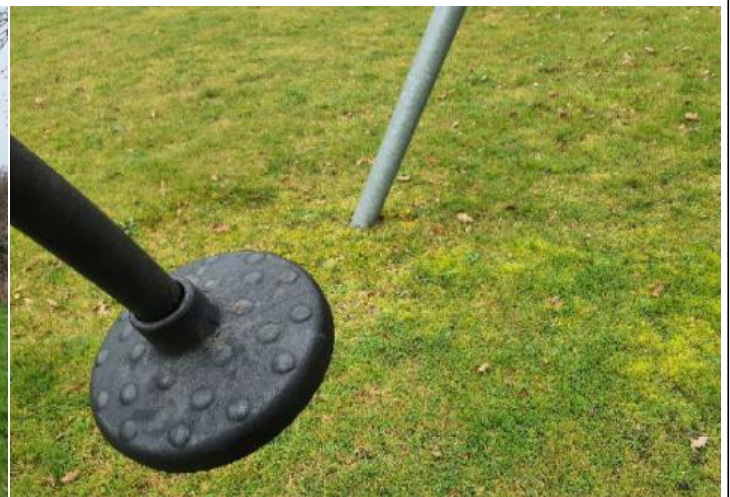
Item: Other - Cable Runway
Manufacturer: Sutcliffe Play Limited

Finding: The seat is less than 2.0 metres from the post when extended at 45 degrees at the end of the area of travel and does not meet the requirements of BS EN 1176 Part 4

Action: Adjust the cable stop position to ensure the minimum distance is maintained

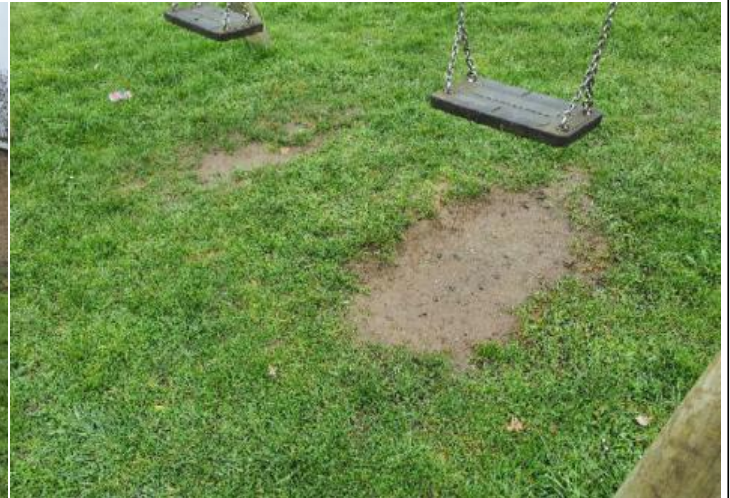
Item: Swings - 1 Bay 2 Seat (Flat)
Manufacturer: Adventure Playgrounds

Finding: The grass mats are silted up, the soil is compacted and the area will become very slippery when the soil is wet. **Action:** Reinstate as required

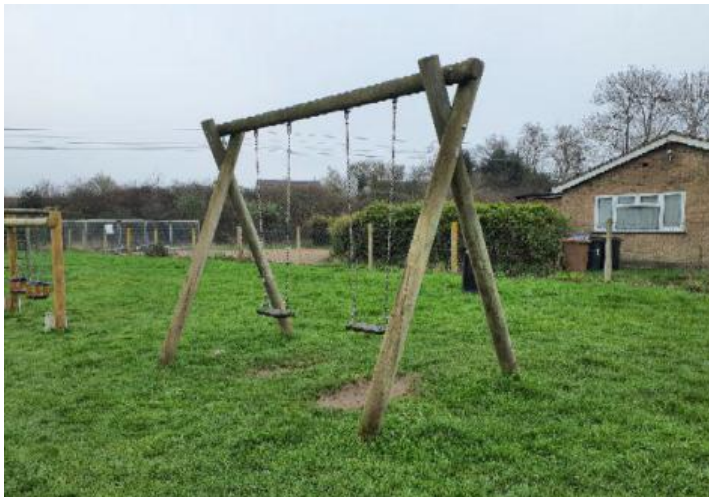
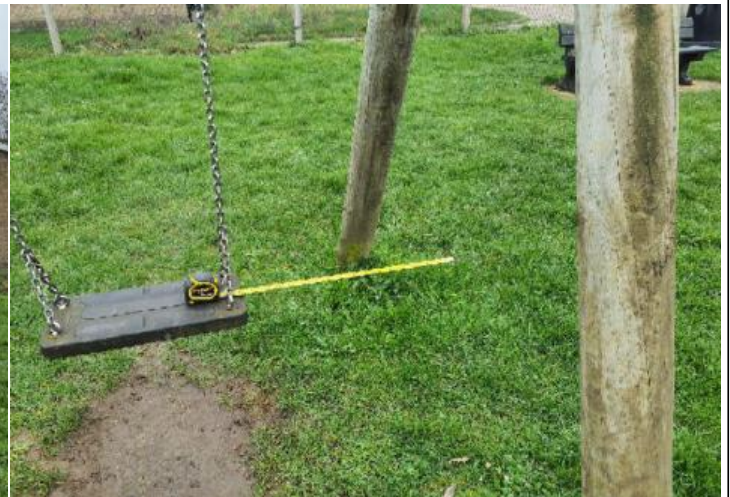
Item: Swings - 1 Bay 2 Seat (Flat)
Manufacturer: Adventure Playgrounds

Finding: The seat/s is / are too close to the frame as defined in BS EN 1176 Part 2

Action: Monitor - No action given the risk assessment

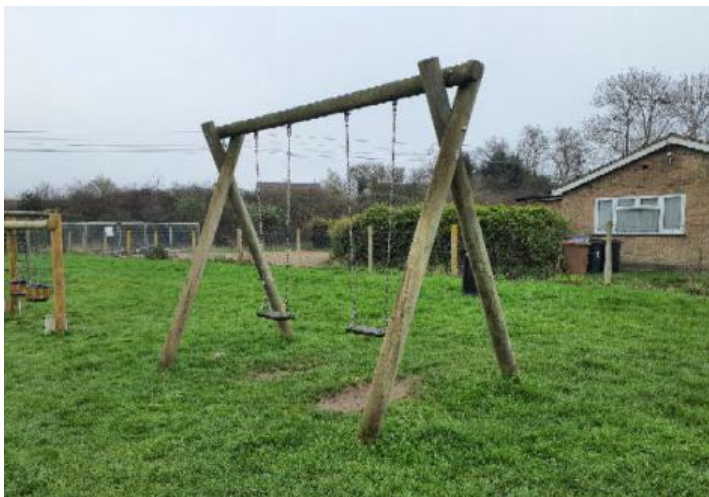
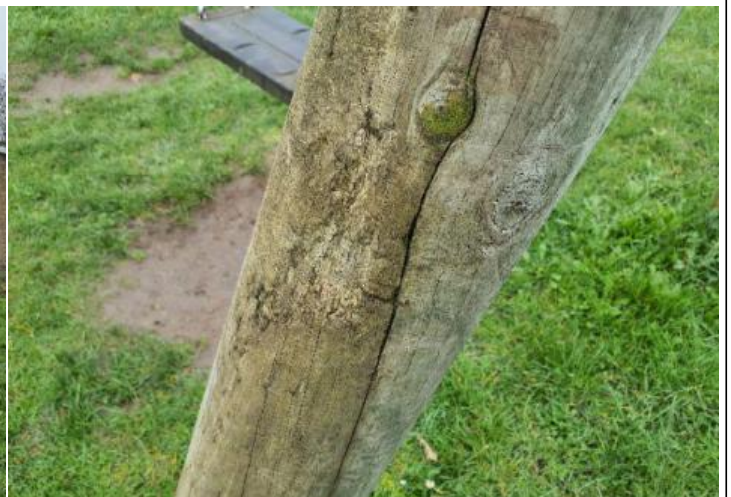
Item: Swings - 1 Bay 2 Seat (Flat)
Manufacturer: Adventure Playgrounds

Finding: Parts of the timber are rough or splintered

Action: Remove all rough or sharp edges

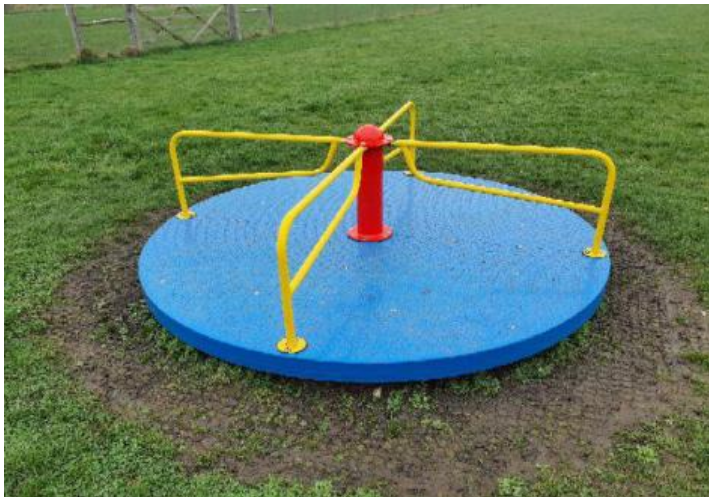
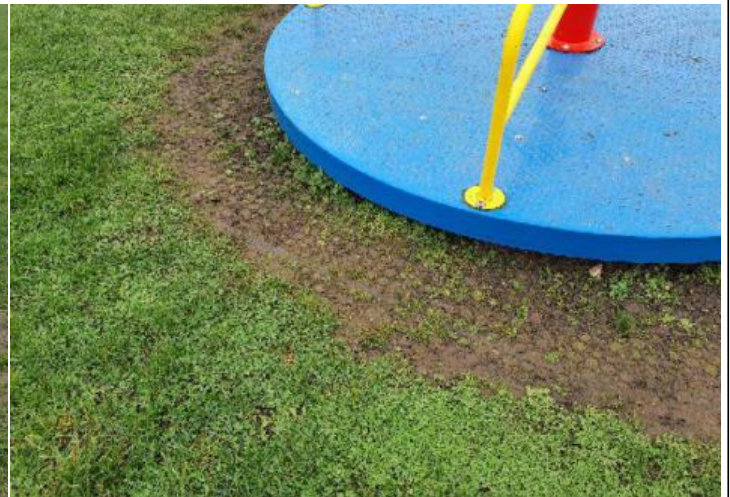
Item: Rotor Play - Roundabout
Manufacturer: Yates Playgrounds Ltd

Finding: The grass mats are silted up, the soil is compacted and the area will become very slippery when the soil is wet.

Action: Reinstate as required

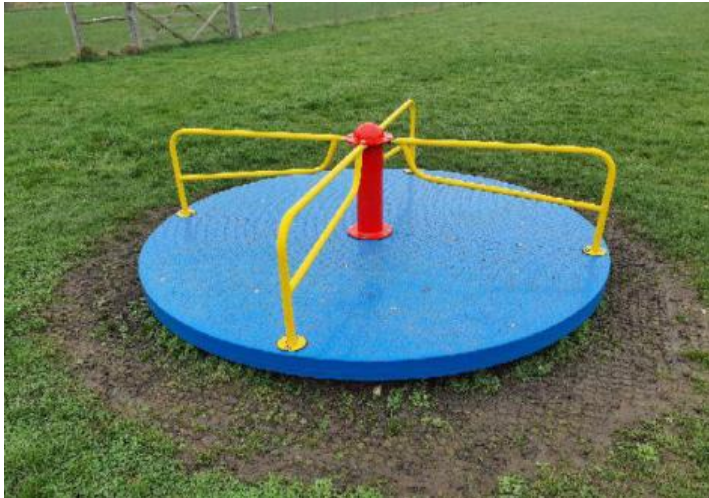
Item: Rotor Play - Roundabout
Manufacturer: Yates Playgrounds Ltd

Finding: The distance between the underside of the roundabout platform and the playing surface is less than 60mm and contravenes the requirements of BS EN 1176 Part 5 which requires that the distance be maintained between 60mm-110mm for the entire circumference of the roundabout

Action: Monitor - No action given the risk assessment

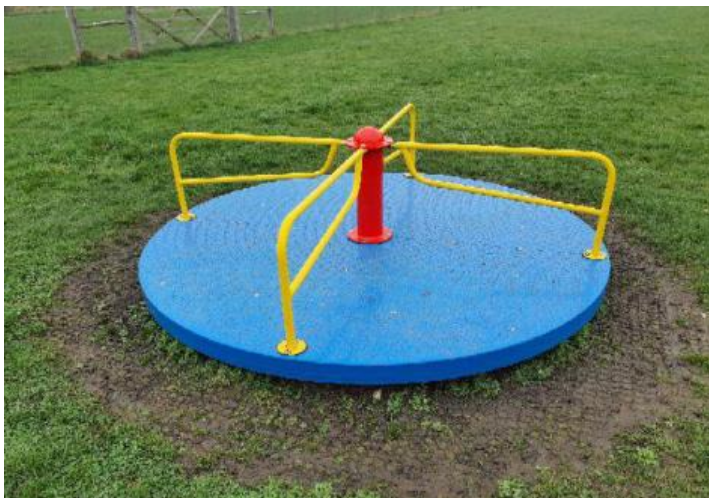
Item: Rotor Play - Roundabout
Manufacturer: Yates Playgrounds Ltd

Finding: There are projecting bolt thread(s) present

Action: Remove excess thread length and deburr or provide cap
